# **Asbestos Register Resurvey Report**

<b>Asset Name:</b>	Blackheath Early Childhood Centre	<b>Date:</b>	8 April 2019	<b>RAR No:</b>	RAR-94
<b>Asset Address:</b>	267-269 Great Western Highway Blackheath	<b>Inspection Carried Out By:</b>	John Parkinson	<b>HPE No:</b>	19/84675
<b>Are Staff/PCBU aware that there is ACM onsite?</b>		YES			
<b>Is there a copy of the Asbestos Register for this location onsite?</b>		Yes			
<b>Is there a copy of the Asbestos Management Plan for this location onsite?</b>		YES

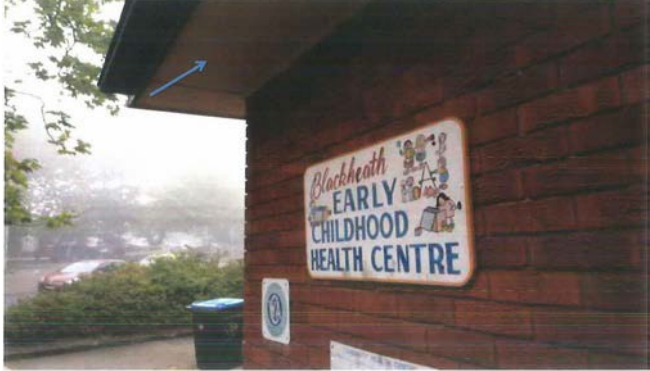
Reference Number Int / Ext Floor Specific Location	Photographs
<p>2992 External Eave Lining</p>

Reference Number	Sample Number	Location			Analysis	Risk assessment						Additional information		
		Int / Ext Floor Specific Location	Material Type	Extent	Result	Accessibility	Condition	Friability of Asbestos	Sealed/ Surface Treatments	Risk Assessment	Recommended Control Actions	Labels Affixed	Additional Comments	Next Inspection due date
2992	21880-4	External – Eave Lining	Fibrous Cement Sheeting	100m2	Positive	1 Non-Accessible	1 Good	1 Non-Friable	1 Sealed	4 Very low	A4	N	Flaking Paint some areas	12 Months
2993	Similar to 21880-4	External Entrance ceiling lining	Fibrous Cement Sheeting	5m2	Assumed Positive	1 Non-Accessible	1 Good	1 Non-Friable	1 Sealed	4 Very low	A4	N		12 Months
2994	21880-5	External Eastern Bay Windows (waiting room) shingles above	Fibrous Cement Sheeting	5m2	Positive	1 Non-Accessible	1 Good	1 Non-Friable	1 Sealed	4 Very low	A4	N		12 Months
2995	Similar to 21880-5	External Western Bay Windows (waiting room) shingles above	Fibrous Cement Sheeting	5m2	Assumed Positive	1 Non-Accessible	1 Good	1 Non-Friable	1 Sealed	4 Very low	A4	N		12 Months

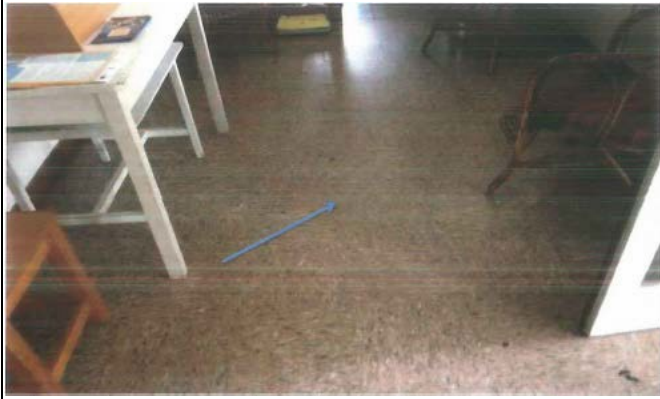
2997  
Internal  
Entrance Room  
Vinyl floor tiles

2996	21880-6	External window frames window putty	Mastic		Negative						A5			
2997	21880-7	Internal Entrance Room Vinyl floor tiles	Brown Vinyl Tiles	20m2	Positive	1 Non-Accessible	1 Good	1 Non-Friable	1 Sealed	4 Very low	A4	N		12 Months

21880-7	Blackheath Early Childhood Centre - Internal - Entrance Room - vinyl floor tiles	25x16x3mm brown vinyl floor tile fragment	Chrysotile asbestos detected
21880-8	Blackheath Shelter Shed (Near Crossing) - External - Roof shingles	43x18x5mm fibrous cement sheet fragment	Chrysotile asbestos detected
21880-9	Blackheath Shelter Shed (Near Crossing) - External - ceiling lining	4x2x1mm fibrous cement sheet fragment	Chrysotile asbestos detected Crocidolite asbestos detected
21880-10	Blaxland Community Centre/Library - External - brick external walls - expansion joints (red brick areas)	10x9x4mm mastic fragment	No asbestos detected
21880-11	Blaxland Community Centre/Library - External - timber cladding external walls - expansion joints	26x10x5mm mastic fragment	Chrysotile asbestos detected
21880-12	Blaxland Community Centre/Library - External - Library - infill panels beneath windows	4x3x1mm fibreboard fragment	Chrysotile asbestos detected [Organic fibres detected]

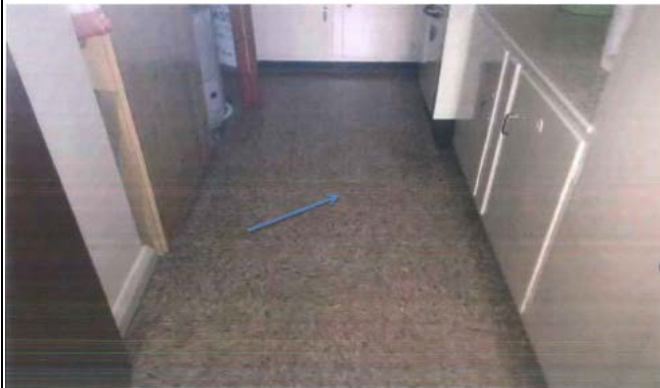
2998  
Internal  
Kitchen  
Vinyl Floor Tiles

2998	Similar to 21880-7	Internal Kitchen Vinyl Floor Tiles	Brown Vinyl Tiles	6m2	Assumed Positive	1 Non-Accessible	1 Good	1 Non-Friable	1 Sealed	4 Very low	A4	N		12 Months
2999	Similar to 21880-7	Internal Waiting Room Vinyl Floor Tiles	Brown Vinyl Tiles	5m2	Assumed Positive	1 Non-Accessible	1 Good	1 Non-Friable	1 Sealed	4 Very low	A4	N		12 Months
3000		Subfloor											No Packers or Fragments
