Lomatia Park - Amenities Block

Asbestos/Lead Register & Management Plan

Blue Mountains City Council conducted Hazardous Materials Management Register for the workplace located at 32-34 Bland Road Springwood NSW 2777.

The inspection was conducted on 01/11/2022, and the following items were identified:

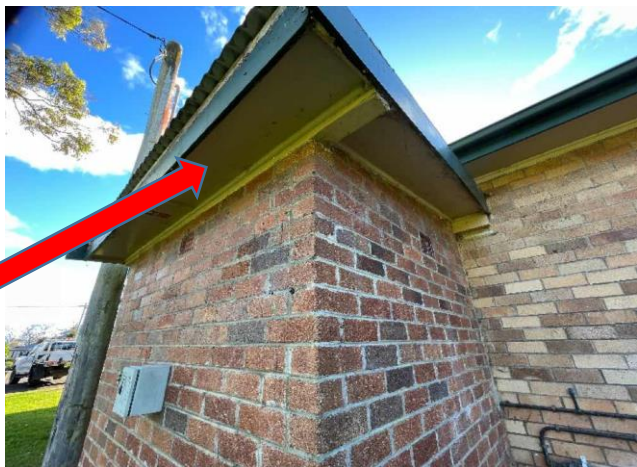
External, GF, Exterior, West, Eaves, Perimeter of electrical room - Fibre Cement Sheet, Chrysotile & Amosite Asbestos detected, Previously sampled, same as B17399S01

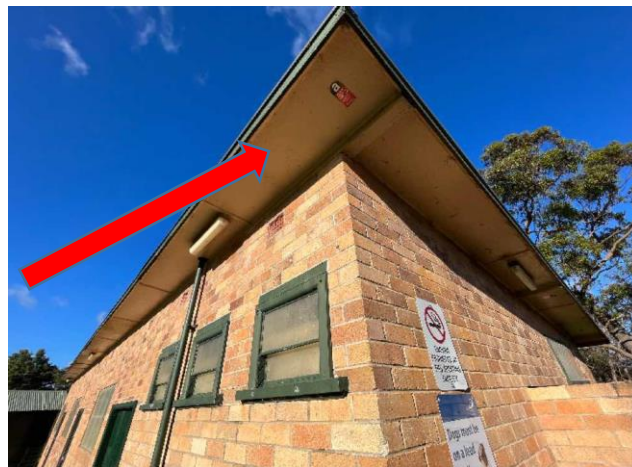
External, GF, Exterior, Eaves, Perimeter of main amenities - Fibre Cement Sheet, Chrysotile & Amosite Asbestos detected, Previously sampled B17399S01

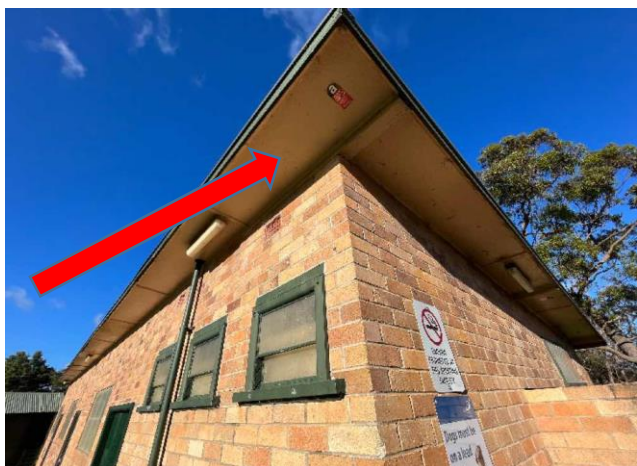
External, GF, Exterior, External cream paint system - Cream - Topcoat, Lead Detected (1.0%w/w), Previously sampled 17399-S05

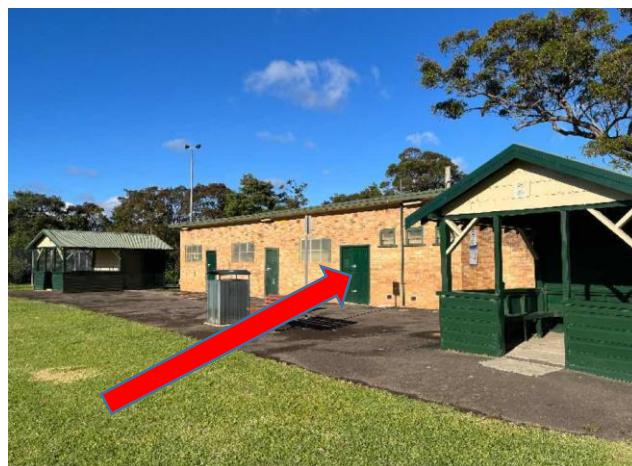
External, GF, Exterior, External green paint system - Green - Topcoat, Lead detected, 437871-LP01

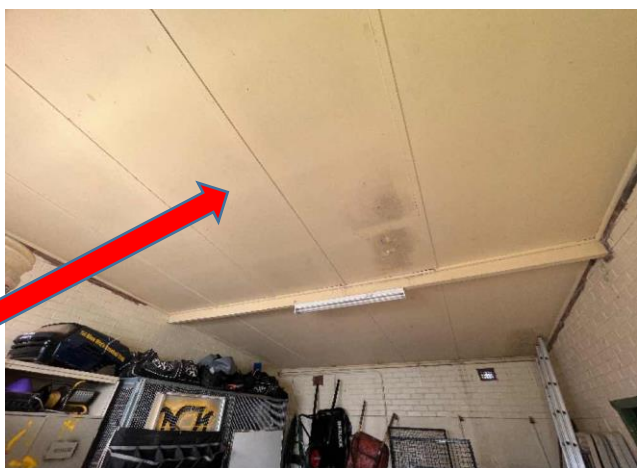
Internal, GF, Central (north) storeroom (Cricket storeroom), Ceiling -

Photo #	REF #	HAZARD	RESULT	SPECIFIC LOCATION	MATERIAL	QUANTITIY	FRIABILITY	OVERALL RISK	ACTION CODE	TIMEFRAME	COMMENTS
5	Previously sampled, similar to B17399S02	Asbestos	Chrysotile & Amosite Asbestos detected	Ceiling	Fibre Cement Sheet	40 m ²	Non-Friable	Very Low	A4	5 Yearly Reinspection	-

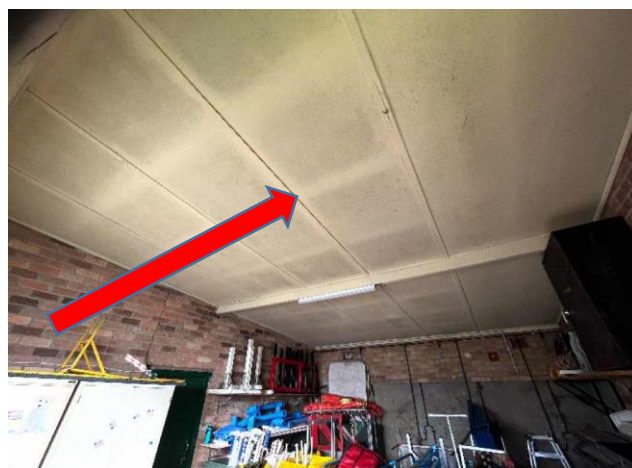
Internal, GF, Central (south) storeroom (Dog club), Ceiling - Fibre Cement

Fibre Cement Sheet, Chrysotile & Amosite Asbestos detected, Previously sampled, similar to B17399S02

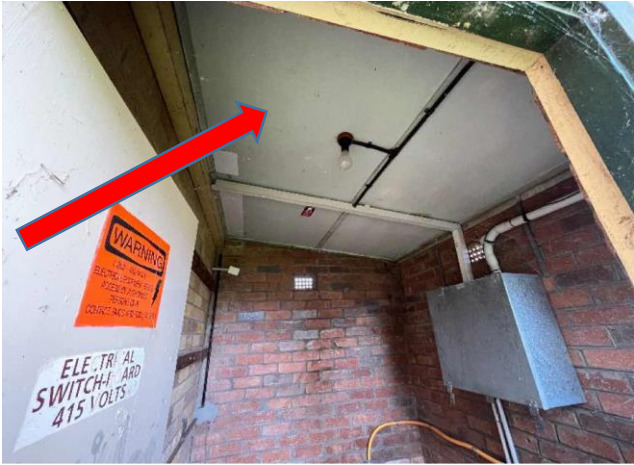
Internal, GF, Electrical board room (western side), Ceiling - Fibre Cement Sheet, Chrysotile & Amosite Asbestos detected, Previously sampled, similar to B17399S02

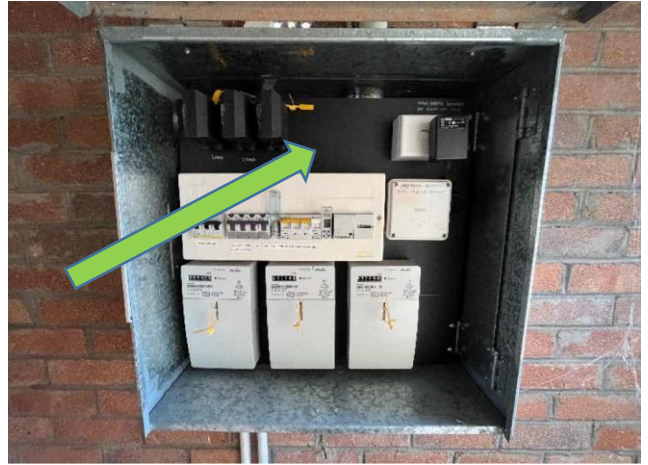
Internal, GF, Electrical board room (western side), West, Wall - Electrical backing board, No Asbestos Detected, Visually identified

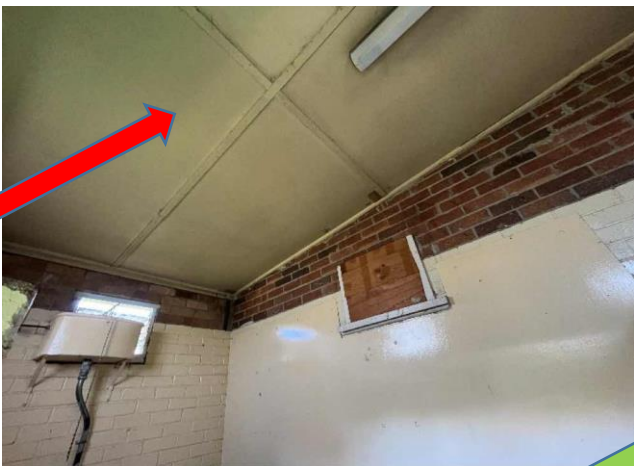
Internal, GF, Men's toilet, Ceiling - Fibre Cement Sheet, Chrysotile & Amosite Asbestos detected, Previously sampled, similar to B17399S02

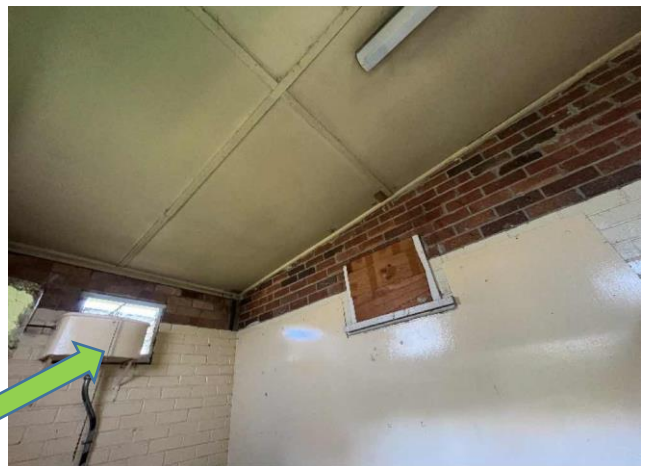
Internal, GF, Men's toilet, Mens urinal cistern - Moulded Fibre Cement, No Asbestos Detected, Previously sampled B17399S03

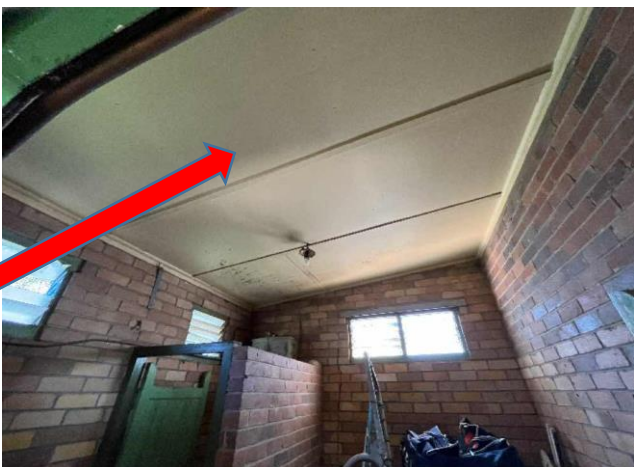
Photo #	REF #	HAZARD	RESULT	SPECIFIC LOCATION	MATERIAL	QUANTITIY	FRIABILITY	OVERALL RISK	ACTION CODE	TIMEFRAME	COMMENTS
11	Previously sampled, similar to B17399S02	Asbestos	Chrysotile & Amosite Asbestos detected	Ceiling	Fibre Cement Sheet	10 m ²	Non-Friable	Very Low	A4	5 Yearly Reinspection	-

Internal, GF, North west corner storeroom/toilet, Ceiling - Fibre Cement Sheet, Chrysotile & Amosite Asbestos detected, Previously sampled, similar to B17399S02

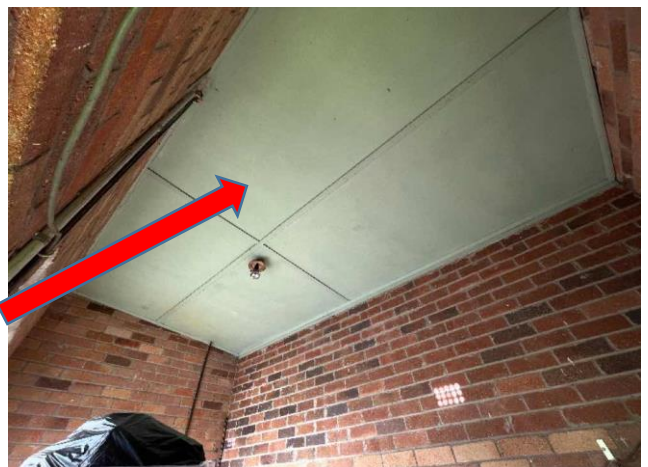
Photo #	REF #	HAZARD	RESULT	SPECIFIC LOCATION	MATERIAL	QUANTITIY	FRIABILITY	OVERALL RISK	ACTION CODE	TIMEFRAME	COMMENTS
12	Previously sampled B17399S02	Asbestos	Chrysotile & Amosite Asbestos Detected	Ceiling	Fibre Cement Sheet	8 m ²	Non-Friable	Very Low	A4	5 Yearly Reinspection	-

Internal, GF, South West Room (kitchen), Ceiling - Fibre Cement Sheet, Chrysotile & Amosite Asbestos Detected, Previously sampled B17399S02

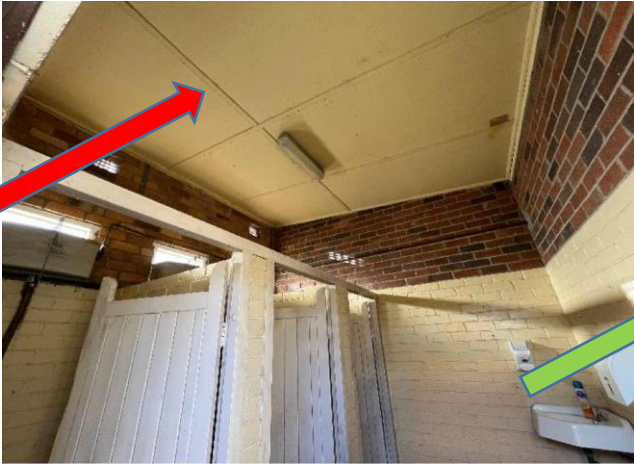
Photo #	REF #	HAZARD	RESULT	SPECIFIC LOCATION	MATERIAL	QUANTITIY	FRIABILITY	OVERALL RISK	ACTION CODE	TIMEFRAME	COMMENTS
13	Previously sampled, similar to B17399S02	Asbestos	Chrysotile & Amosite Asbestos detected	Ceiling	Fibre Cement Sheet	10 m ²	Non-Friable	Very Low	A4	5 Yearly Reinspection	-
14	Previously sampled B17399-S7	Asbestos	No Asbestos Detected	Women's toilet cistern	Moulded Fibre Cement	3 Units	Not Applicable	-	A5	-	-

Internal, GF, Women's toilet, Ceiling - Fibre Cement Sheet, Chrysotile & Amosite Asbestos detected, Previously sampled, similar to B17399S02

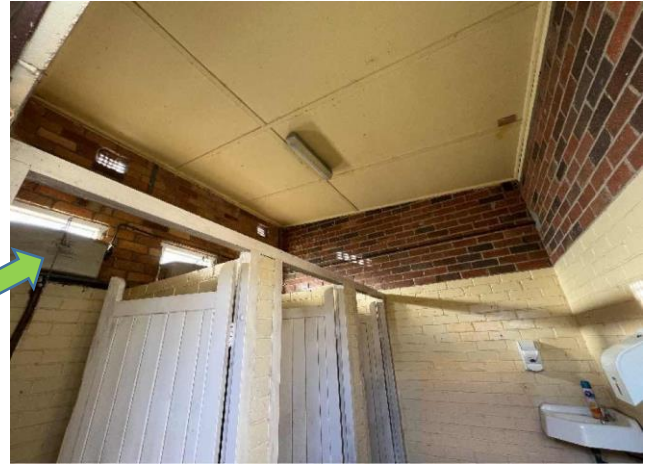
Internal, GF, Women's toilet, Women's toilet cistern - Moulded Fibre Cement, No Asbestos Detected, Previously sampled B17399-S7
