Katoomba Aquatic Centre - Main Centre

# **Asbestos/Lead Register & Management Plan**

<b>REPORT TYPE</b>	Hazardous Materials Management Register
<b>THE CLIENT</b>	Blue Mountains City Council
<b>AREA COVERED BY THE SCOPE</b>	Katoomba Aquatic Centre
<b>LEAD SURVEYOR</b>	Luke Trevena
<b>ASSISTANT SURVERYOR</b>	-
<b>INSPECTION DATE</b>	29/09/2022

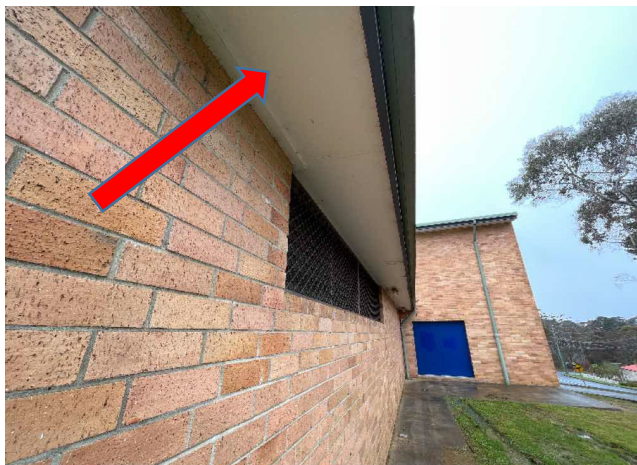
Photo #	REF #	HAZARD	RESULT	SPECIFIC LOCATION	MATERIAL	QUANTITIY	FRIABILITY	OVERALL RISK	ACTION CODE	TIMEFRAME	COMMENTS
1	B17382-S28	Asbestos	Chrysotile	Eave Linings	Fibre Board	Approx 10 m <sup>2</sup>	Non-Friable	Very Low	A4	5 Yearly Reinspection	Accessible to Tradespeople

External, GF, Adjacent Kids Kingdom, Eave Linings - Fibre Board, Chrysotile, B17382-S28

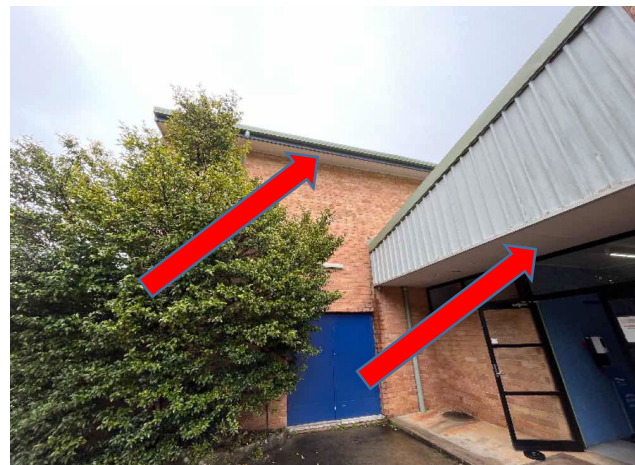
External, GF, Exterior, External Eaves Adjacent Band Hall - Fibreboard, Assumed Positive, Similar to B17382-S28 - Assumed Chrysotile

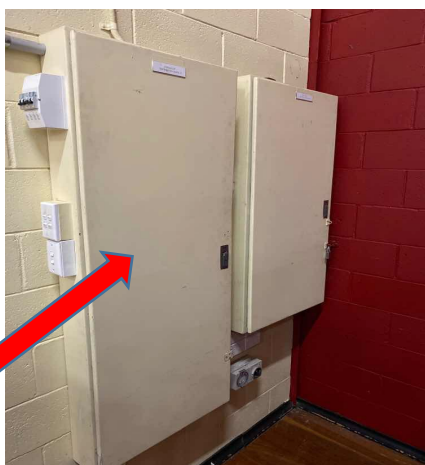
Photo #	REF #	HAZARD	RESULT	SPECIFIC LOCATION	MATERIAL	QUANTITIY	FRIABILITY	OVERALL RISK	ACTION CODE	TIMEFRAME	COMMENTS
3	Assumed positive	Asbestos	Assumed Positive	Electrical Meter Board - Note: Electrical Cabinets were locked Therefore Could Not Be Accessed	Fibre Board	2 m2	Non-Friable	Very Low	A4	5 Yearly Reinspection	Cupboards locked. Condition Unknown Reinspect During Building Maintenance Schedule

Internal, GF, Kids Kingdom Electrical Switchboard, Electrical Meter Board - Note: Electrical Cabinets were locked Therefore Could Not Be Accessed - Fibre Board, Assumed Positive, Assumed positive

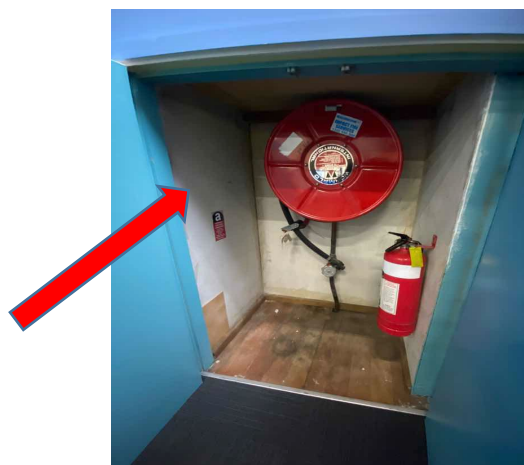
Photo #	REF #	HAZARD	RESULT	SPECIFIC LOCATION	MATERIAL	QUANTITIY	FRIABILITY	OVERALL RISK	ACTION CODE	TIMEFRAME	COMMENTS
4	B17382-S20	Asbestos	Chrysotile	Fire Hydrant Cupboard Lining Fibre Board	Fibre Board	3 m2	Non-Friable	Very Low	A4	5 Year Reinspection	Accessible to anyone.

Internal, GF, Kids Kingdom Fire Hydrant Cupboard, Fire Hydrant Cupboard Lining Fibre Board - Fibre Board, Chrysotile, B17382-S20

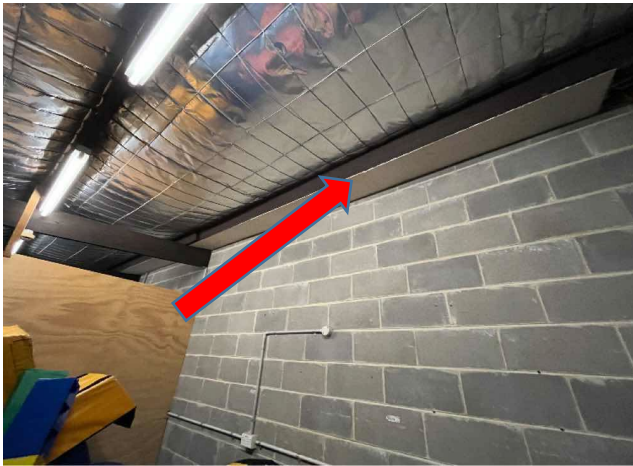
Photo #	REF #	HAZARD	RESULT	SPECIFIC LOCATION	MATERIAL	QUANTITIY	FRIABILITY	OVERALL RISK	ACTION CODE	TIMEFRAME	COMMENTS
5	B17382-S24	Asbestos	Chrysotile	Infill panels at top of wall	Fibre Board	Approx 10 m <sup>2</sup>	Non-Friable	Low	A3	As soon as reasonably practicable	Enclose exposed edge.

Internal, GF, Kids Kingdom Gymnastics Equipment Store Room, Infill panels at top of wall - Fibre Board, Chrysotile, B17382-S24

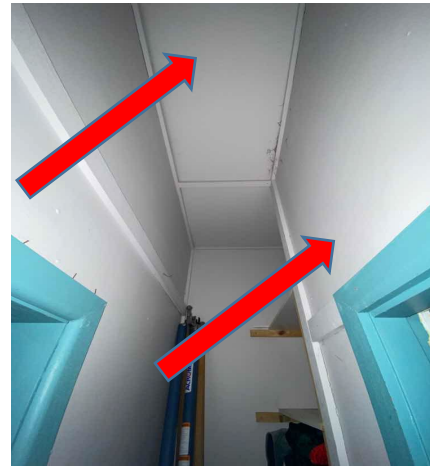
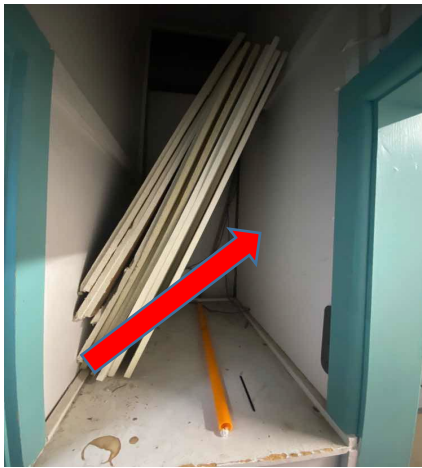
Photo #	REF #	HAZARD	RESULT	SPECIFIC LOCATION	MATERIAL	QUANTITIY	FRIABILITY	OVERALL RISK	ACTION CODE	TIMEFRAME	COMMENTS
6&7	B17382-S23	Asbestos	Chrysotile	Walls and Ceiling	Fibre Board	15 m2	Non-Friable	Very Low	A4	5 Yearly Reinspection	Accessible to Tradespeople

Internal, GF, Kids Kingdom Kitchen Foyer/Storage Room, Walls and Ceiling - Fibre Board, Chrysotile, B17382-S23
