Mount Riverview Community Hall & Tennis
Clubhouse

Asbestos/Lead Register & Management Plan

Blue Mountains City Council conducted Hazardous Materials Management Register for the workplace located at 178 Rusden Road Mount Riverview NSW 2774.

The inspection was conducted on 21/09/2022, and the following items were identified:

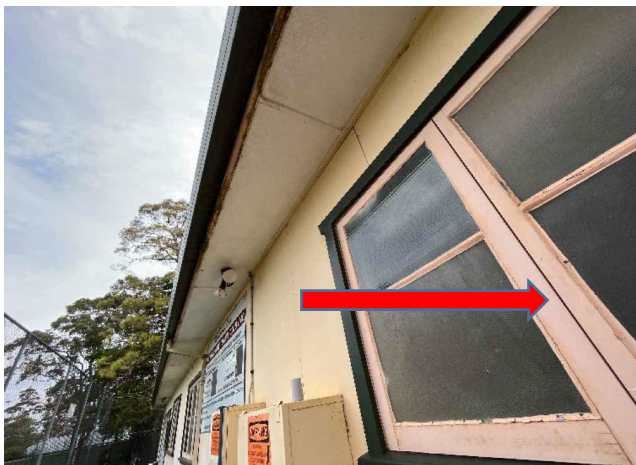
External, GF, All Windows, Frames - Pink - Topcoat, Lead Detected (%0.82 w/w), 17380-1

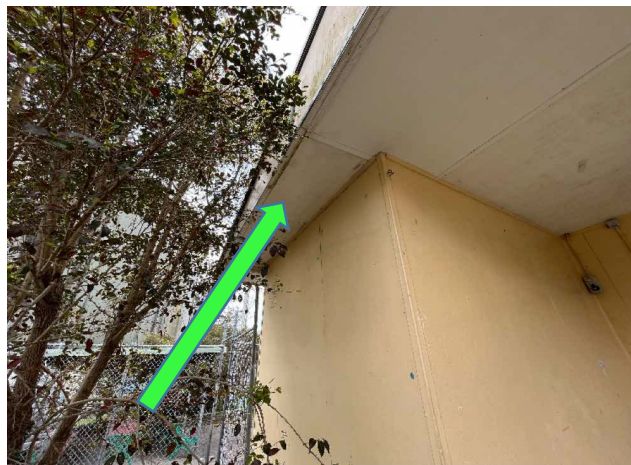
External, GF, Exterior, East, Eave - Fibre Cement Sheet, No Asbestos Detected, B17380S24

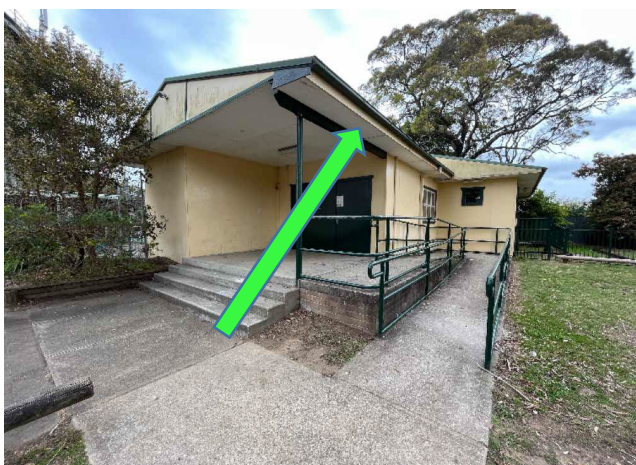
External, GF, Exterior, North East, Eave - Fibre Cement Sheet, No Asbestos Detected, Similar to B17380S24

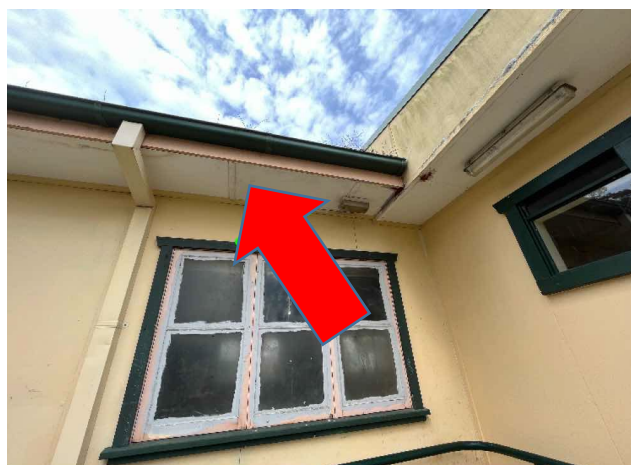
External, GF, Exterior, North, Eave lining to Approx 1.2m, Above Wheelchair Ramp - Fibre Cement Sheet, Chrysotile Asbestos, B17380S02 & B17380S32

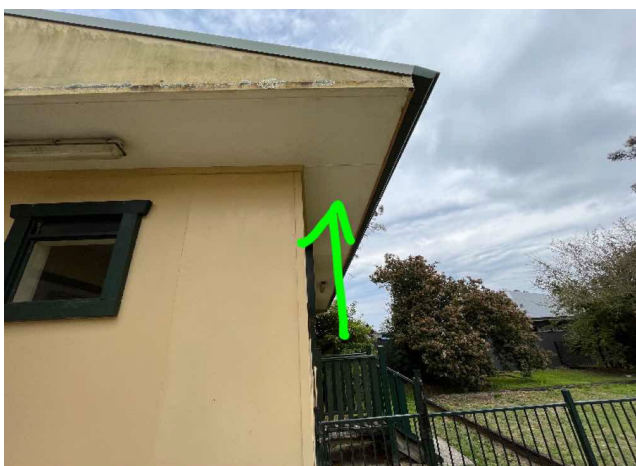
External, GF, Exterior, North, Eaves - Fibre Cement Sheet, No

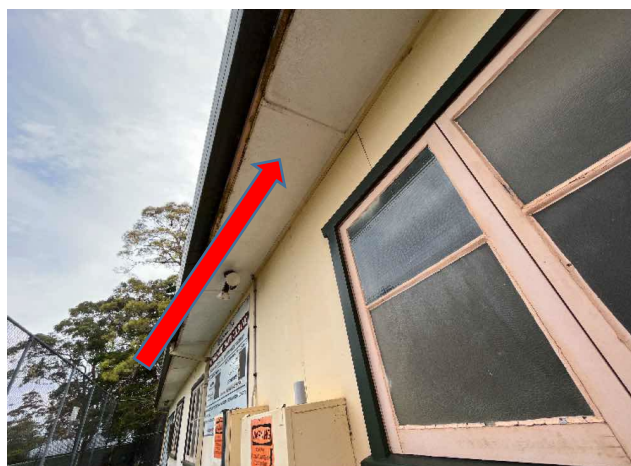
External, GF, Exterior, South, Eaves adjacent original hall - Fibre Cement

Asbestos Detected, B17380S03 & B17380S25

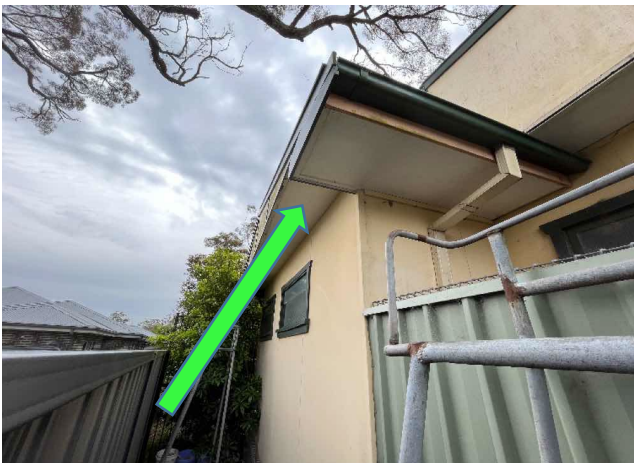
External, GF, Exterior, South West, Eaves adjacent tennis club amenities - Fibre Cement Sheet, No Asbestos Detected, B17380S31

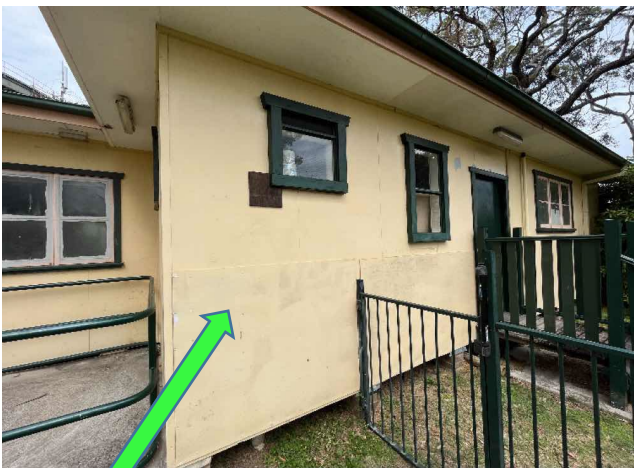
External, GF, Exterior, East, External wall - Bituminous Material, No Asbestos Detected, B17380S09

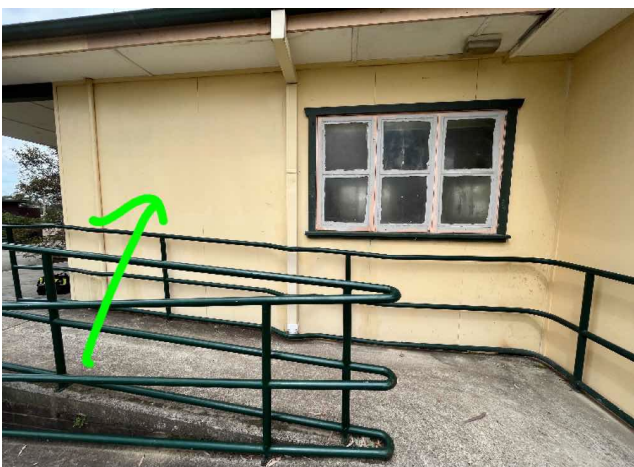
External, GF, Exterior, North, External wall - Fibre Cement Sheet, No Asbestos Detected, B17380S06

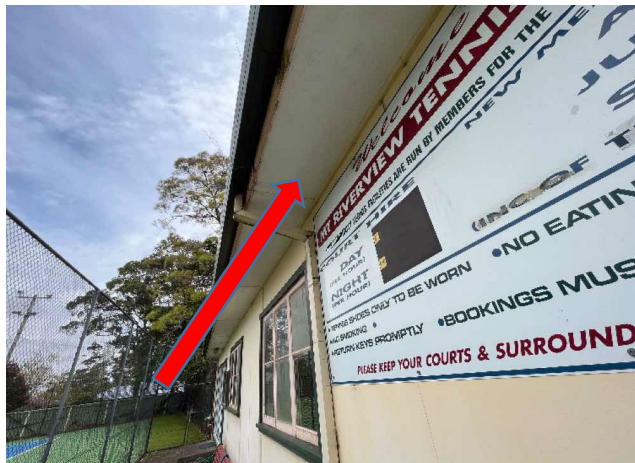
External, GF, Exterior, South, Eaves adjacent to clubhouse - Fibre Cement Sheet, Chrysotile & Amosite, B17380S11

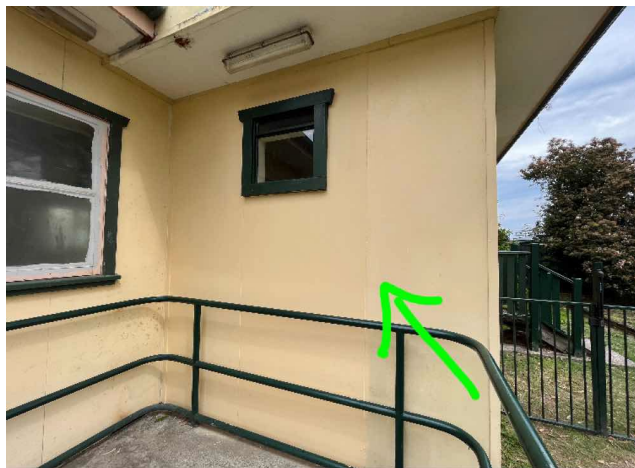
External, GF, Exterior, East, External wall - Fibre Cement Sheet, No Asbestos Detected, B17380S04

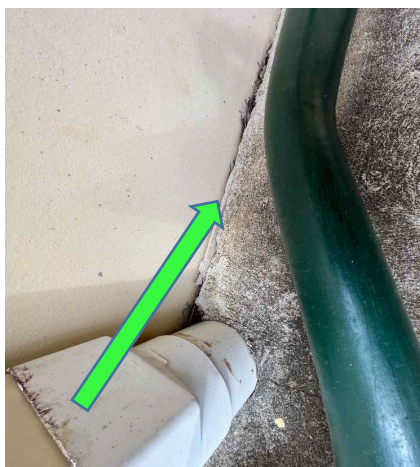
External, GF, Exterior, North, External wall - Fibre Cement Sheeting, No Asbestos Detected, B17380S08

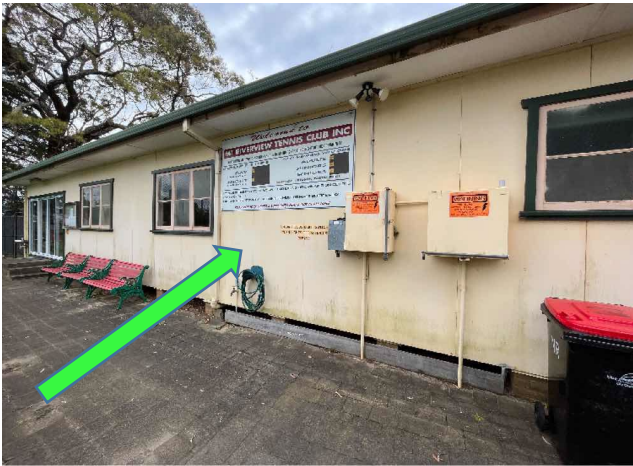
External, GF, Exterior, External walls - Cream - Topcoat, Lead Not Detected (<0.05%w/w), 17380-2

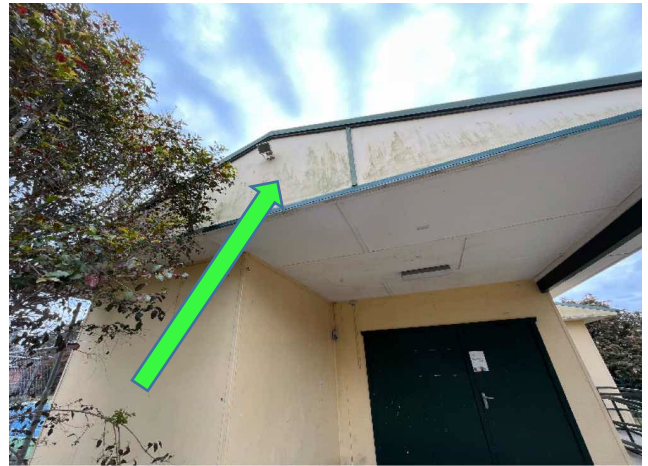
External, GF, Exterior, East, Gable end - Fibre Cement Sheet, No Asbestos Detected, B17380 S24

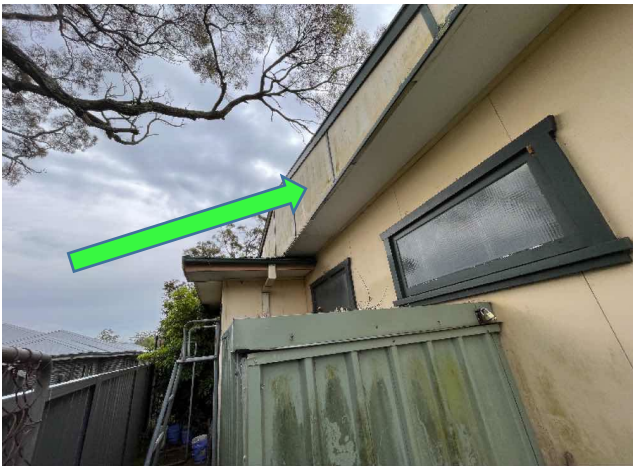
External, GF, Exterior, West, Gable end - Fibre Cement Sheet, No Asbestos Detected, B17380S23

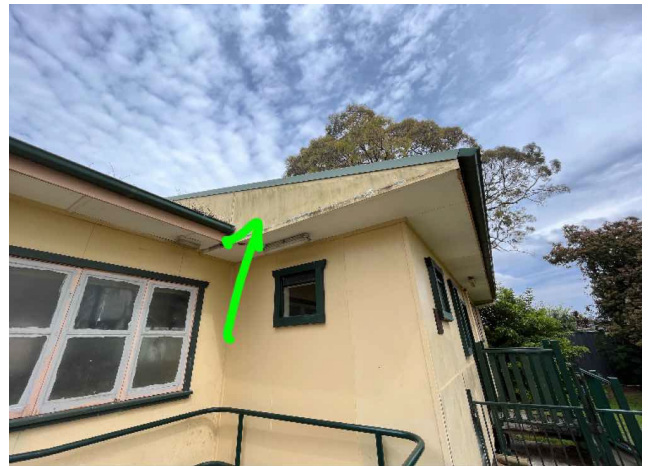
External, GF, Exterior, East, Gable infill - Fibre Cement Sheet, No Asbestos Detected, B17380S01 & B17380S26

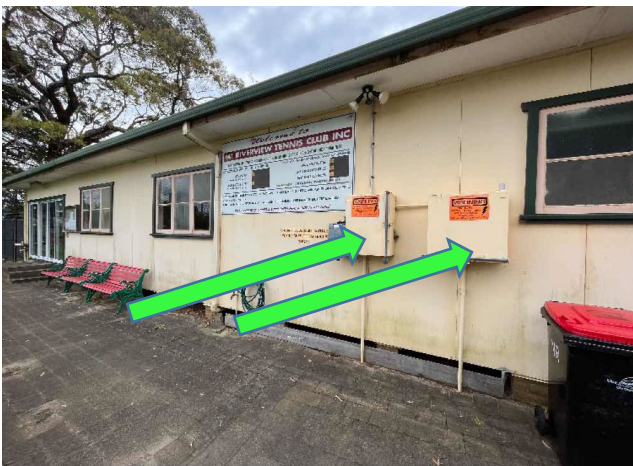
External, GF, Exterior, Wall - Electrical backing board, No Asbestos Detected, -

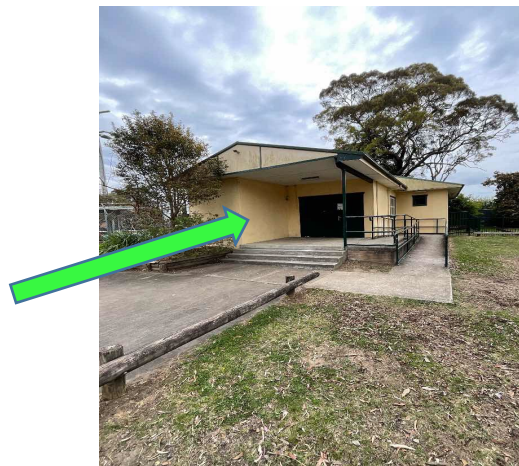
External, GF, Exterior, North East, Wall cladding - Fibre Cement Sheet, No Asbestos Detected, B17380S24 & B17380S28

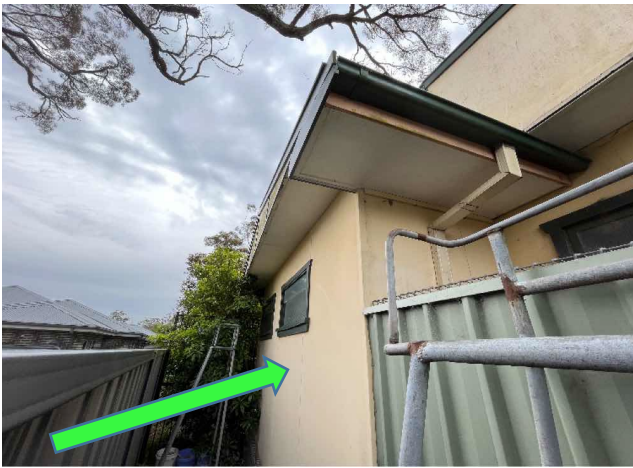
External, GF, Exterior, North West, Wall cladding - Fibre Cement Sheet, No Asbestos Detected, B17380S30

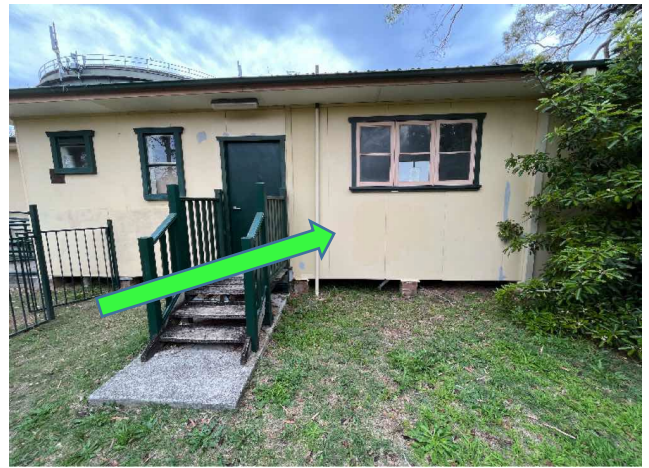
External, GF, Exterior, North West, Wall cladding - Fibre Cement Sheet, No Asbestos Detected, B17380S29

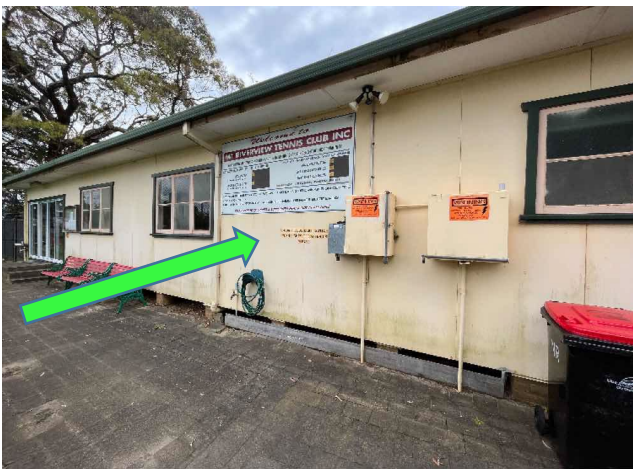
External, GF, Exterior, South, Wall cladding - Fibre Cement Sheet, No Asbestos Detected, B17380S28

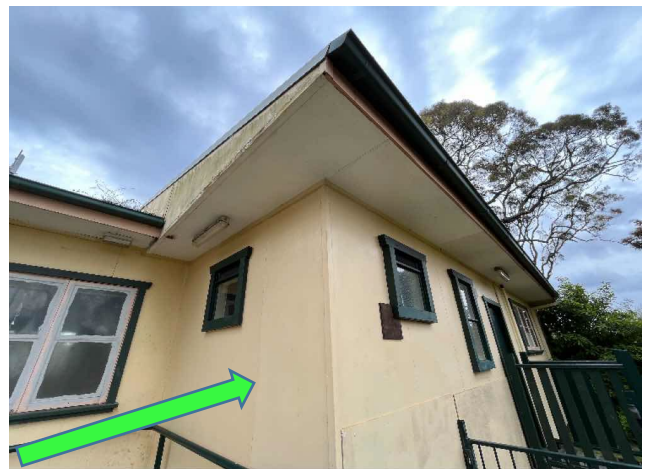
External, GF, Exterior, North, Walls and eaves adjacent wheelchair access - Fibre Cement Sheet, No Asbestos Detected, B17380S25 & B17380S31

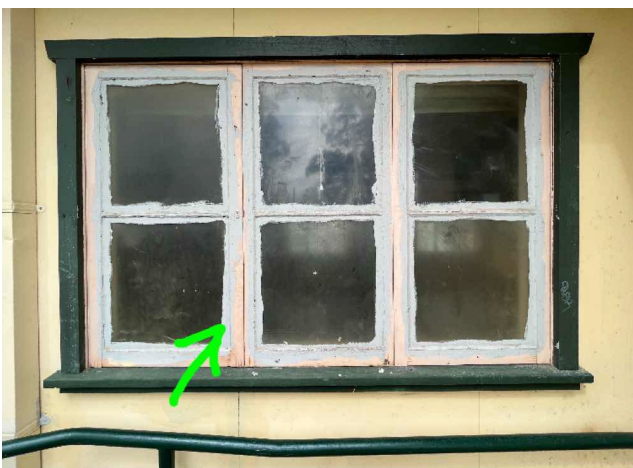
External, GF, Exterior, North, Window - Window putty, No Asbestos Detected, B17380S07

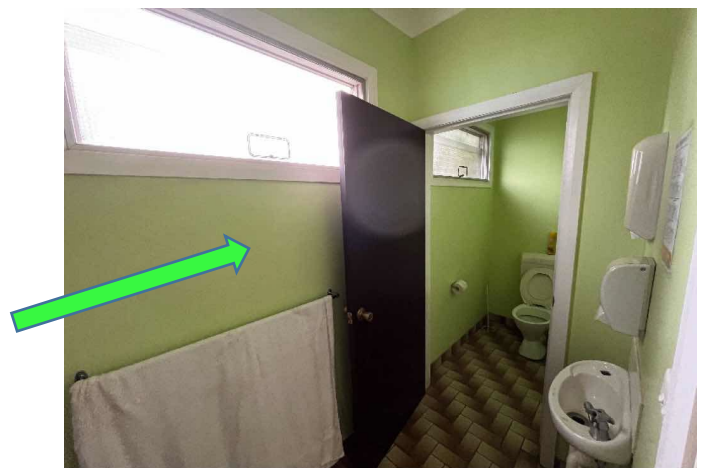
Internal, GF, Amenities, Ceiling Lining and Wall Cladding - Fibre Cement, Assumed Negative, Similar to B17380-S14 - Assumed Negative

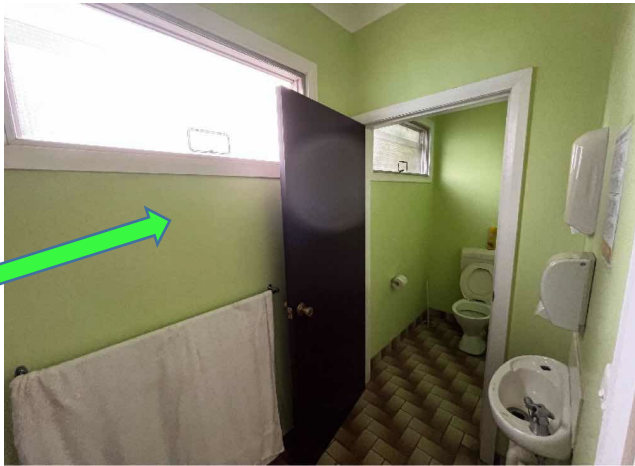
Internal, GF, Amenities, Ceilings and Walls - Fibre Cement, No Asbestos identified, B17380S14

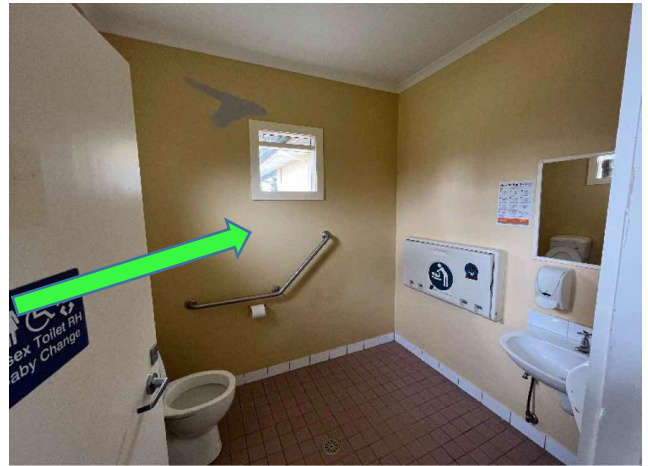
Internal, GF, Disabled Toilet and Baby Room, Ceiling Lining and Wall Cladding - Fibre Cement, No Asbestos identified, B17380S21

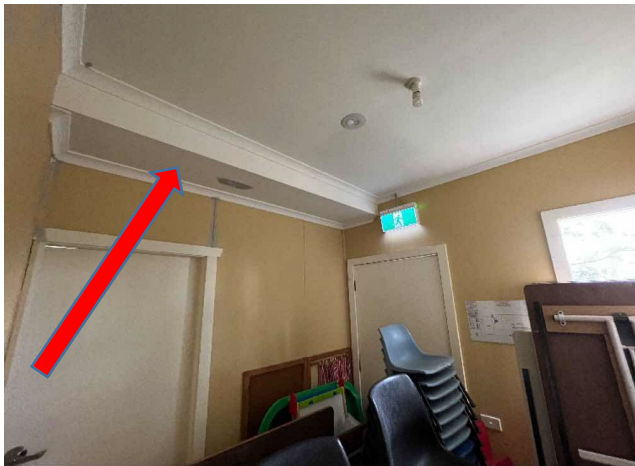
Internal, GF, Gutory Room, Bulkhead Lining - Fibre Cement, Assumed Positive, Similar to B17380S02 - Assumed Chrysotile

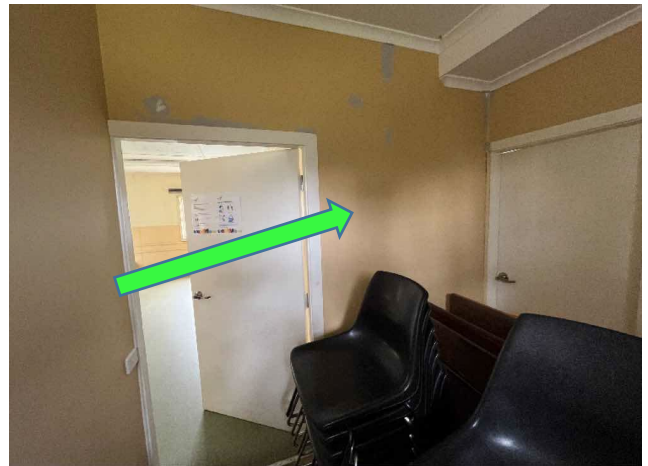
Internal, GF, Gutory Room, South, Wall cladding - Fibre Cement, No Asbestos identified, B17380S18 & B17380S20

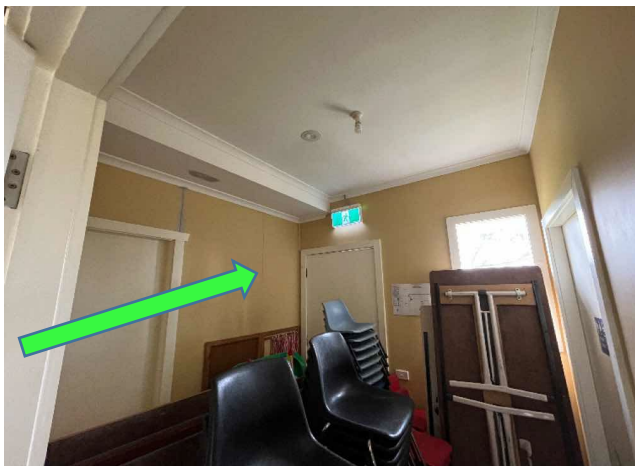
Internal, GF, Gutory Room, West And South, Wall Cladding - Fibre Cement, No Asbestos identified, B17380-S19 & B17380-S20

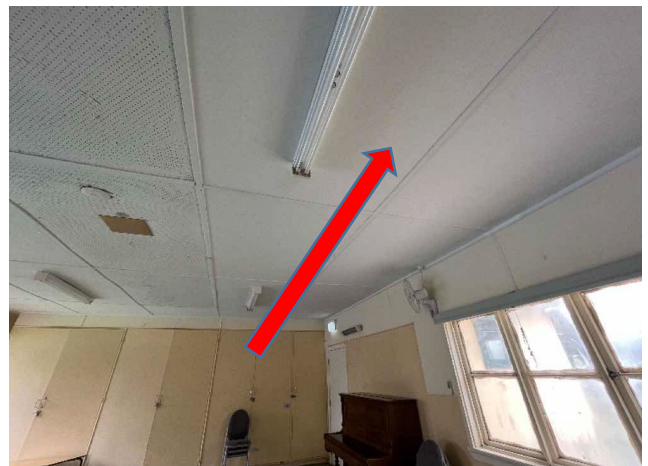
Internal, GF, Hall, Ceiling Lining - Fibre Cement, Chrysotile, B17380S15

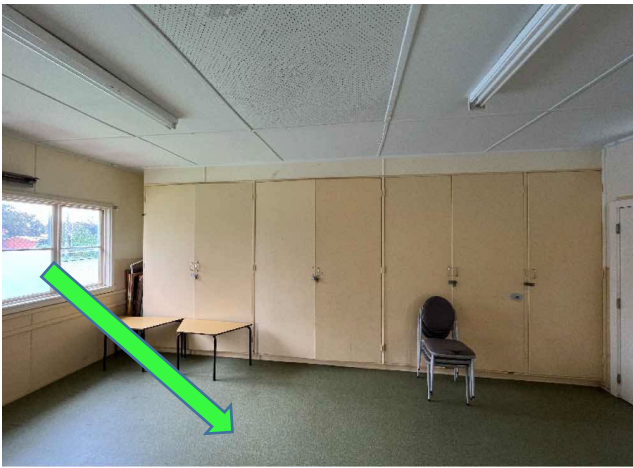
Internal, GF, Hall, Floor Linoleum - Linoleum, No Asbestos identified, B17380S16

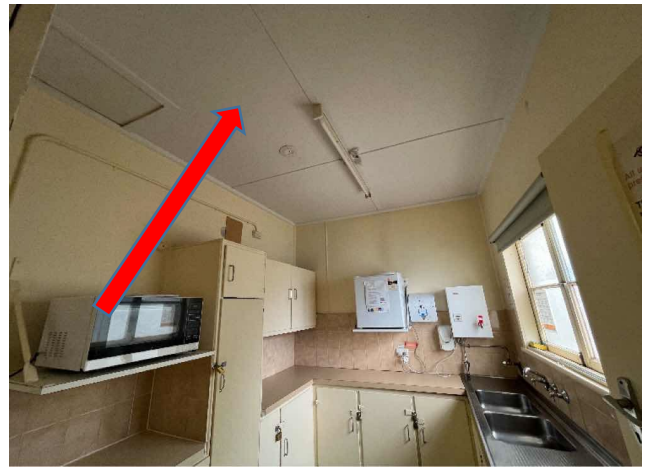
Internal, GF, Kitchen, Ceiling Lining - Fibre Cement, Assumed Positive, Similar to B17380S15 - Assumed Chrysotile
