Asbestos Risk Assessment
Blue Mountains City Council
Springwood Depot - Store, Office and Storage Buildings
2-20 Lawson Road, Springwood NSW 2777

Site Reference: 001

Our Reference : C109993 :

J154900 Date: February 2018

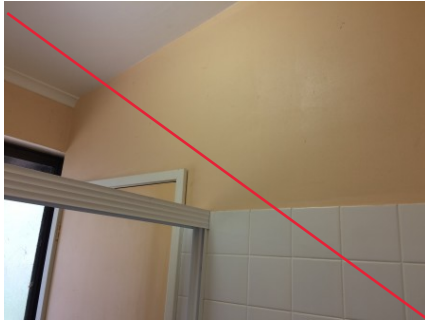
PHOTO NO.: J154900-001-PHOTO142
 RESULT: ASBESTOS - PRESUMED POSITIVE
 BUILDING/LEVEL: AMENITIES BUILDING - LEVEL ONE
 ROOM/LOCATION: FEMALE SHOWER - THROUGHOUT
 FEATURE/MATERIAL: CEILING - FIBRE CEMENT SHEETING
 SAMPLE NO.: SIMILAR TO: J154900-001-006

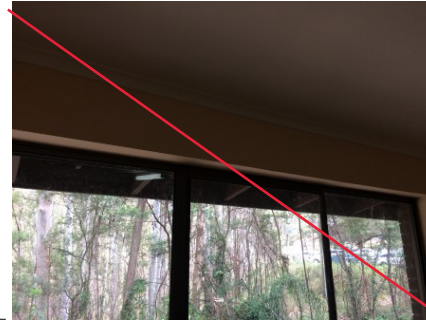
PHOTO NO.: J154900-001-PHOTO143
 RESULT: ASBESTOS - PRESUMED POSITIVE
 BUILDING/LEVEL: AMENITIES BUILDING - LEVEL ONE
 ROOM/LOCATION: FEMALE SHOWER - WEST
 FEATURE/MATERIAL: INFILL PANELS - FIBRE CEMENT SHEETING
 SAMPLE NO.: SIMILAR TO: J154900-001-007

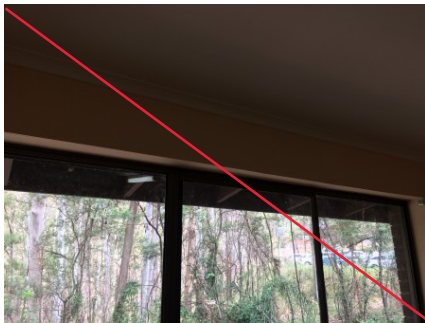
PHOTO NO.: J154900-001-PHOTO146
 RESULT: ASBESTOS - POSITIVE
 BUILDING/LEVEL: AMENITIES BUILDING - LEVEL ONE
 ROOM/LOCATION: FEMALE CHANGE ROOM - WEST
 FEATURE/MATERIAL: INFILL PANELS - FIBRE CEMENT SHEETING
 SAMPLE NO.: J154900-001-007

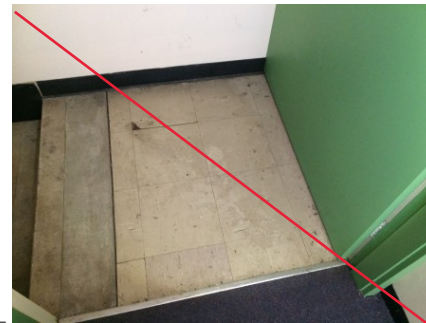
Rear Stairwell - To Conference Room - Entry Area Floor Covering - Vinyl Tiles & Adhesive 1677	Asbestos	Previously-Sampled-Regional-EnviroScience B47336-S14	Positive	J154900-001-Photo157	2-m ²	Good	Non-Friable	Low	Low	Not-Labelled	29/01/2023	P4	Maintain in current condition, label and incorporate into an AMP. Remove by licensed asbestos contractor prior to demolition or refurbishment.	Item removed Refer to Clearance certificate Greencap Reference May 2018 J155165-02
Rear Stairwell - To Conference Room - Throughout Ceiling - Fibre Cement Sheeting 1678	Asbestos	Similar To:- J154900-001-006	Presumed-Positive	J154900-001-Photo147	40-m ²	Good	Non-Friable	Low	Low	Suspect	29/01/2023	P4	Maintain in current condition and incorporate into an AMP. Remove by licensed asbestos contractor prior to demolition or refurbishment.	Item removed Refer to Clearance certificate Greencap Reference May 2018 J155165-02

PHOTO NO.: J154900-001-PHOTO157
 RESULT: ASBESTOS - POSITIVE
 BUILDING/LEVEL: AMENITIES BUILDING - LEVEL ONE
 ROOM/LOCATION: REAR STAIRWELL - TO CONFERENCE ROOM - ENTRY AREA
 FEATURE/MATERIAL: FLOOR COVERING - VINYL TILES & ADHESIVE
 SAMPLE NO.: PREVIOUSLY SAMPLED REGIONAL ENVIROSCIENCE B17336-S14

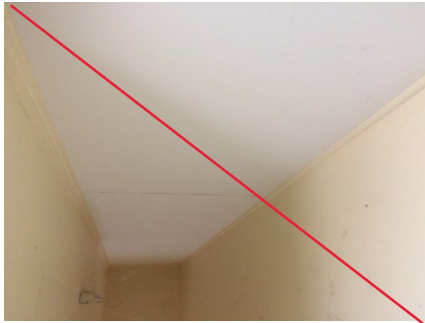
PHOTO NO.: J154900-001-PHOTO147
 RESULT: ASBESTOS - PRESUMED POSITIVE
 BUILDING/LEVEL: AMENITIES BUILDING - LEVEL ONE
 ROOM/LOCATION: REAR STAIRWELL - TO CONFERENCE ROOM - THROUGHOUT
 FEATURE/MATERIAL: CEILING - FIBRE CEMENT SHEETING
 SAMPLE NO.: SIMILAR TO: J154900-001-006

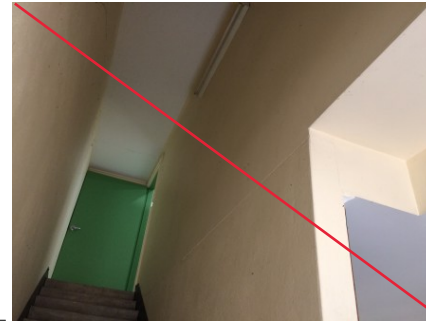
Rear Stairwell - To Conference Room - West Wall - Fibre Cement Sheeting 1682	Asbestos	J154900-001-014	Positive	J154900-001-Photo148	15-m ²	Good	Non-Friable	Low	Low	Suspect	29/01/2023	P4	Maintain in current condition and incorporate into an AMP. Remove by licensed asbestos contractor prior to demolition or refurbishment.	Item removed Refer to Clearance certificate Greencap Reference May 2018 J155165-02
Central Foyer - To Conference/Female Toilet/Shower/ Change Rooms - Central Partition Wall - Fibre Cement Sheeting - Both sides of the partition wall. 1683	Asbestos	J154900-001-010	Negative											
Central Foyer - To Conference/Female Toilet/Shower/ Change Rooms - East Wall - Fibre Cement Sheeting - High level walls around windows. 1685	Asbestos	J154900-001-011	Positive	J154900-001-Photo149	40-m ²	Good	Non-Friable	Low	Low	Suspect	29/01/2023	P4	Maintain in current condition and incorporate into an AMP. Remove by licensed asbestos contractor prior to demolition or refurbishment.	Item removed Refer to Clearance certificate Greencap Reference May 2018 J155165-02

PHOTO NO.: J154900-001-PHOTO148
 RESULT: ASBESTOS - POSITIVE
 BUILDING/LEVEL: AMENITIES BUILDING - LEVEL ONE
 ROOM/LOCATION: REAR STAIRWELL - TO CONFERENCE ROOM - WEST
 FEATURE/MATERIAL: WALL - FIBRE CEMENT SHEETING
 SAMPLE NO.: J154900-001-014

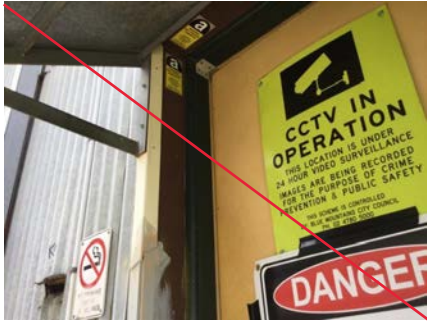
PHOTO NO.: J154900-001-PHOTO083
 RESULT: ASBESTOS - POSITIVE
 BUILDING/LEVEL: ADMINISTRATION BUILDING - GROUND LEVEL
 ROOM/LOCATION: EXTERIOR - SOUTHEAST
 FEATURE/MATERIAL: INFILL PANELS - FIBRE CEMENT SHEETING
 SAMPLE NO.: PREVIOUSLY SAMPLED REGIONAL ENVIROSCIENCE B17336-S07

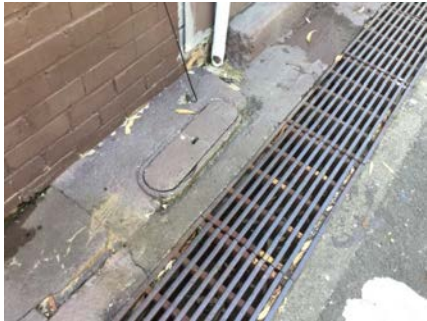
PHOTO NO.: J154900-001-PHOTO040
 RESULT: ASBESTOS - NEGATIVE
 BUILDING/LEVEL: ADMINISTRATION BUILDING - GROUND LEVEL
 ROOM/LOCATION: EXTERIOR - SOUTHWEST
 FEATURE/MATERIAL: TELECOMMUNICATIONS PIT - COMPRESSED CEMENT SHEETING
 SAMPLE NO.: J154900-001-031

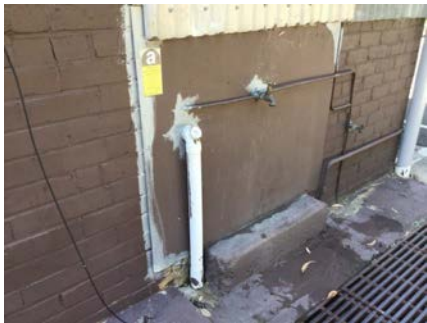
PHOTO NO.: J154900-001-PHOTO039
 RESULT: ASBESTOS - NEGATIVE
 BUILDING/LEVEL: ADMINISTRATION BUILDING - GROUND LEVEL
 ROOM/LOCATION: EXTERIOR - SOUTHWEST
 FEATURE/MATERIAL: WALL LINING - FIBRE CEMENT SHEETING
 SAMPLE NO.: J154900-001-030

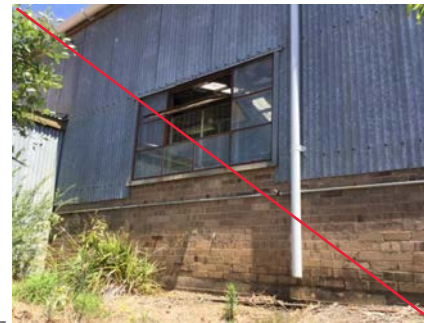
PHOTO NO.: J154900-001-PHOTO056
 RESULT: ASBESTOS - NEGATIVE
 BUILDING/LEVEL: ADMINISTRATION BUILDING - GROUND LEVEL
 ROOM/LOCATION: EXTERIOR - VARIOUS THROUGHOUT
 FEATURE/MATERIAL: WINDOW FRAMES - PUTTY
 SAMPLE NO.: J154900-001-033

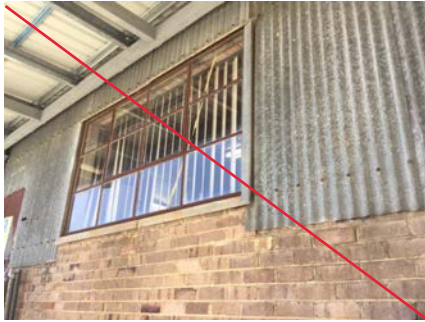
PHOTO NO.: J154900-001-PHOTO057
 RESULT: ASBESTOS - NEGATIVE
 BUILDING/LEVEL: ADMINISTRATION BUILDING - GROUND LEVEL
 ROOM/LOCATION: EXTERIOR - VARIOUS THROUGHOUT
 FEATURE/MATERIAL: WINDOW FRAMES - PUTTY
 SAMPLE NO.: J154900-001-033

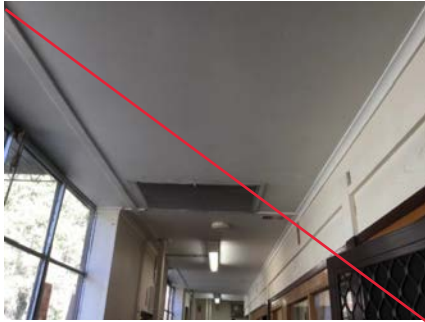
PHOTO NO.: J154900-001-PHOTO006
 RESULT: ASBESTOS - POSITIVE
 BUILDING/LEVEL: ADMINISTRATION BUILDING - GROUND LEVEL
 ROOM/LOCATION: HALLWAY - SOUTHERN OFFICE - THROUGHOUT
 FEATURE/MATERIAL: CEILING - FIBRE CEMENT SHEETING
 SAMPLE NO.: PREVIOUSLY SAMPLED REGIONAL ENVIROSCIENCE B17336-S10

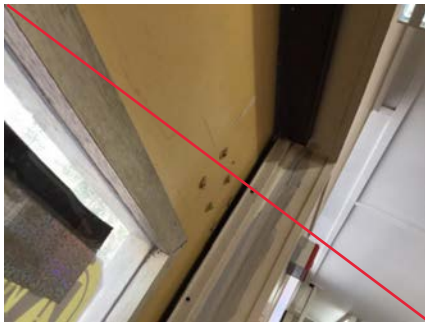
PHOTO NO.: J154900-001-PHOTO035
 RESULT: ASBESTOS - POSITIVE
 BUILDING/LEVEL: ADMINISTRATION BUILDING - GROUND LEVEL
 ROOM/LOCATION: HALLWAY - SOUTHERN OFFICE - VARIOUS THROUGHOUT
 FEATURE/MATERIAL: WALL - FIBRE CEMENT SHEETING
 SAMPLE NO.: PREVIOUSLY SAMPLED REGIONAL ENVIROSCIENCE B17336-S09

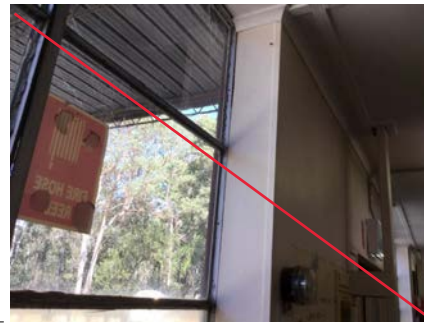
PHOTO NO.: J154900-001-PHOTO034
 RESULT: ASBESTOS - POSITIVE
 BUILDING/LEVEL: ADMINISTRATION BUILDING - GROUND LEVEL
 ROOM/LOCATION: HALLWAY - SOUTHERN OFFICE - VARIOUS THROUGHOUT
 FEATURE/MATERIAL: WALL - FIBRE CEMENT SHEETING
 SAMPLE NO.: PREVIOUSLY SAMPLED REGIONAL ENVIROSCIENCE B17336-S09

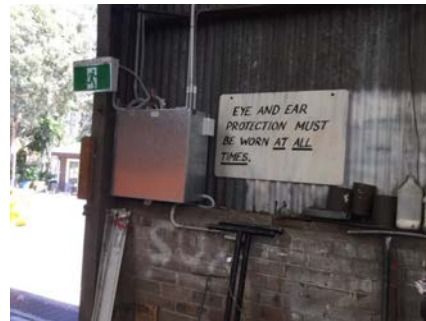
PHOTO NO.: J154900-001-PHOTO048
 RESULT: ASBESTOS - NEGATIVE
 BUILDING/LEVEL: ADMINISTRATION BUILDING - GROUND LEVEL
 ROOM/LOCATION: RMT SHED - SOUTHWEST
 FEATURE/MATERIAL: ELECTRICAL - SWITCH BOARD - DUST
 SAMPLE NO.: J154900-001-032

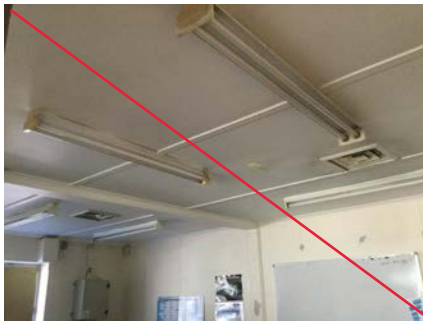
PHOTO NO.: J154900-001-PHOTO010
 RESULT: ASBESTOS - POSITIVE
 BUILDING/LEVEL: ADMINISTRATION BUILDING - GROUND LEVEL
 ROOM/LOCATION: SOUTHERN OFFICE - HUMAN RESOURCES OFFICE - VARIOUS THROUGHOUT
 FEATURE/MATERIAL: CEILING - FIBRE CEMENT SHEETING
 SAMPLE NO.: PREVIOUSLY SAMPLED REGIONAL ENVIROSCIENCE B17336-S10

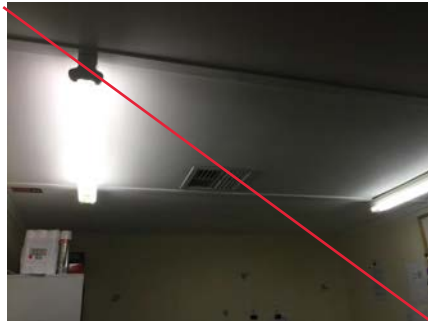
PHOTO NO.: J154900-001-PHOTO013
 RESULT: **ASBESTOS - POSITIVE**
 BUILDING/LEVEL: **ADMINISTRATION BUILDING - GROUND LEVEL**
 ROOM/LOCATION: **SOUTHERN OFFICE - TRUCKS COORDINATOR OFFICE - VARIOUS THROUGHOUT**
 FEATURE/MATERIAL: **CEILING - FIBRE CEMENT SHEETING**
 SAMPLE NO.: **PREVIOUSLY SAMPLED REGIONAL ENVIROSCIENCE B17336-S10**

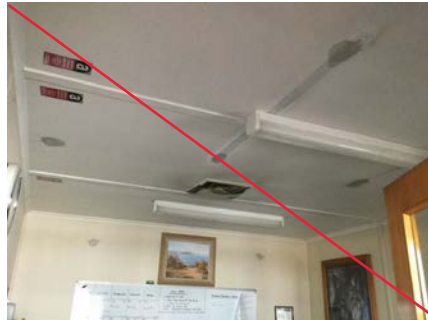
PHOTO NO.: J154900-001-PHOTO012
 RESULT: **ASBESTOS - POSITIVE**
 BUILDING/LEVEL: **ADMINISTRATION BUILDING - GROUND LEVEL**
 ROOM/LOCATION: **SOUTHERN OFFICE - BULK WASTE COORDINATOR OFFICE - VARIOUS THROUGHOUT**
 FEATURE/MATERIAL: **CEILING - FIBRE CEMENT SHEETING**
 SAMPLE NO.: **PREVIOUSLY SAMPLED REGIONAL ENVIROSCIENCE B17336-S10**

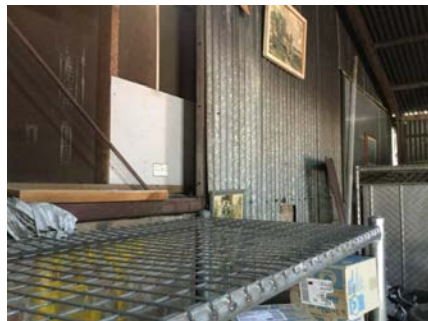
PHOTO NO.: J154900-001-PHOTO036
 RESULT: **ASBESTOS - NEGATIVE**
 BUILDING/LEVEL: **ADMINISTRATION BUILDING - GROUND LEVEL**
 ROOM/LOCATION: **WASTE BINS SHED - WEST**
 FEATURE/MATERIAL: **SWITCHBOARD BACKING PANEL - FIBRE CEMENT SHEETING**
 SAMPLE NO.: **J154900-001-028**

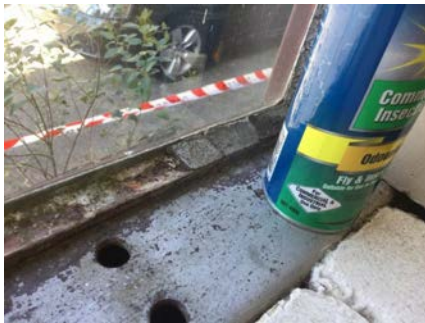
PHOTO NO.: J154900-001-PHOTO019
 RESULT: ASBESTOS - NEGATIVE
 BUILDING/LEVEL: ADMINISTRATION BUILDING - GROUND LEVEL
 ROOM/LOCATION: WASTE SERVICES OFFICE - HALLWAY - SOUTH
 FEATURE/MATERIAL: WINDOW FRAMES - PUTTY
 SAMPLE NO.: J154900-001-025

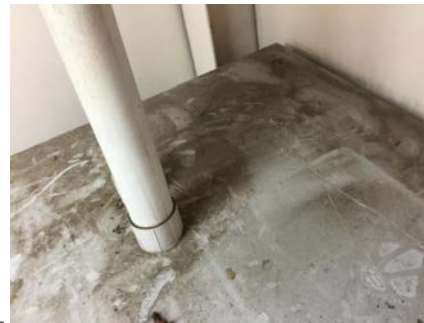
PHOTO NO.: J154900-001-PHOTO031
 RESULT: ASBESTOS - NEGATIVE
 BUILDING/LEVEL: ADMINISTRATION BUILDING - GROUND LEVEL
 ROOM/LOCATION: WASTE SERVICES OFFICE - HALLWAY - WEST
 FEATURE/MATERIAL: DEBRIS - DUST
 SAMPLE NO.: J154900-001-027

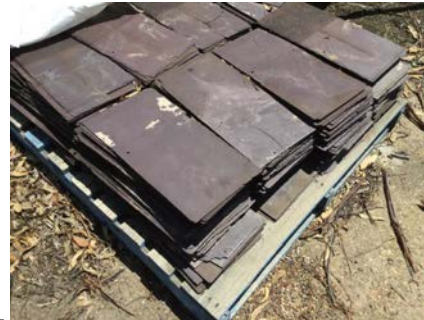
PHOTO NO.: J154900-001-PHOTO069
 RESULT: ASBESTOS - NEGATIVE
 BUILDING/LEVEL: TRADES SHED - GROUND LEVEL
 ROOM/LOCATION: EXTERIOR - NORTHEAST
 FEATURE/MATERIAL: DUMPED MATERIAL - ROOF TILES
 SAMPLE NO.: J154900-001-037

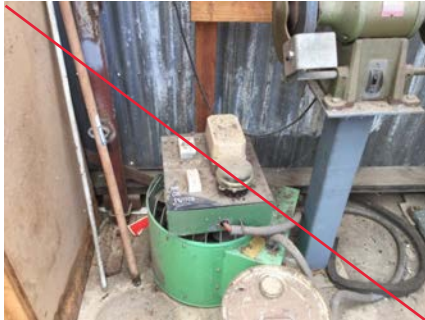
PHOTO NO.: J154900-001-PHOTO072
 RESULT: ASBESTOS - POSITIVE
 BUILDING/LEVEL: TRADES SHED - GROUND LEVEL
 ROOM/LOCATION: MAIN SHED - WEST
 FEATURE/MATERIAL: DUMPED MATERIAL - COMPRESSED BITUMINOUS ELECTRICAL PANEL
 SAMPLE NO.: J154900-001-038

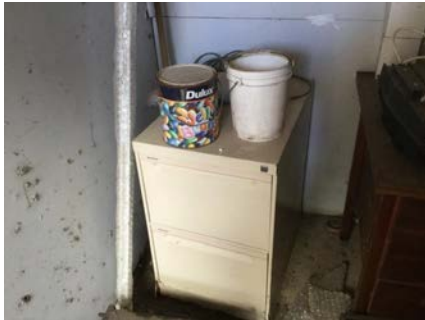
PHOTO NO.: J154900-001-PHOTO073
 RESULT: ASBESTOS - NEGATIVE
 BUILDING/LEVEL: TRADES SHED - GROUND LEVEL
 ROOM/LOCATION: OFFICE/STORE - NORTHWEST - SOUTHEAST
 FEATURE/MATERIAL: LOWER WALL LINING - FIBRE CEMENT SHEETING
 SAMPLE NO.: J154900-001-039

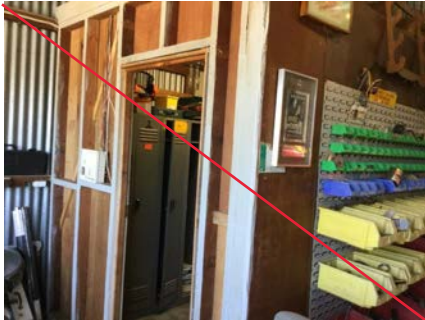
PHOTO NO.: J154900-001-PHOTO060
 RESULT: ASBESTOS - POSITIVE
 BUILDING/LEVEL: GARDENERS SHED - GROUND LEVEL
 ROOM/LOCATION: LOCKER ROOM (LOWER LEVEL) - SOUTH
 FEATURE/MATERIAL: DEBRIS - FIBRE CEMENT DEBRIS
 SAMPLE NO.: PREVIOUSLY SAMPLED REGIONAL ENVIROSCIENCE B17336-S26

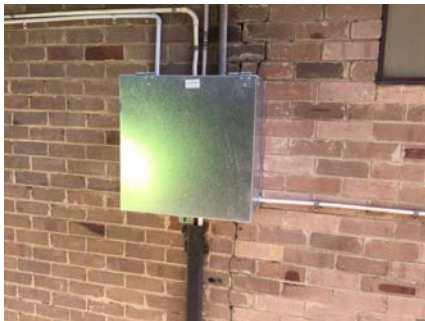
PHOTO NO.: J154900-001-PHOTO089
 RESULT: ASBESTOS - PRESUMED POSITIVE
 BUILDING/LEVEL: STORAGE SHED - GROUND LEVEL
 ROOM/LOCATION: EXTERIOR - NORTH
 FEATURE/MATERIAL: ELECTRICAL - SWITCH BOARD - COMPRESSED BITUMINOUS ELECTRICAL PANEL
 SAMPLE NO.: SIMILAR TO:

- It was noted that where asbestos electrical backing boards were identified components such as fuses have been installed into the asbestos. It would be prudent as a precaution to vacuum out these cabinets using an H-Type vacuum cleaner in accordance with the Code of Practice.
