Asbestos Register

Regional EnviroScience Pty Ltd was requested by Mr. Rick Harris of Blue Mountain City Council to undertake a Hazardous Building Materials Survey and to prepare a Hazardous Materials Register and Management Plan of the Mechanics Workshop, Toilet Block, Halfway House and Golf Cart Shed at the property known as Katoomba Golf Course located at 1-39 Acacia Street, Katoomba, NSW, 2780. The purpose of the audit was to locate and identify asbestos based building materials and product within the building in accordance with the *NSW Work Health and Safety Act and Regulation 2017* and the *Code of Practice; How to Manage and Control Asbestos in the Workplace* [Safe Work Australia: 2016] and the *Code of Practice; How to Safely Remove Asbestos* [Safe Work Australia: 2016].

On the 4th April 2018, an Asbestos Audit was conducted at the Halfway House, Toilet Block, Mechanics Workshop and Golf Cart Shed of the Katoomba Golf Course and asbestos containing materials were found to be present at the premises. Please refer Appendix I for results of products that were considered and consequently analysed but did not contain asbestos.

ASBESTOS MATERIALS REGISTER		ASSET: Katoomba Golf

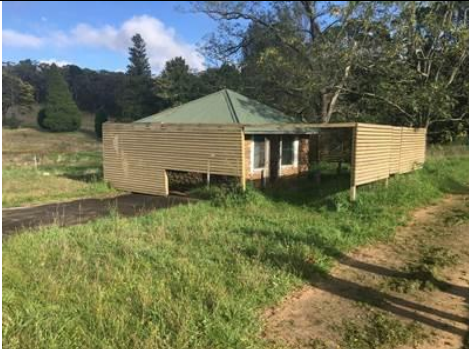
Half-Way House. East Aspect. Corrugated Iron Roof, Steel Gutters, Rendered Brick Infill and Stone and Mason Walls, Steel Door Frame.	N/A	N/A	N/A
4 th April 2018

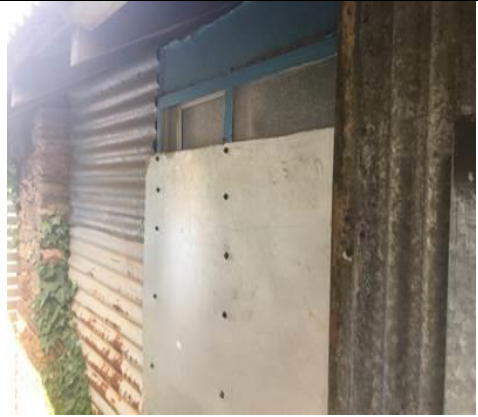
Half-Way House. South Aspect. Exposed Timber Trusses, Steel Gutters, Stone and Mason Wall, Corrugated Iron & Chipboard Infill Around Window, Aluminium Window Frame.	No Sample Taken. No Asbestos Containing Materials Sighted. 2671	A5	N/A
4 th April 2018

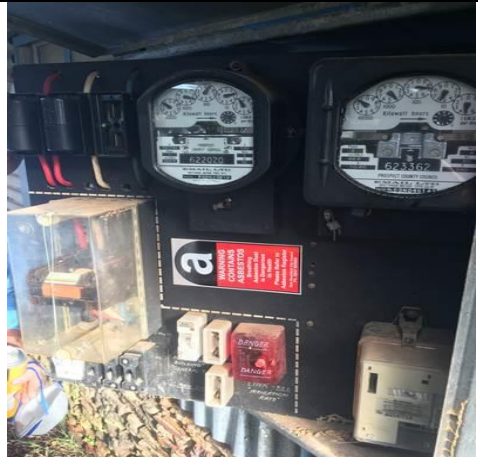
Half-Way House. 'Lebah' Type Electrical Backing Board. Approximately 0.5m ²	No Sample Taken. Assume Asbestos Containing Material. 2672	A4	Good Condition Accessible to Tradespeople Refer to Asbestos Management Plan.
4 th April 2018

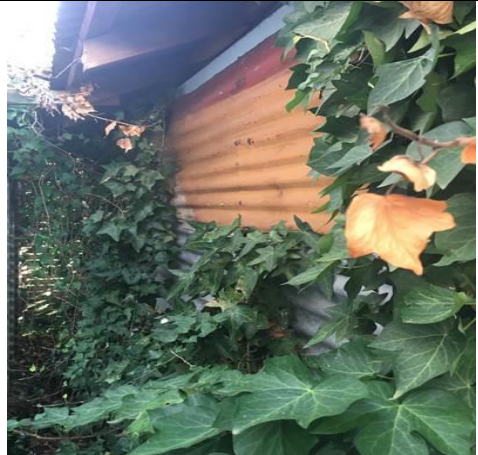
Half-Way House. West Aspect. Exposed Timber Trusses, Stone Wall & Corrugated Iron Infills.	No Sample Taken. No Asbestos Containing Materials Sighted. 2673	A5	Restricted Access due to Overgrown Vegetation.

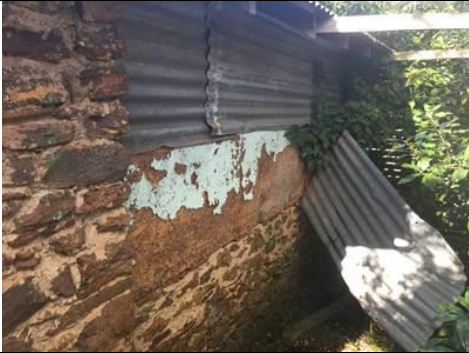
Half-Way House. North Aspect. Exposed Timber Trusses, Corrugated Iron & Chipboard Infill Around Window, Stone & Mason Wall. 2674	No Sample Taken. No Asbestos Containing Materials Sighted.	A5	N/A
4 th April 2018

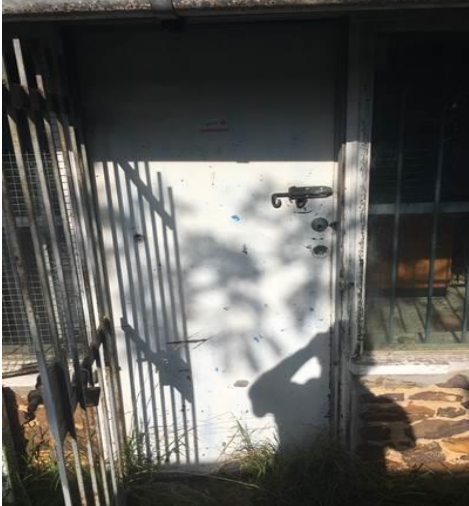
Half-Way House. East Aspect. Hollow Timber Door with Timber Door Frame. 2675	No Sample Taken. No Asbestos Containing Materials Sighted.	A5	N/A

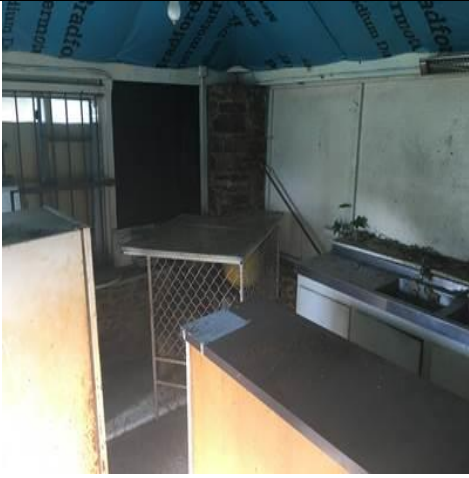
Half-Way House. Aluminium Roof Insulation, Exposed Timber Trusses, Timber Bearers and Architraves, Foam Filling Between Bearers & Walls, North, South and West Chipboard Wall Infills, Stone and Masonry Footers, Steel Window Guards, Concrete Floor.	No Sample Taken. No Asbestos Containing Material Sighted. 2676	A5	N/A
4 th April 2018

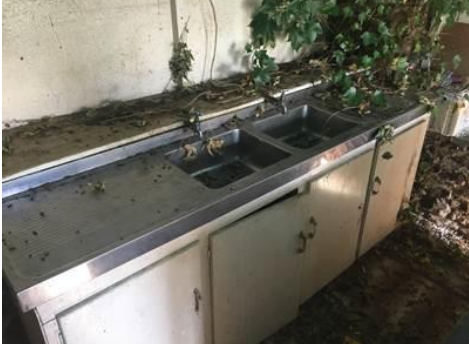
Half-Way House. West Wall. Compressed Timber Cabinets & Island Bench, Stainless Steel Sink, Masonite Lining Beneath Sink.	No Sample Taken. No Asbestos Containing Materials Sighted. 2678	A5	N/A

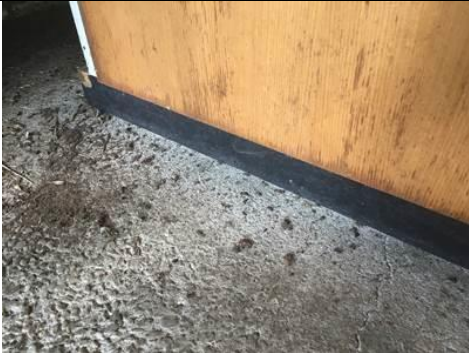
Half-Way House. Bituminous Lining to Island Bench & Bench Top. 2679	Sample #B18166S01 No Asbestos Detected.	A5	N/A
4 th April 2018

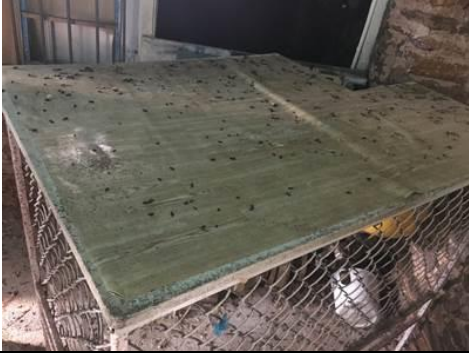
Half-Way House. Vinyl Lining to Table Top. 2680	Sample #B18166S02 No Asbestos Detected.	A5	N/A
4 th April 2018

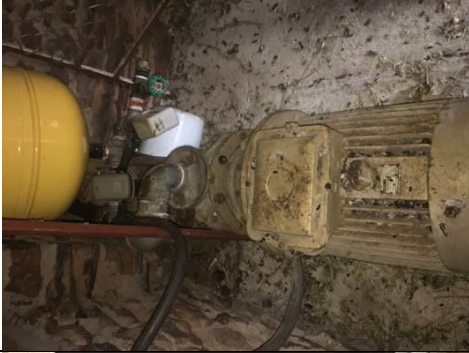
Half-Way House. Pump Gasket. 2681	Sample #B18166S03 No Asbestos Detected.	A5	N/A
4 th April 2018

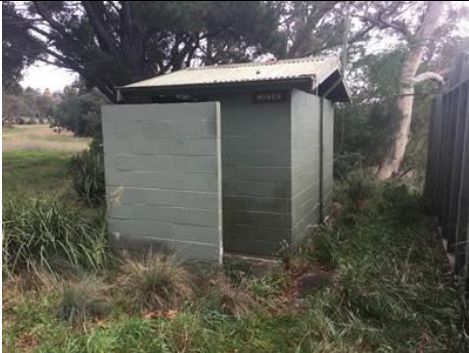
Toilet Block. South-West Aspect Corrugated Iron Roof, Steel Gutters, PVC Downpipes, Timber Fascia, Cement Block Walls, Concrete Floor.	No Sample Taken. No Asbestos Containing Materials Sighted. 2683	A5	N/A
4 th April 2018

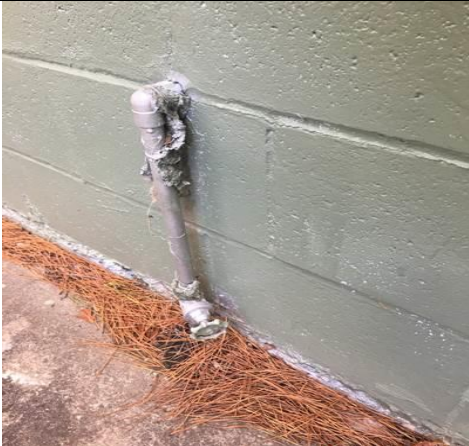
Toilet Block. North West Aspect. Lagged Piping. 2687	Sample #B18166-S4 No Asbestos Detected.	A5	N/A
4 th April 2018

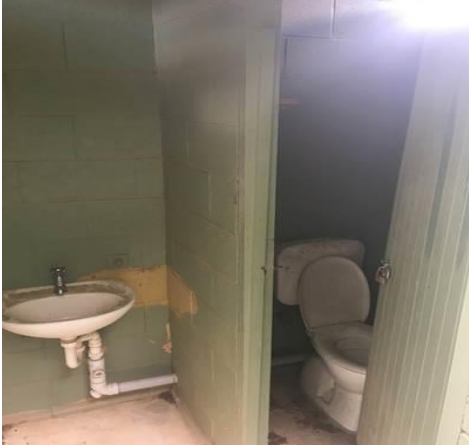
Toilet Block. Women's Toilet. Corrugated Iron, Exposed Timber Trusses, Cement Brick Walls, Timber Door, PVC Piping. 2688	No Sample Taken. No Asbestos Containing Materials Sighted.	A5	N/A
4 th April 2018

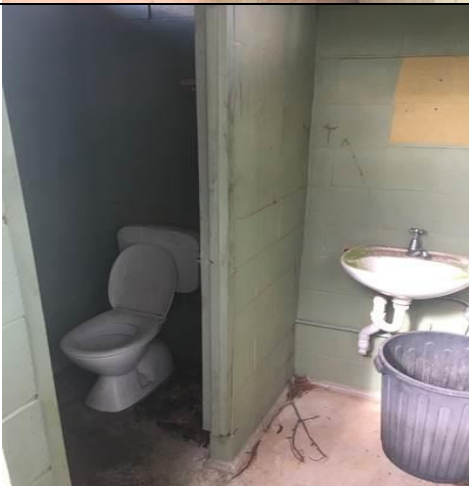
Toilet Block. Men's Toilet. Corrugated Iron, Exposed Timber Trusses, Cement Brick Walls, Timber Door, PVC Piping. 2689	No Sample Taken. No Asbestos Containing Materials Sighted.	A5	N/A

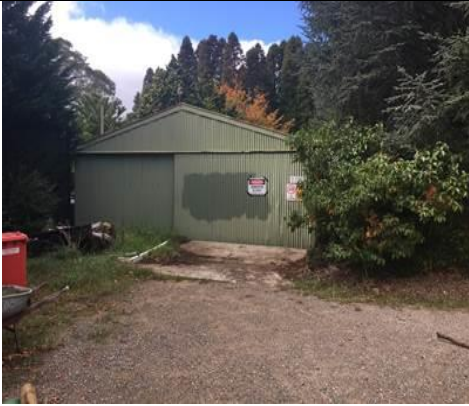
Mechanics Workshop. North Entrance Corrugated Iron Roof, Exterior Wall & Sliding Door, Concrete Floor & Brick Footing, Iron Whirly Birds, Steel Fascia, Steel Pipe Work.	N/A	N/A	N/A
4 th April 2018

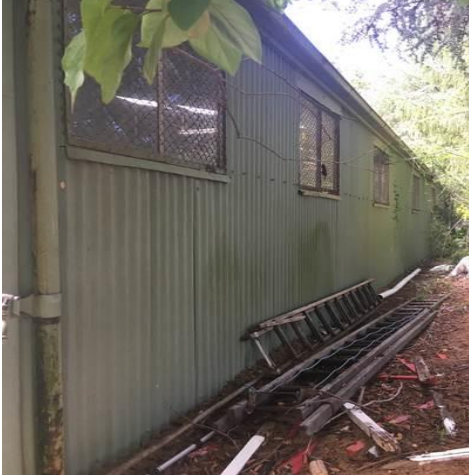
Mechanics Workshop. Western Aspect Corrugated Iron Wall, Steel Gutters, Timber Fascia, Steel Infill Above Windows, Steel Window Guards & Frames, PVC Downpipes.	No Sample Taken. No Asbestos Containing Materials Sighted. 2691	A5	N/A

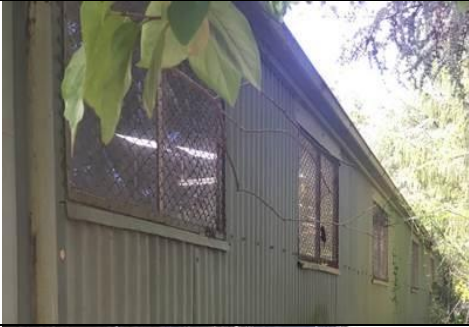
Mechanics Workshop Western Aspect Window Mastic on Seven Windows.	Sample #B18166S05 No Asbestos Detected 2692	A5	N/A
4 th April 2018

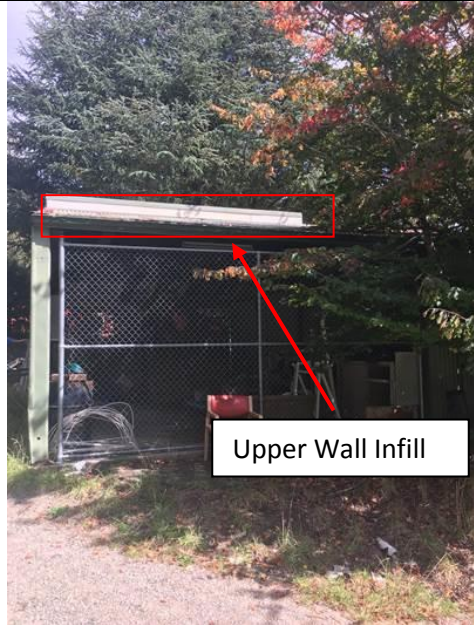
Mechanics Workshop. East Aspect Southern Extension. Upper Wall Infill. 2696	Similar to Sample #B18166S06 No Asbestos Detected.	A5	N/A
4 th April 2018

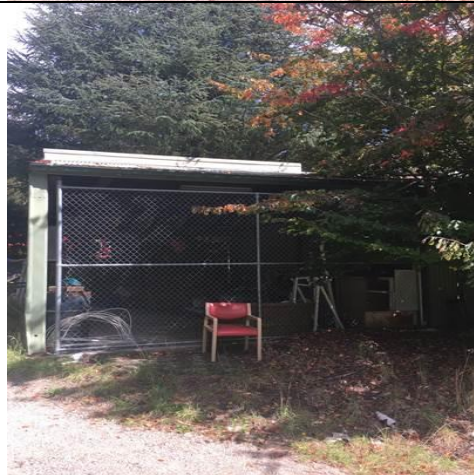
Mechanics Workshop. East Aspect South Extension Corrugated Iron Roof, Timber Fascia, Wire Wall, Timber and Steel Support Posts. 2697	No Sample Taken. No Asbestos Containing Materials Sighted.	A5	N/A

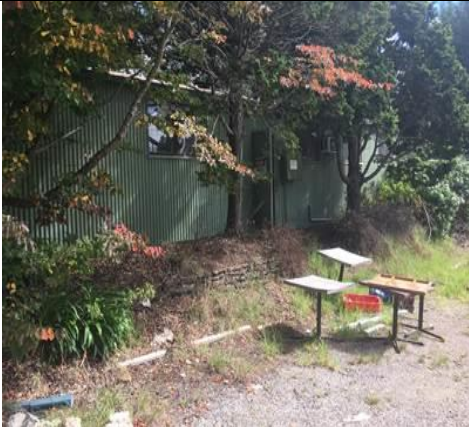
Mechanics Workshop. East Aspect Corrugated Iron Wall, Steel Gutters, Timber Fascia, Aluminium Infill Above Windows, Steel Window Guards & Window Frames, PVC Downpipes.	No Sample Taken. No Asbestos Containing Materials Sighted. 2698	A5	N/A
4 th April 2018

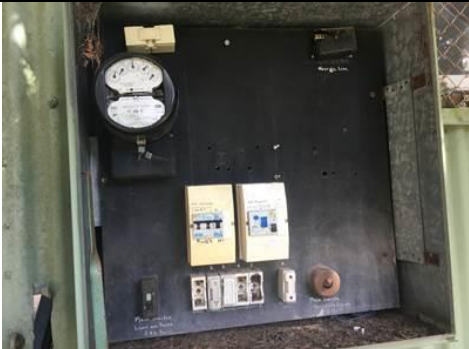
Mechanics Workshop. East Aspect Electrical Bakelite Backing Board. Approximately 0.5m ²	No Sample Taken. Assume Contains Asbestos. 2699	A4	Good Condition Accessible to Tradespeople Refer to Asbestos Management Plan.
4 th April 2018

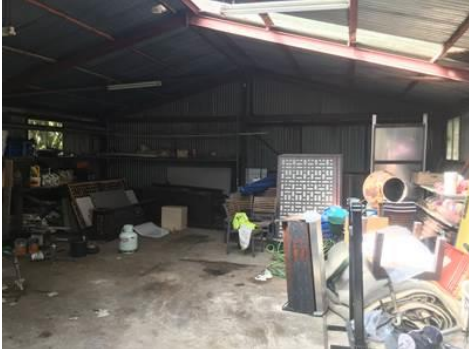
Mechanics Workshop. South End Corrugated Iron Roof, Sliding Door & Walls, Reinforced Steel Joists, Plastic Skylight Sheeting, Concrete Floor.	No Samples Taken. No Asbestos Containing Material Sighted. 2700	A5	N/A

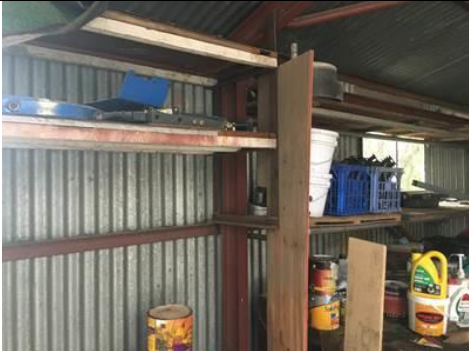
Mechanics Workshop. South End East Wall, Steel Frame Shelving with Timber & Masonite Shelf Bases. 2701	No Samples Taken. No Asbestos Containing Material Sighted.	A5	N/A
4 th April 2018

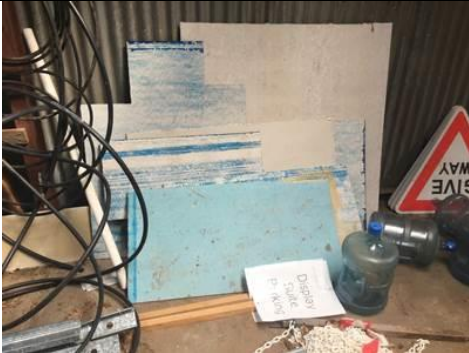
Mechanics Workshop. South End of Workshop. Stockpiled Fibre Cement Sheet. 2705	Sample #B18166S08 No Asbestos Detected.	A5	N/A
4th April 2018

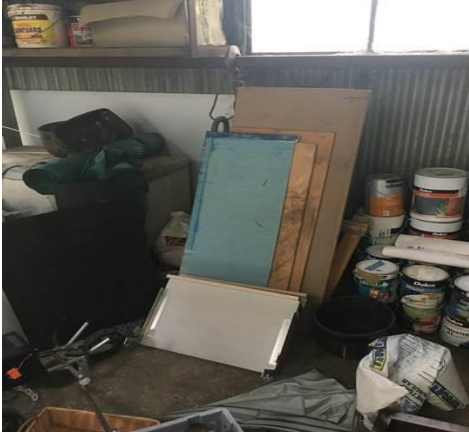
Mechanics Workshop. South End of Workshop. Stockpiled Fibre Cement Sheet. 2707	Similar to Sample #B18166S08 No Asbestos Detected.	A5	N/A

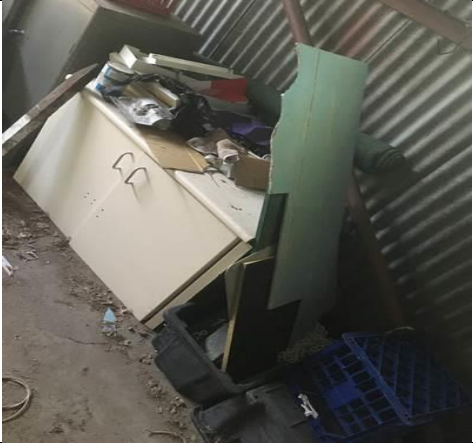
Mechanics Workshop. South End of Workshop. Stockpiled Fibre Cement Sheet. 2708	Similar to Sample #B18166S08 No Asbestos Detected.	A5	N/A
4th April 2018

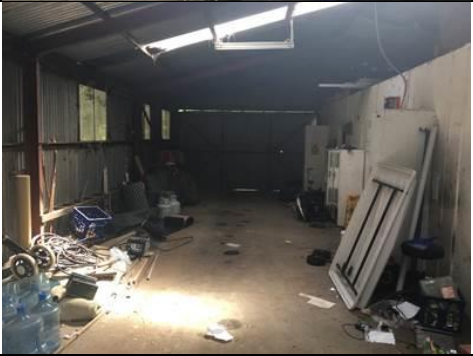
Mechanics Workshop. Western Corridor. Corrugated Iron Roof & Wall, Reinforced Steel Joists to West & North Walls, Concrete Floor. 2709	No Sample Taken. No Asbestos Containing Material Sighted.	A5	N/A
4th April 2018

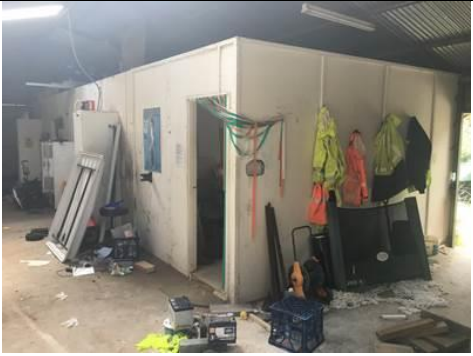
Mechanics Workshop. External Southern Wall Lining to Kitchen. 2710	Sample #B18166S09 No Asbestos Detected.	A5	N/A

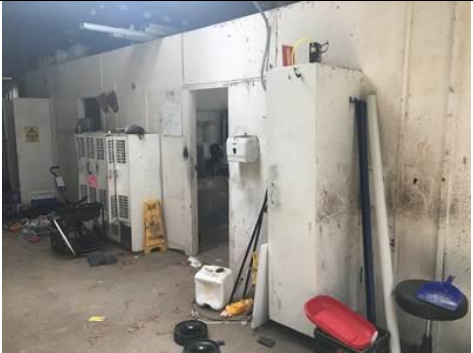
Mechanics Workshop. Western External Wall Lining to Kitchen & Welding Room. Approximately 20m ² 2711	Sample #B18166S18 Chrysotile, Amosite & Crocidolite Asbestos Detected. Non-Friable	A3	Fair Condition Accessible to Tradespeople Refer to Asbestos Management Plan.
4th April 2018

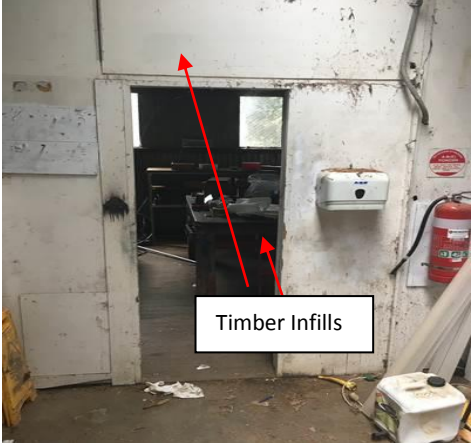
Mechanics Workshop. Welding Room Entrance. Timber Door Frames, Architraves, Cover Strips & Infills Around Door. 2712	No Sample Taken. No Asbestos Containing Materials Sighted.	A5	N/A
4th April 2018

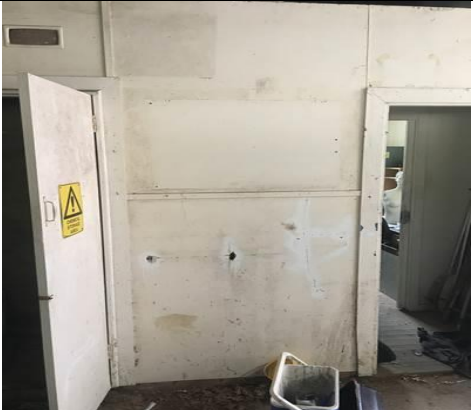
Mechanics Workshop. External Lower Wall Panel to Chemical Store. 2713	Similar to Sample #B18166S09 No Asbestos Detected.	A5	N/A

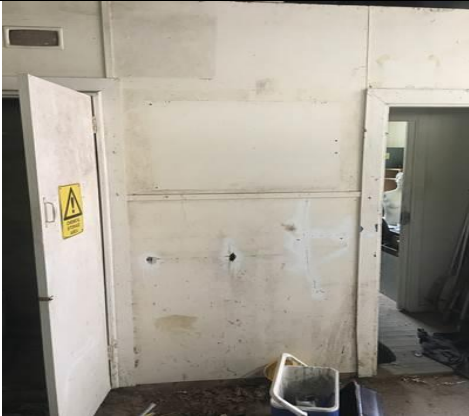
Mechanics Workshop. Cover Strip Adjacent Chemical Store. Approximately 0.5m^2 2714	Sample #B18166S10 Chrysotile Asbestos Detected. Non-Friable.	A4	Good Condition Accessible to Tradespeople Refer to Asbestos Management Plan.
4th April 2018

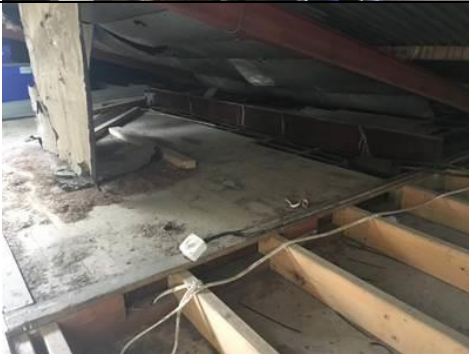
Mechanics Workshop. Roof Aspect of Workshop Rooms. Corrugated Iron Roofing, Foil Insulation, Stored Goods, Fibre Cement Sheet Ceiling, Timber Cross Beams.	N/A 2715	N/A	N/A
4th April 2018

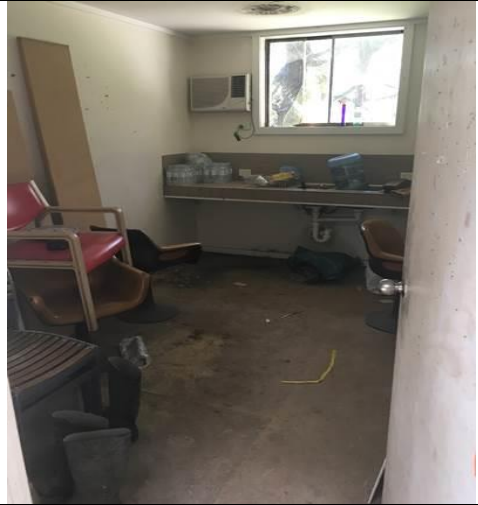
Mechanics Workshop. Kitchen. Compressed Timber Floor on Concrete, Timber Door, Architraves, Skirting & Window Frame, Plasterboard Walls & Ceiling, Ceramic Tiled Kitchenette & Stainless-Steel Sink.	No Sample Taken. No Asbestos Containing Material Sighted. 2717	A5	N/A
4th April 2018

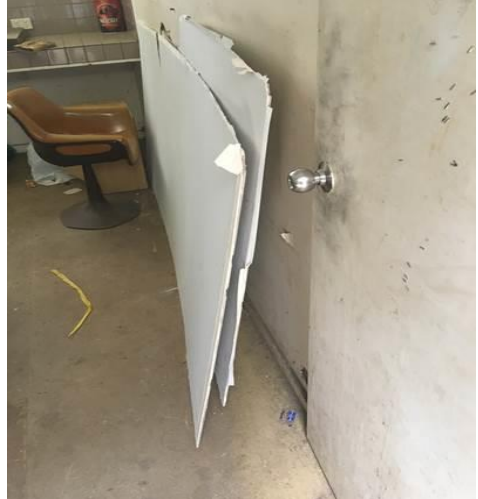
Mechanics Workshop. Stored Fibre Cement Sheet in Kitchen on South Wall. 2718	Sample #B18166S12 No Asbestos Detected.	A5	N/A

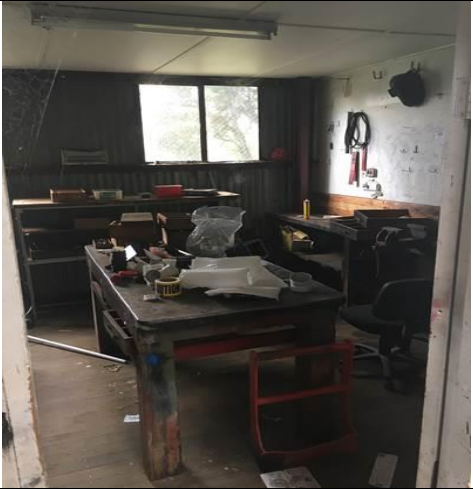
Mechanics Workshop. Welding Room. Fibre Cement Sheet Ceiling. Approximately 16m ² 2719	Sample #B18166S13 Chrysotile, Amosite, Crocidolite Asbestos Detected. Non-Friable	A4	Good Condition Accessible to Tradespeople Refer to Asbestos Management Plan.
4th April 2018

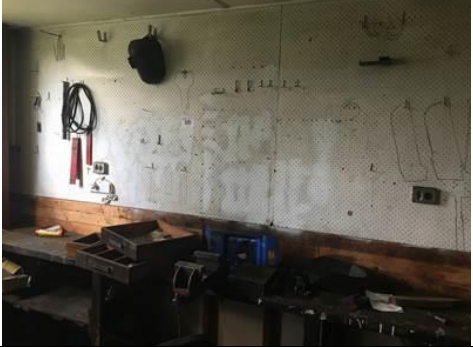
Mechanics Workshop. Welding Room Southern Wall, Masonite Panelling & Exposed Plasterboard Below Timber Bench.	No Sample Taken. No Asbestos Containing Material Sighted. 2720	A5	N/A
4th April 2018

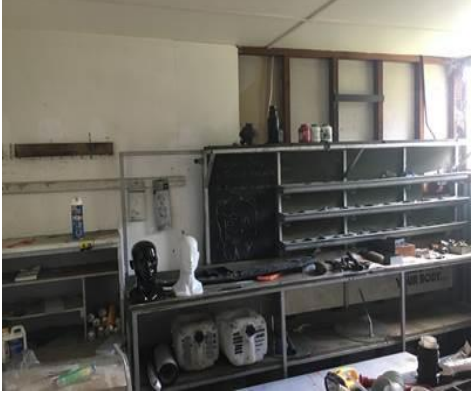
Mechanics Workshop. Welding Room Northern Wall, Masonite Panelling to North West Wall – North East Wall Exposed Fibre Cement Sheet. Approximately 4m ²	Sample #B18166S14 Chrysotile, Amosite, Crocidolite Asbestos Detected. Non-Friable 2721	A3	Fair Condition Accessible to Tradespeople Refer to Asbestos Management Plan.

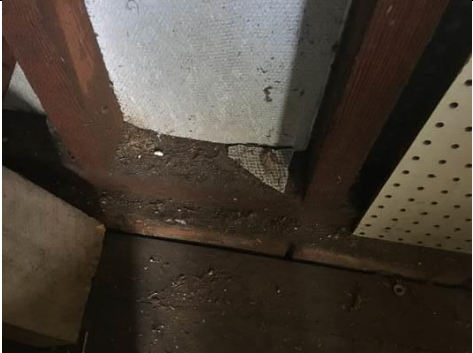
Mechanics Workshop. Welding Room, Western Wall Masonite Panelling with Exposed Fibre Cement Sheet in South West Corner. Approximately 3m ²	Similar to Sample #B18166S14 Chrysotile, Amosite, Crocidolite Asbestos Detected. Non-Friable	A3	Fair Condition Accessible to Tradespeople Refer to Asbestos Management Plan. 2722
4th April 2018

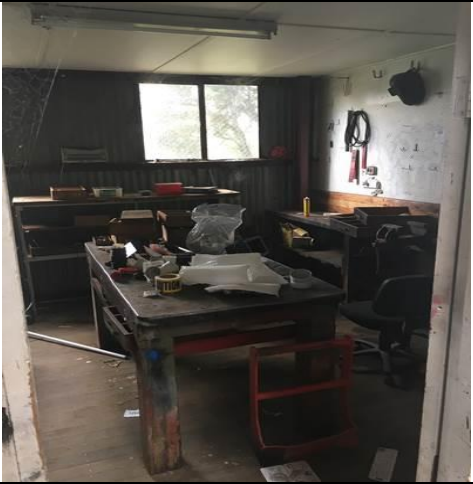
Mechanics Workshop. Welding Room, Eastern Wall Corrugated Iron, Steel Reinforcements, Timber Window Frames. 2723	No Sample Taken. No Asbestos Containing Materials Sighted.	A5	N/A
4th April 2018

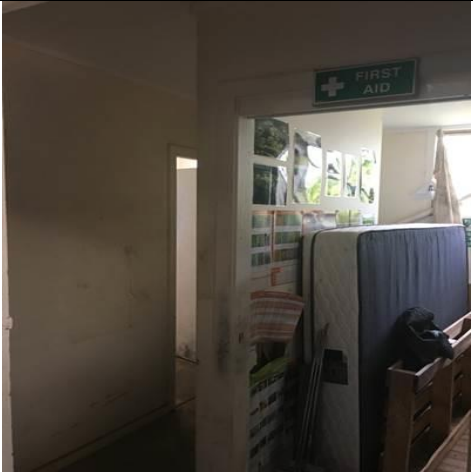
Mechanics Workshop. Void. North Wall Rendered Brick, Remaining Walls Plasterboard, Plasterboard Ceiling, Timber Door Frames & Architraves & Concrete Floor. 2724	No Sample Taken. No Asbestos Containing Materials Sighted.	A5	N/A

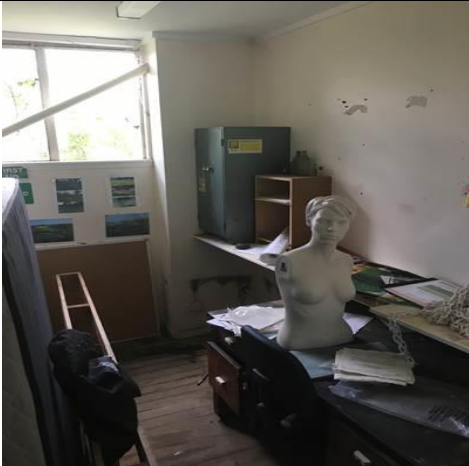
Mechanics Workshop. First Aid Room. Plasterboard Walls & Ceiling, Timber Door, Door Frame, Architraves, Skirting & Floor. 2725	No Sample Taken. No Asbestos Containing Materials Sighted.	A5	N/A
4th April 2018

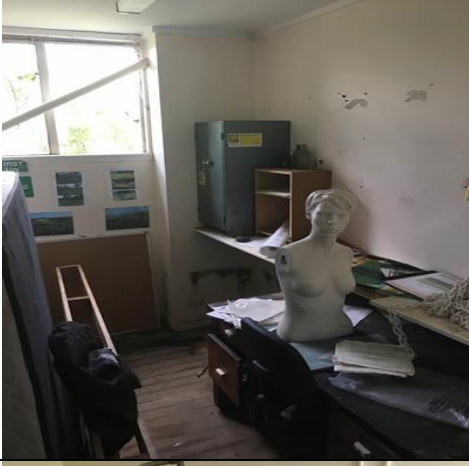
Mechanics Workshop. First Aid Room. Fibre Cement Sheet Behind Southern Plasterboard Wall. Approximately 8m ² 2726	Similar to Sample #B18166S14 Chrysotile, Amosite, Crocidolite Asbestos Detected. Non-Friable	A3	Fair Condition Accessible to Tradespeople Refer to Asbestos Management Plan.
4th April 2018

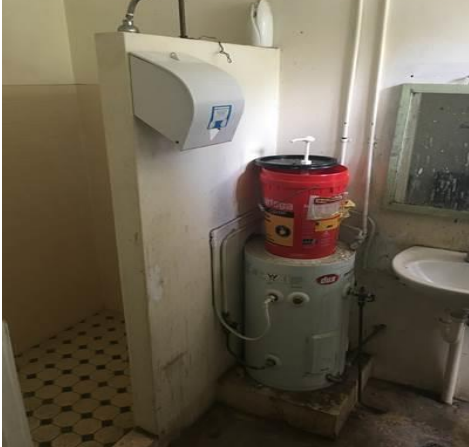
Mechanics Workshop. Bathroom. Timber Cornices, Architraves & Cover Strips, Rendered Brick Walls, Ceramic Tile Shower & Timber Doors. 2727	No Sample Taken. No Asbestos Containing Materials Sighted.	A5	N/A

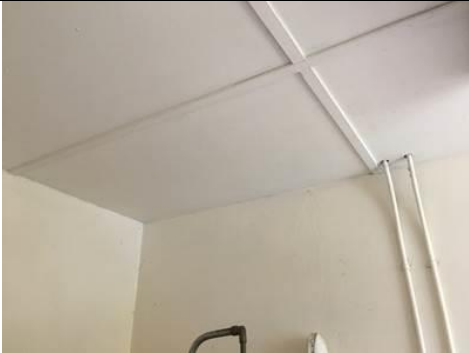
Mechanics Workshop. Bathroom. Fibre Cement Sheet Ceiling. Approximately 5m ² 2728	Similar to Sample #B18166S13 Chrysotile, Amosite, Crocidolite Asbestos Detected. Non-Friable.	A4	Good Condition Accessible to Tradespeople Refer to Asbestos Management Plan.
4th April 2018

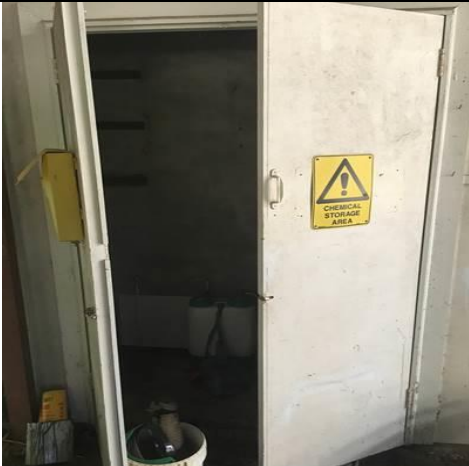
Mechanics Workshop. Chemical Stores. Hollow Timber Doors, Concrete Floor – Fibre Cement Sheet Walls & Ceiling. Approximately 2m ² 2729	Similar to Sample #B18166S18 Chrysotile, Amosite & Crocidolite Asbestos Detected. Non-Friable	A4	Good Condition Accessible to Tradespeople Refer to Asbestos Management Plan.
4th April 2018

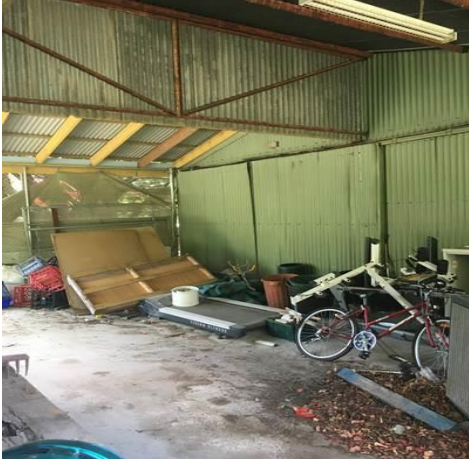
Mechanics Workshop. Southern Extension. Corrugated Iron Ceiling & North Wall, Reinforced Steel Joists, Wire Mesh Fenced Walls to East, West & South, Timber Beams, Concrete Floor.	No Sample Taken. No Asbestos Containing Materials Sighted. 2730	A5	N/A

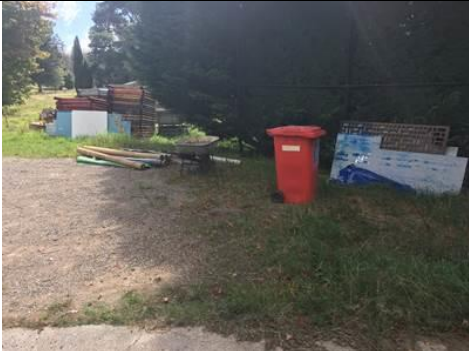
Mechanics Shed. Stockpiled Fibre Cement Sheet to North of Shed. 2731	Similar to Sample #B18166S08 No Asbestos Detected.	A5	N/A
4th April 2018

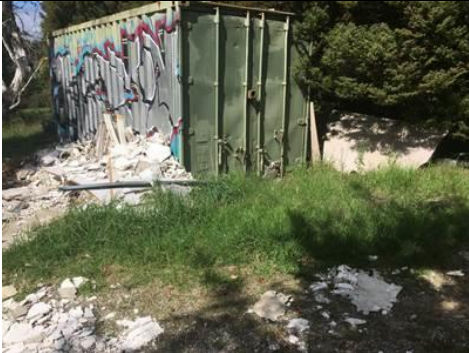
Mechanics Shed. Stockpiled Fibre Cement Sheet Around Container to South East of Shed. 2735	Sample #B18166S17 No Asbestos Detected.	A5	N/A
4th April 2018

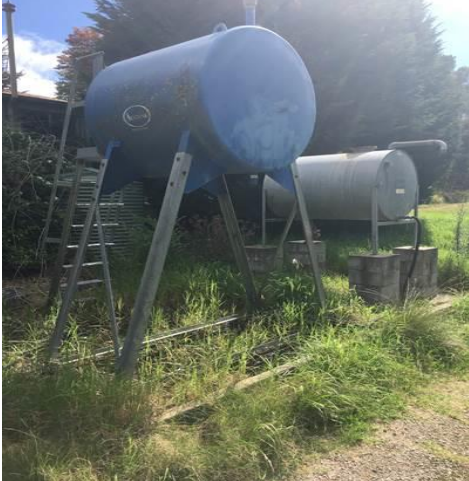
Mechanics Shed. East of Shed. Old Fuel Tanks. 2738	No Sample Taken. No Asbestos Containing Materials Sighted.	A5	N/A

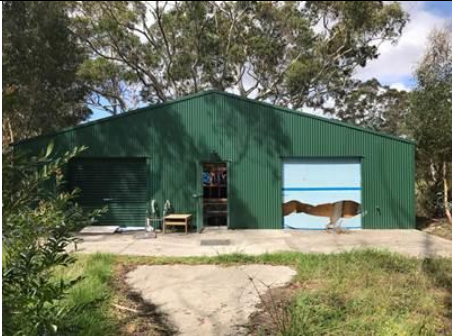
Golf Cart Shed. North Aspect. Corrugated Iron Shed, Two Roller Doors, Concrete Slab, Timber Door. 2738	No Sample Taken. No Asbestos Containing Materials Sighted.	A5	N/A
4th April 2018

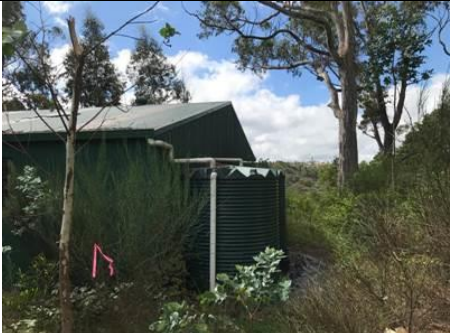
Golf Cart Shed. South Aspect. Corrugated Iron Wall & Roofing, PVC Pipes & Tank, Concrete Slab. 2742	No Sample Taken. No Asbestos Containing Materials Sighted.	A5	N/A
4th April 2018

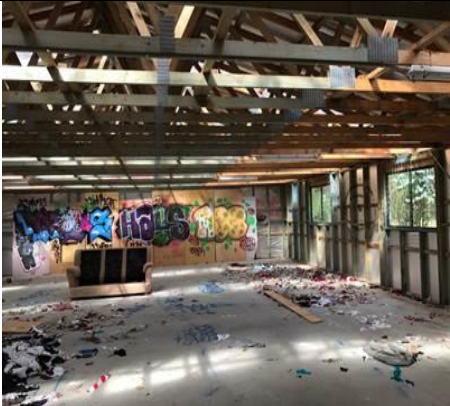
Golf Cart Shed. Concrete Floor, Corrugated Iron Walls & Roof, Foil Insulation, Exposed Timber Studs, Trusses & Window Frames, Aluminium Windows, Compressed Timber Boards to Southern Wall.	No Sample Taken. No Asbestos Containing Materials Sighted. 2744	A5	N/A
4th April 2018

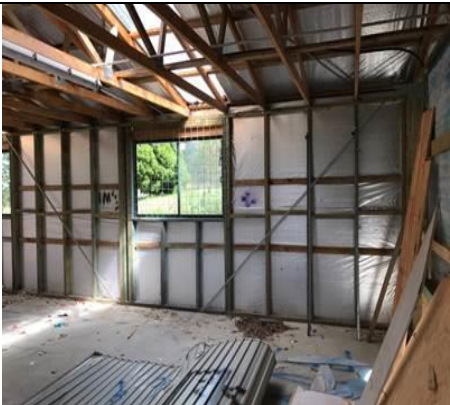
Golf Cart Shed. Concrete Floor, Corrugated Iron Walls & Roof, Foil Insulation, Exposed Timber Studs, Trusses & Window Frames, Aluminium Windows, Compressed Timber Boards to Southern Wall.	No Sample Taken. No Asbestos Containing Materials Sighted. 2745	A5	N/A

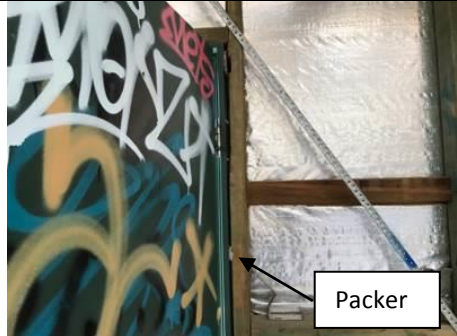
Golf Cart Shed. Fibre Cement Sheet Packers Around Door. 2745	Sample #B18166S20 No Asbestos Detected.	A5	N/A
