Asbestos Register

Prepared for:
Blue Mountains City Council,
2-6, Civic Place,
Katoomba,
NSW, 2780

On the 26th and 27th of February and the 23rd and 24th April 2018, an Asbestos Audit was conducted at the Katoomba Depot located at 22, South Street, Katoomba, NSW, 2780. Asbestos containing building materials were found to be present at the premises. Please refer Appendix I for results of products that were sampled and analysed but did not contain asbestos.

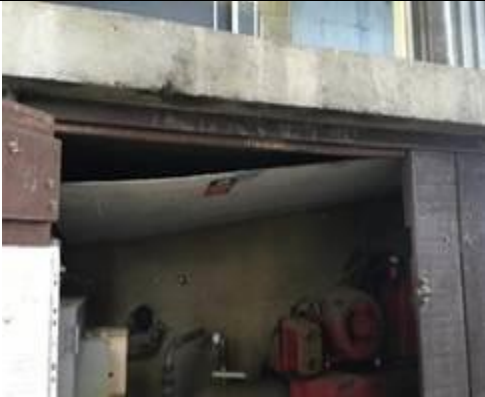
Internal - Compressor Room Soffit Lining 2071	Sample B17955 -S1 Chrysotile & Amosite Asbestos Detected Non-Friable Approximately 1m ²	A3	Good Condition Accessible to Tradespeople Refer to Asbestos Management Plan
26 th February 2018

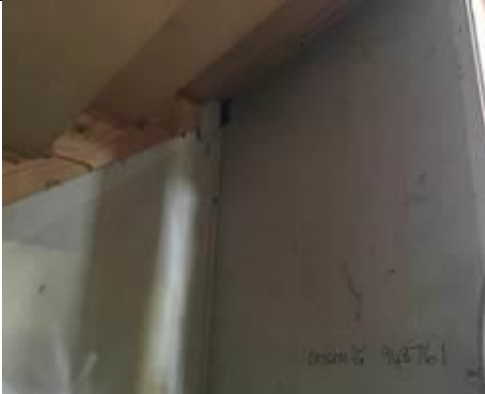
Internal - Ground Floor Beneath Stairs to 1 st Floor Offices Wall Lining Fibre Cement 2072	Sample B17955-S2 Chrysotile and Amosite Asbestos Detected Non-Friable Approximately 6m ²	A4	Good Condition Accessible to Tradespeople Refer to Asbestos Management Plan Encapsulated 18/166456

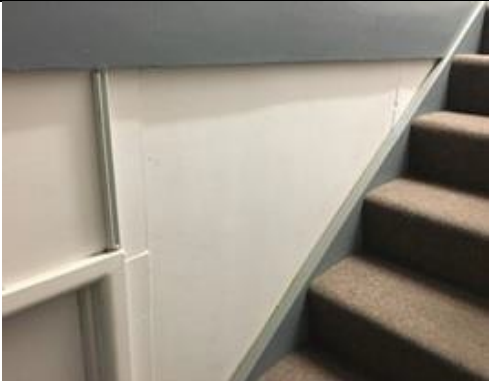
Internal - North Side of Stairs Below Timber Header Wall Lining Infills Fibre Cement 2073	Sample B17955-S3 Chrysotile Asbestos Detected Non-Friable Approximately 4m ²	A4	Good Condition Accessible to Tradespeople Refer to Asbestos Management Plan
26 th February 2018

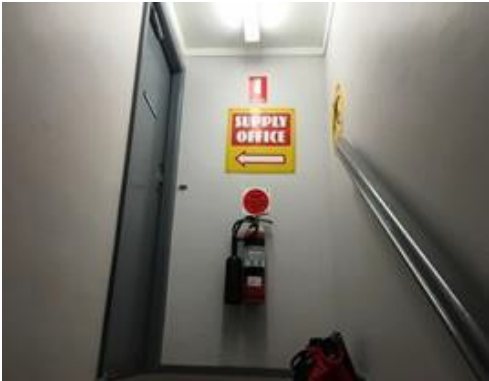
Internal - Supply Office Wall Above North Side of Stairs and to East Side of Landing Fibre Cement 2074	Similar to Sample B17955-S3 Chrysotile Asbestos Detected Non-Friable Approximately 17m ²	A4	Good Condition Accessible to Tradespeople Refer to Asbestos Management Plan
26 th February 2018

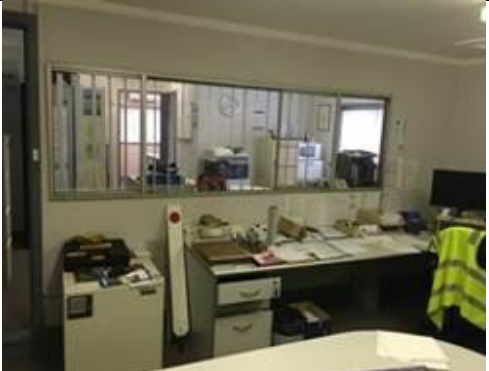
Internal - First Floor Eastern Office West Wall Lining Fibre Cement 2075	Sample B17955-S4 Chrysotile Asbestos Detected Non-Friable Approximately 7m ²	A4	Fair Condition Accessible to Tradespeople Refer to Asbestos Management Plan

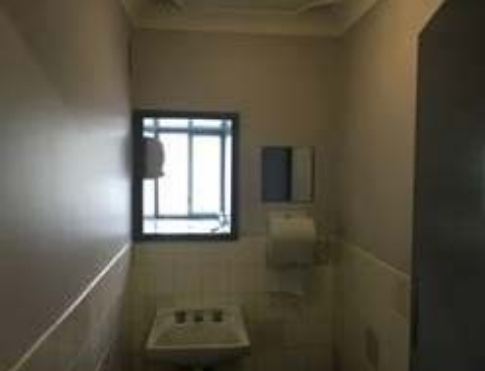
Internal - First Floor Wash Room & Toilet Wall Linings Fibre Cement 2076	Sample B17955-S5 Chrysotile Asbestos Detected Non-Friable Approximately 17m ²	A4	Good Condition Accessible to Tradespeople Refer to Asbestos Management Plan
24 th April 2018

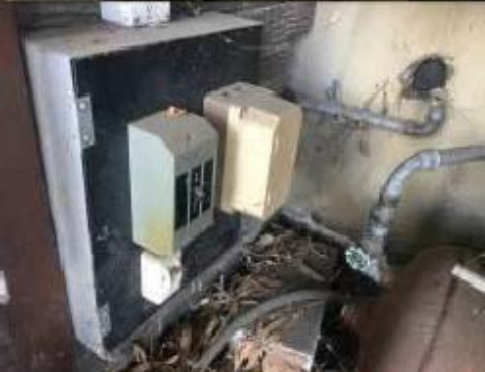
Internal - Compressor Room Meter Board Electrical Bakelite Backing Board 2077	No Sample Taken Assume Containing Material Non-Friable Approximately 0.5m ²	A4	Good Condition Accessible to Tradespeople Refer to Asbestos Management Plan
26 th February 2018

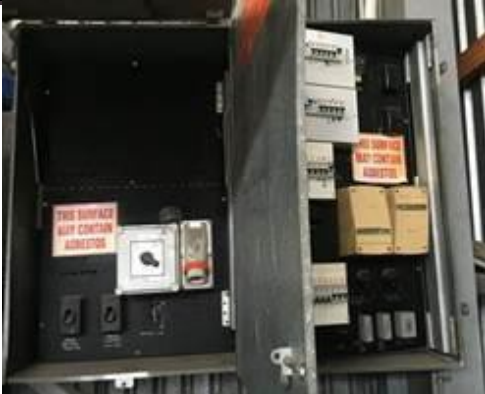
Internal - Warehouse Electric Backing Board (x2) 2078	No Sample Taken Assume Asbestos Containing Material Non-Friable Approximately 2m ²	A4	Good Condition Accessible to Tradespeople Refer to Asbestos Management Plan

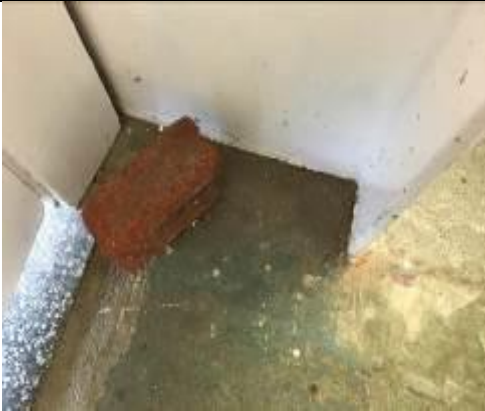
Stores Building (Unexpected Find) 1 Broken Piece Under Brick Used to Hold Door Open in Store Office, Identified Monday 26/2/18 Removed on 26/2/18 By Blue Mountains City Council Staff Member 2094	Sample B17955-S11 Chrysotile Asbestos Detected Non-Friable Photograph is Representative of Area Following removal	A2	Poor Condition, Potential for Airborne Asbestos Immediate Action Required Arrange Asbestos Removal

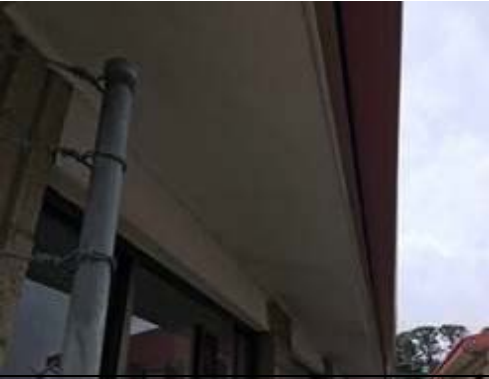
External - North & South Aspects Soffit Linings Fibre Cement Sheet 2095	Sample B17955-S6 Chrysotile Asbestos Detected Non-Friable Approximately 13m ²	A4	Fair Condition Accessible to Tradespeople Refer to Asbestos Management Plan
26 th February 2018

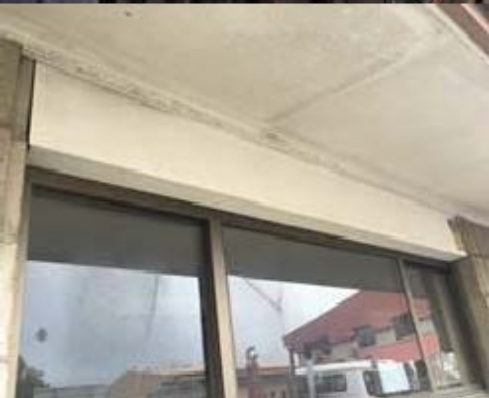
External - Southern Aspect Infills to Bulkhead Over Windows Fibre Cement Sheet 2096	Similar to Sample B17955-S6 Chrysotile Asbestos Detected Non-Friable Approximately 2m ²	A4	Fair Condition Accessible to Tradespeople Refer to Asbestos Management Plan
26 th February 2018

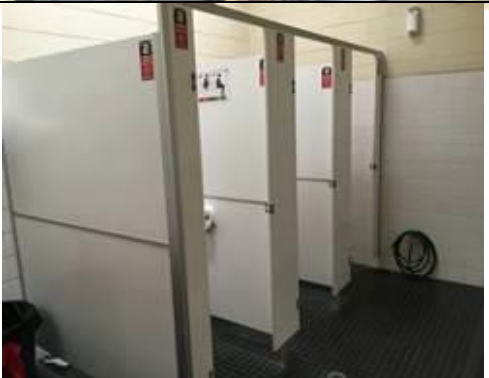
Internal - Male Toilet Cubicle Partitions to (Timber Doors) Fibre Cement Sheet Removed on 2/2/19 by Blue Mountains City Council Staff Members 2097	Sample B17955-S9 Chrysotile Asbestos Detected Non-Friable Approximately 13m ²	A4	Good Condition Accessible to Tradespeople Refer to Asbestos Management Plan SLR CC #610.17816.00000.0780R01-v1.0-CLR - 19/25355

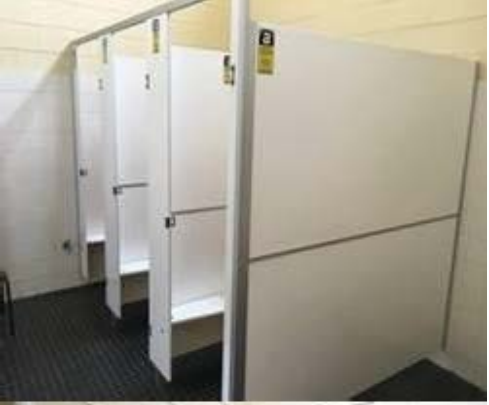
Internal – Male Showers Cubicle Partitions (Timber Doors) Fibre Cement Sheet Removed on 2/2/19 by Blue Mountains City Council Staff Members 2098	Similar to Sample B17955-S9 Chrysotile Asbestos Detected Non-Friable Approximately 14m ²	A4	Good Condition Accessible to Tradespeople Refer to Asbestos Management Plan SLR CC #610.17816.00000.0780R01-v1.0-CLR - 19/25355
26 th February 2018

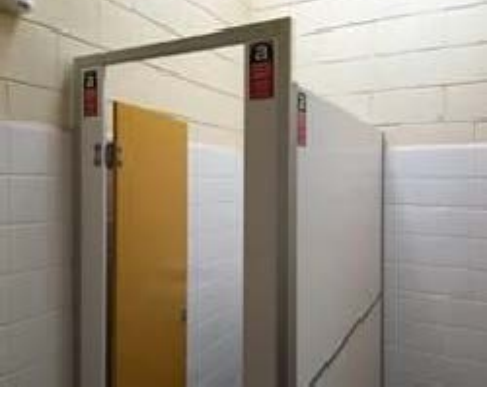
Internal – Female Toilet Cubicle Partitions (Timber Doors) Fibre Cement Sheet Removed on 2/2/19 by Blue Mountains City Council Staff Members 2099	Similar to Sample B17955-S9 Chrysotile Asbestos Detected Non-Friable Approximately 4m ²	A4	Good Condition Accessible to Tradespeople Refer to Asbestos Management Plan SLR CC #610.17816.00000.0780R01-v1.0-CLR - 19/25355

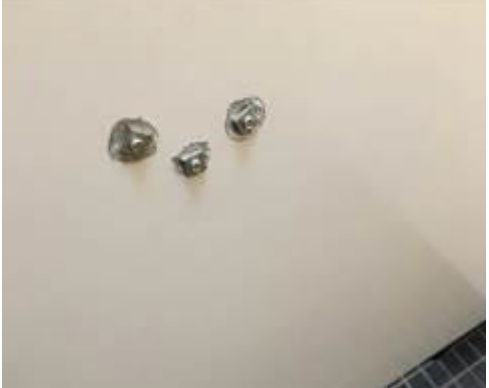
Internal – Female Toilet Exposed Board Around Nut & Bolt Fasteners Fibre Cement Sheet Removed on 2/2/19 by Blue Mountains City Council Staff Members 2100	Similar to Sample B17955-S9 Chrysotile Asbestos Detected Non-Friable Approximately 4m ²	A4	Fair Condition Accessible to Tradespeople Refer to Asbestos Management Plan SLR CC #610.17816.00000.0780R01-v1.0-CLR - 19/25355

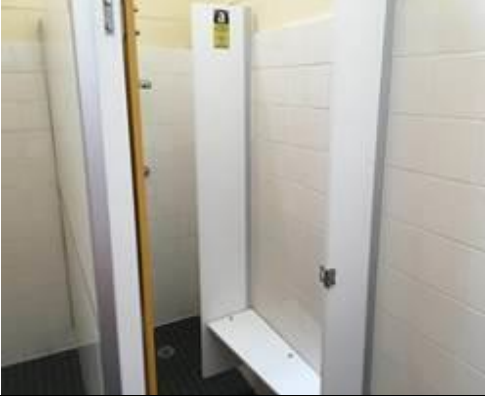
Internal – Female Shower Cubicle Partition Fibre Cement Sheet Removed on 2/2/19 by Blue Mountains City Council Staff Members 2101	Similar to Sample B17955-S9 Chrysotile Asbestos Detected Non-Friable Approximately 14m ²	A4	Good Condition Accessible to Tradespeople Refer to Asbestos Management Plan SLR CC #610.17816.00000.0780R01-v1.0-CLR - 19/25355
4 th April 2018

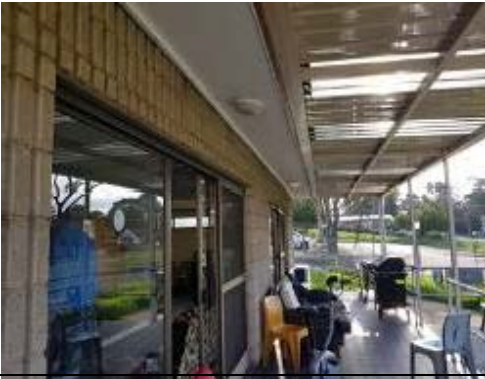
Internal - Amenities Building North Veranda Soffit Lining Fibre Cement 2102	Sample B17955-S25 Chrysotile Asbestos Detected Non-Friable Approximately 6m ²	A4	Good Condition Accessible to Tradespeople Refer to Asbestos Management Plan

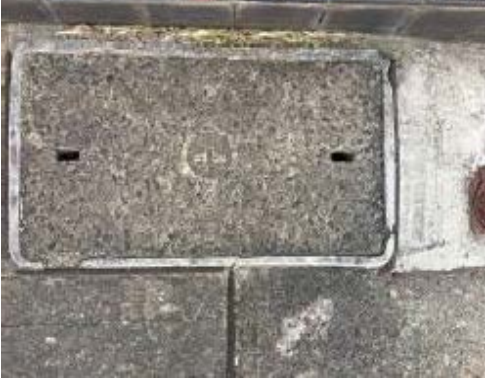
External - Lunch Room Eastern Entry Telstra Services Pit Preformed Fibre Cement Box 2103	Sample B17955-S28 Chrysotile Asbestos Detected	A3	Fair Condition Accessible to Tradespeople Refer to Asbestos Management Plan Note: This Pit Should Be the Responsibility of Telstra

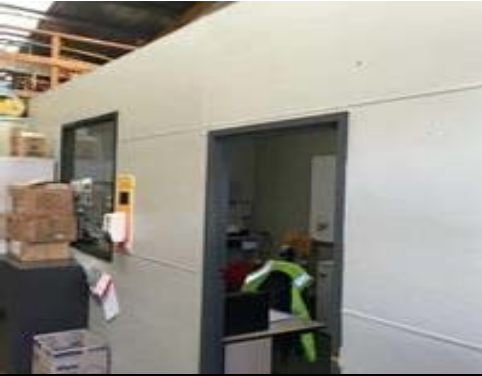
Internal - Trades Ground Floor Main Office External Bonded Board Wall Lining 2176	Sample B17955-S16 Chrysotile Asbestos Detected Approximately 45m ² Non-Friable	A4	Good Condition Accessible to Tradespeople Refer to Asbestos Management Plan
26 th February 2018

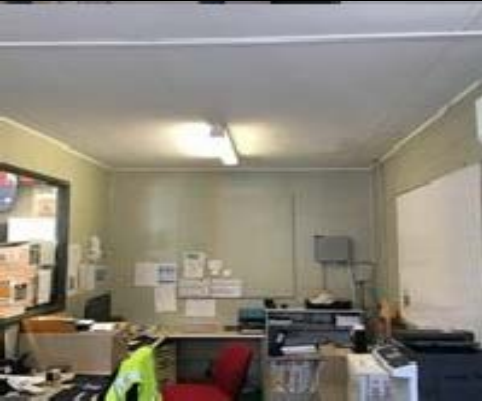
Internal - Trades Ground Floor Offices Block Walls, Bonded Board Ceiling / Walls, Carpet Floor 2177	Similar to Sample B17955-S16 Chrysotile Asbestos Detected Approximately 100m ² Non-Friable	A4	Good Condition Accessible to Tradespeople Refer to Asbestos Management Plan
26 th February 2018

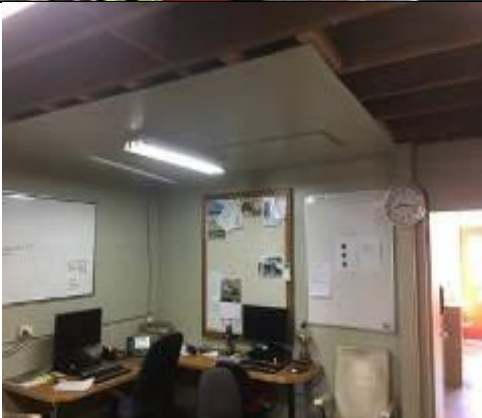
Internal - Trades Ground Floor Meal Room Northern Half Ceiling and Northern Wall Bonded Board, Remaining Ceiling Exposed Timber Supports Beams, Block Walls, Concrete Floor	Similar to Sample B17955-S16 Chrysotile Asbestos Detected Approximately Non-Friable	A4	Good Condition Accessible to Tradespeople Refer to Asbestos Management Plan 2178

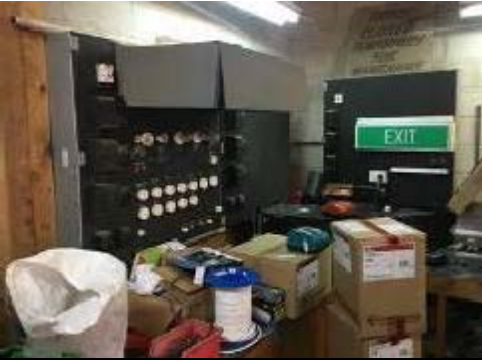
Internal – Trades Ground Floor Electrical Area Electric Backing Board Bakelite 2179	No Sample Taken Assume Asbestos Containing Material Approximately 4m ²	A4	Good Condition Accessible to Tradespeople Refer to Asbestos Management Plan
26 th February 2018

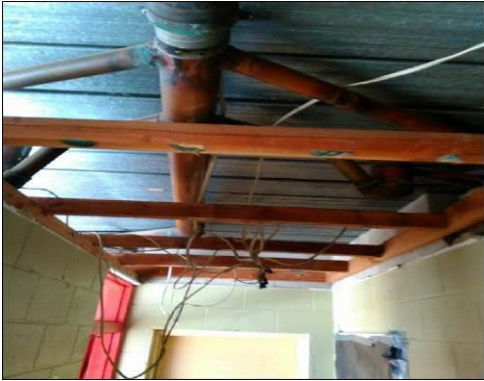
Administration Building Ceiling Above Entry Doors Fibre Cement Sheets Sample B17955-S12 Chrysotile Asbestos Detected Non-Friable Approximately 9m ² 2218	Company Empire Contracting Pty Ltd SafeWork NSW Licence Number AD204967 Supervisor Buntha Thia SafeWork NSW Notification & Removal Number Not Provided	Company SLR Consulting Pty Ltd Clearance Signatory for Removal Area Occupancy Jordan Harley Clearance Report Number 610.17816.00000.36 0-RO1-v1.0-CLR
3 rd April 2018

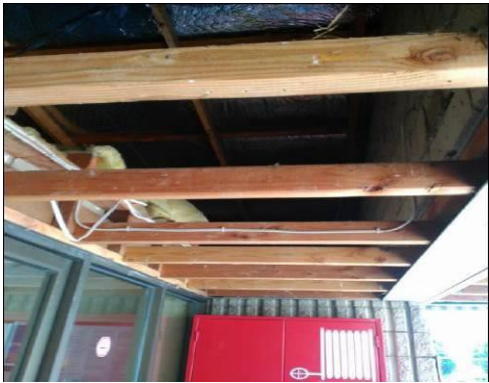
<p>Amenities Block</p> <p>Main Entry Door Awning</p> <p>Fibre Cement Sheets Similar to Sample B17955-S16</p> <p>Chrysotile Asbestos- Detected</p> <p>Non-Friable</p> <p>Approximately 8m²</p> <p>2220</p>	<p>Company</p> <p>Empire Contracting Pty Ltd</p> <p>SafeWork NSW Licence Number</p> <p>AD204967</p> <p>Supervisor</p> <p>Buntha Thia</p> <p>SafeWork NSW Notification & Removal Number</p> <p>Not Provided</p>	<p>Company</p> <p>SLR Consulting Pty Ltd</p> <p>Clearance Signatory for Removal Area Occupancy</p> <p>Jordan Harley</p> <p>Clearance Report Number</p> <p>610.17816.00000.36 0-RO1-v1.0-CLR</p>

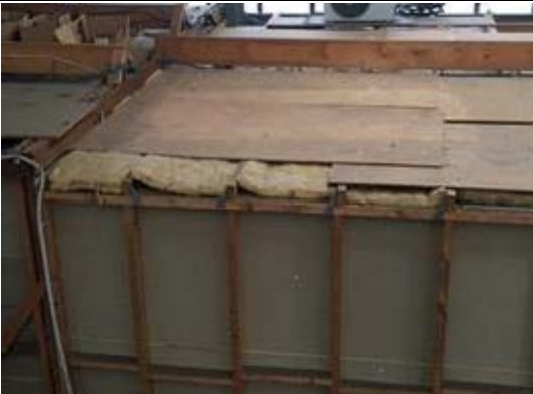
Store Ceiling Insulation to 1 st Floor Offices Approximately 50m ²	No Sample Taken Visual Inspection Only	A4	Accessible to Tradespeople Refer to Management Plan
26 th February 2018

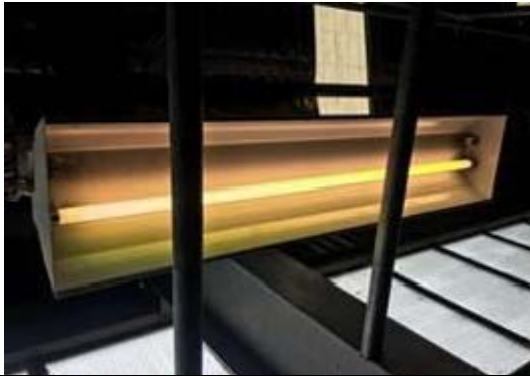
Stores 4 x Fluorescent Lights Located on Southern Side	Ducon APF 265 Type Capacitor Contains PCB's	A3	Accessible to Tradespeople Refer to Management Plan
26 th February 2018

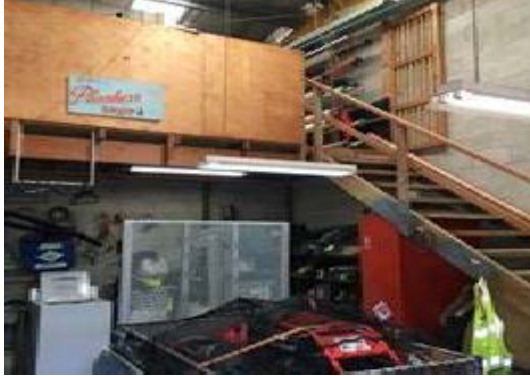
Parks & Gardens / Trades Plumbers Shop, Suspended Double Internal Fluorescent Light Assemblies	RIFA PHN 3µF Type Capacitor Contains PCB's	A3	Accessible to Tradespeople Refer to Management Plan

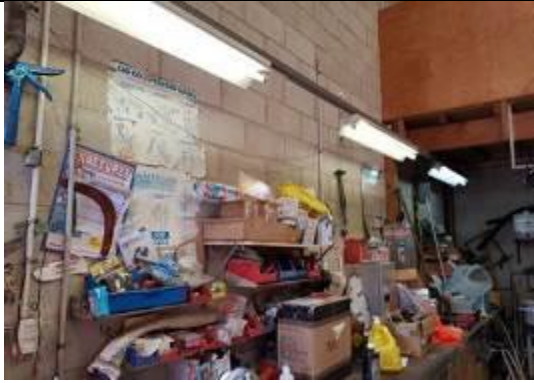
Parks & Gardens / Trades Plumbers Shop, Suspended Single Internal Fluorescent Light Assemblies	RIFA PHN 3µF Type Capacitor Contains PCB's	A3	Accessible to Tradespeople Refer to Management Plan
4 th April 2018

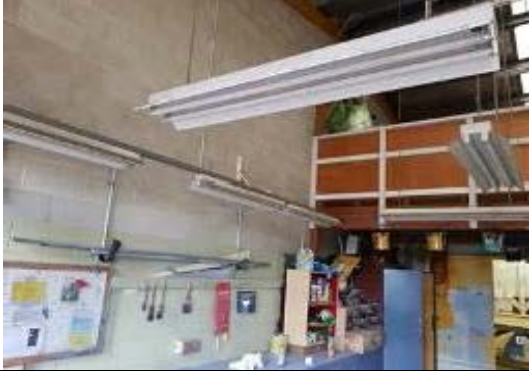
Parks & Gardens / Trades Sign Writer's Room, Single & Double Fluorescent Light Assemblies.	RIFA PHN 3µF Type Capacitor Contains PCB's	A3	Accessible to Tradespeople Refer to Management Plan
4 th April 2018

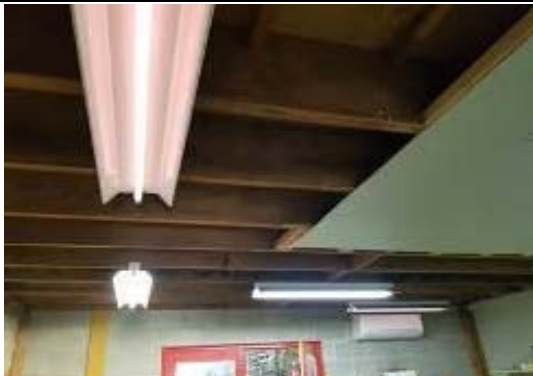
Parks & Gardens / Trades Offices, 4 x Single Fluorescent Light Assemblies	RIFA PHN 3µF Type Capacitor Present Contains PCB's	A3	Accessible to Tradespeople Refer to Management Plan
4 th April 2018

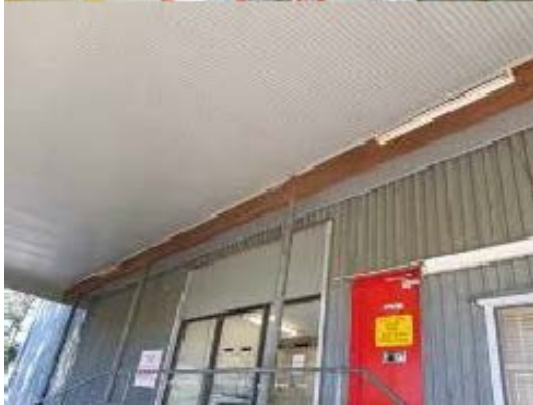
Stores 4 x Fluorescent Lights to Entrance of Stores Building – North Aspect	Assume PCB Containing Until Confirmed Otherwise No Safe Access Due to Height of Lights (>4m)	A4	Unknown Condition Accessible to Tradespeople with Appropriate Height Safety Equipment
4 th April 2018

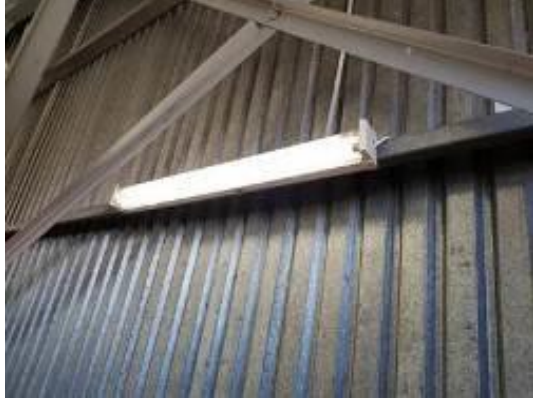
Stores Warehouse Single Fluorescent Light Assembly Above Stairs	Assume PCB Containing Until Confirmed Otherwise No Safe Access Due to Height of Lights (>4m)	A4	Unknown Condition Accessible to Tradespeople with Appropriate Height Safety Equipment

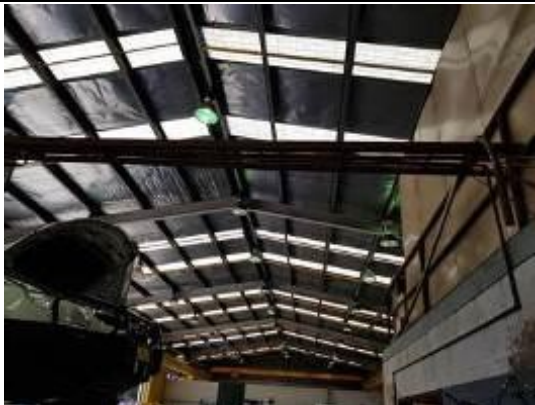
Mechanical Services Workshop Floor Lights No Access	Assume PCB Containing Until Confirmed Otherwise No Safe Access Due to Height of Lights (>4m)	A4	Unknown Condition Accessible to Tradespeople with Appropriate Height Safety Equipment
4 th April 2018

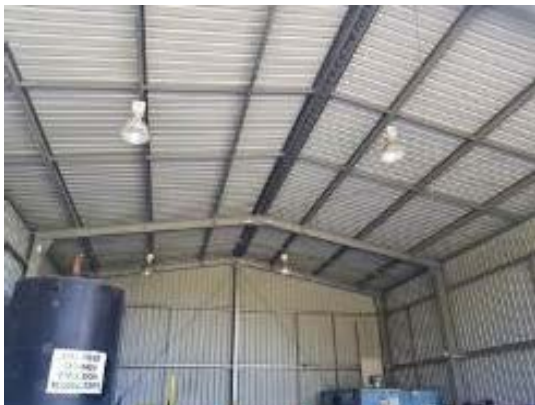
Bitumen Shed 4 x Hanging Fluorescent Lights	Assume PCB Containing Until Confirmed Otherwise No Safe Access Due to Height of Lights (>4m)	A4	Unknown Condition Accessible to Tradespeople with Appropriate Height Safety Equipment
4 th April 2018

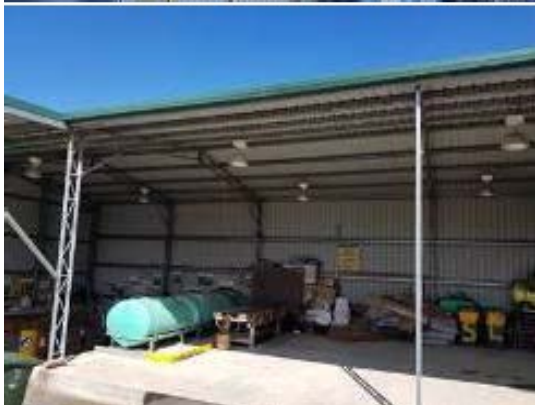
Bushland Regeneration's Shed 6 x Hanging Fluorescent Lights	Assume PCB Containing Until Confirmed Otherwise No Safe Access Due to Height of Lights (>4m)	A4	Unknown Condition Accessible to Tradespeople with Appropriate Height Safety Equipment
