HAZARDOUS BUILDING MATERIALS SURVEY REPORT

Attunga Road RFS
24 Attunga Road, Blaxland NSW 2774

Report Number 610.18030.00000-R01-ASR

13 April 2018

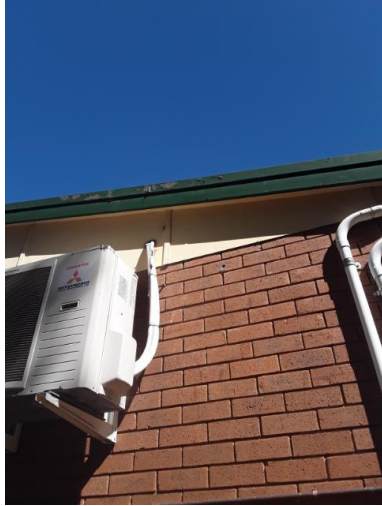
Negative			
Test Number	Test Location	Test Result	Photo
ST07	External trims - Green colour paint to Paint on gutter and external trims	Negative <1%

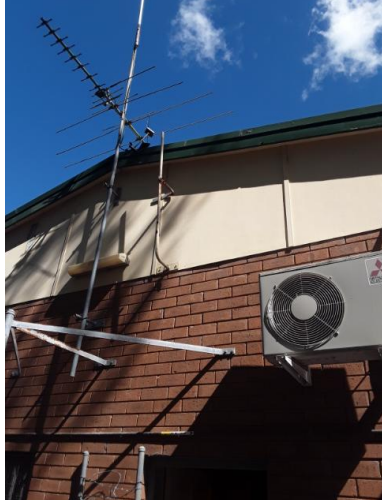
FA08	External trims - Cream colour paint to Paint on cladding and eaves	Negative <1%

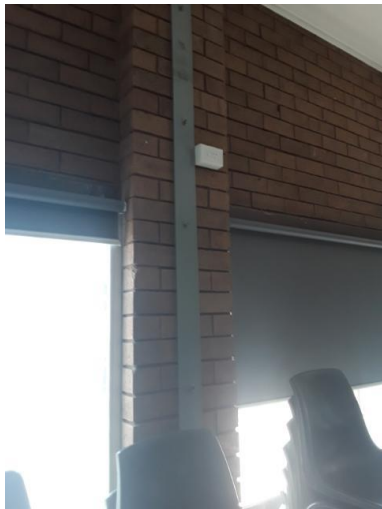
Test Number	Test Location	Test Result	Photo
ST06	Internal Walls - Blue colour paint to Paint on lintel strips	Negative <1%

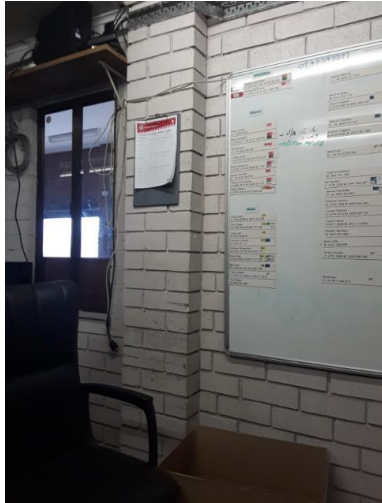
ST06	Internal Walls - White colour paint to Paint on office wall	Negative <1%

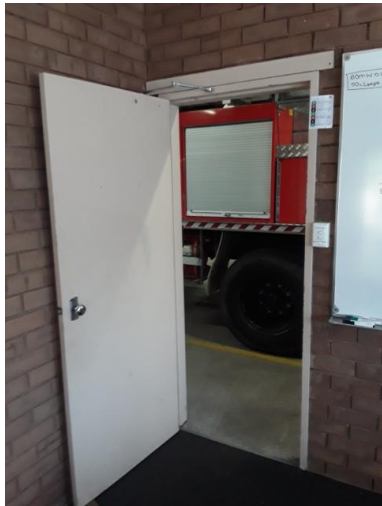
ST02	Internal - Cream colour paint to Doors and trims	Negative <1%

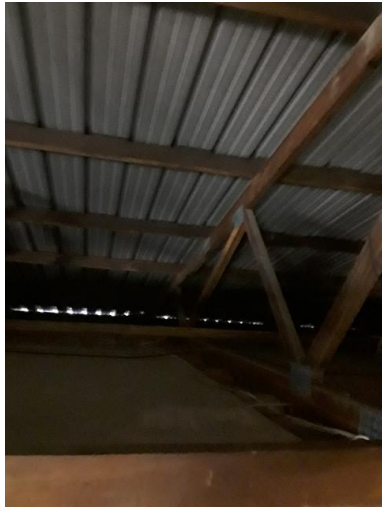
Test Number	Test Location	Test Result	Photo
LD01	Ground Floor Ceiling Cavity - Ceiling Void	5.3
