Hazardous Materials Survey

Prepared for:	Blue Mountains City Council
Prepared by:	Alex Tam Licensed Asbestos Assessor #001241 Trinitas Group
Site:	Springwood Community Arts Centre
Address:	22 Ferguson Rd, Springwood NSW 2777
Field Work Date:	Wednesday, 1 September 2021
Date of Report:	15/09/2021

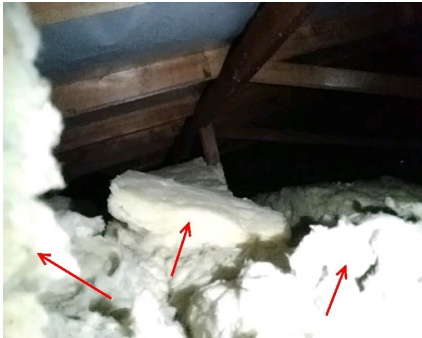
Photo No: 210811-095033
Result: SMF - Presumed Positive
Location-Level: Interior - Roof
Room-Location: Roof - insulation
Feature-Material: Insulation
Item No - Risk Rating: 1 - N/A

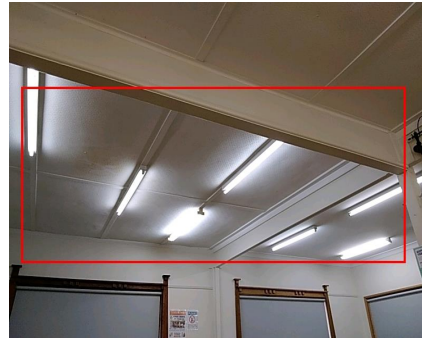
Photo No: 210811-105634
Result: PCB - Presumed Positive
Location-Level: Interior - Ground Floor
Room-Location: Meeting room and studio - light fitting
Feature-Material: Single and double capacity
Item No - Risk Rating: 13 - N/A

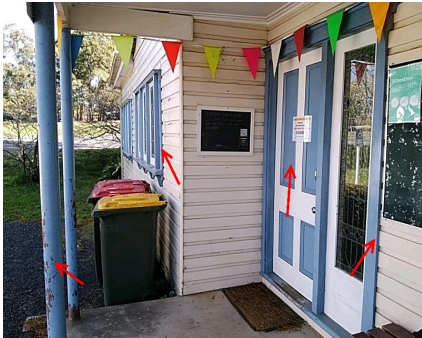
Photo No: 210811-111218
Result: Lead in Paint - Positive
Location-Level: Exterior - Ground Floor
Room-Location: All elevation of the building - door frames, windows frames, handrail and column
Feature-Material: Lower colour paint system
Item No - Risk Rating: 16 - N/A

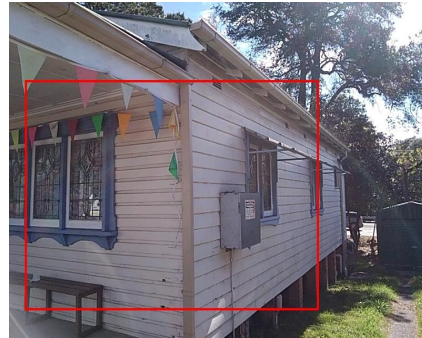
Photo No: 210811-111231
Result: Lead in Paint - Positive
Location-Level: Exterior - Ground Floor
Room-Location: All elevation of the building - external walls
Feature-Material: Lower colour paint system
Item No - Risk Rating: 17 - N/A

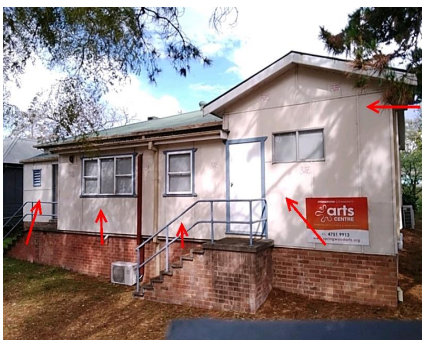
Photo No: 210823-124111
Result: Asbestos - Positive
Location-Level: Exterior - Ground Floor
Room-Location: Northern elevation of the building - external walls
Feature-Material: FC sheeting
Item No - Risk Rating: 19 - Low

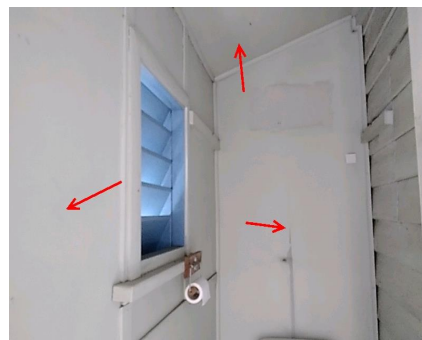
Photo No: 210811-111626
Result: Asbestos - Positive
Location-Level: Exterior - Ground Floor
Room-Location: External toilet - internal walls and ceiling
Feature-Material: FC sheeting
Item No - Risk Rating: 20 - Low

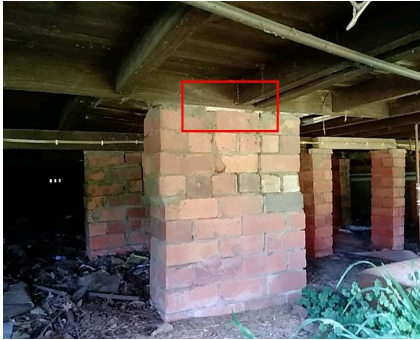
Photo No: 210811-111734
Result: Asbestos - Positive
Location-Level: Exterior - Ground Floor
Room-Location: All elevation of the building - packer to support beams
Feature-Material: FC sheeting
Item No - Risk Rating: 21 - Low

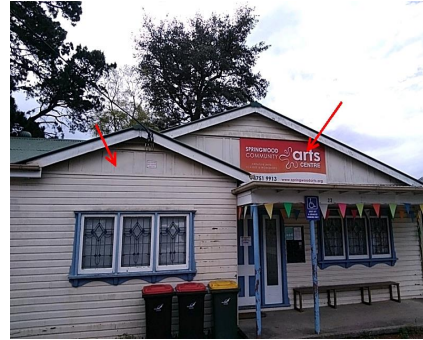
Photo No: 210823-123900
Result: Asbestos - Presumed Positive
Location-Level: Exterior - Ground Floor
Room-Location: Southern and northern elevation of the building - gable
Feature-Material: FC sheeting
Item No - Risk Rating: 22 - Low

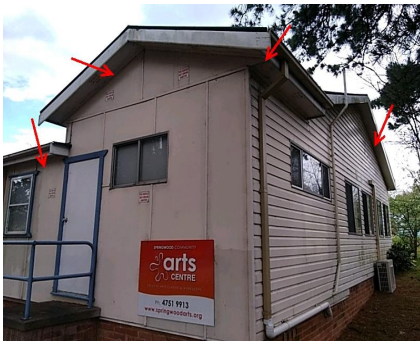
Photo No: 210823-120443
Result: Asbestos - Presumed Positive
Location-Level: Exterior - Ground Floor
Room-Location: Western and northern elevation of the building - eaves
Feature-Material: FC sheeting
Item No - Risk Rating: 23 - Low

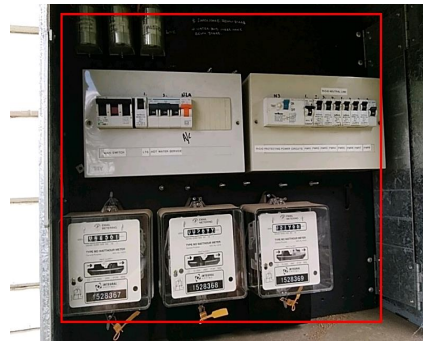
Photo No: 210823-120217
Result: Asbestos - Presumed Positive
Location-Level: Exterior - Ground Floor
Room-Location: SE elevation of the building - electrical distribution backing board
Feature-Material: Bituminous-like material
Item No - Risk Rating: 24 - Low

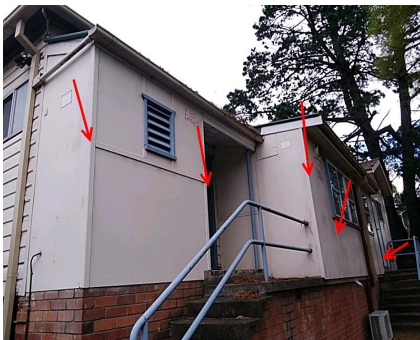
26	Exterior	Ground Floor	Eastern, western and northern elevation of the building - walls corner cover strip	Asbestos	Moulded FC	12	Positive	210823-121005	Through out	Fair	Non-Friable	Low	Low	No	P4	P4 - No short term remediation works required. Review periodically and manage as part of an AMP
27	Exterior	Ground Floor	NE elevation of the building - flooring	Asbestos	Moulded FC	13	Positive	210823-121504	Through out	Fair	Non-Friable	Low	Low	No	P4	P4 - No short term remediation works required. Review periodically and manage as part of an AMP

Photo No: 210823-121005
Result: Asbestos - Positive
Location-Level: Exterior - Ground Floor
Room-Location: Eastern, western and northern elevation of the building - walls corner cover strip
Feature-Material: Moulded FC
Item No - Risk Rating: 26 - Low

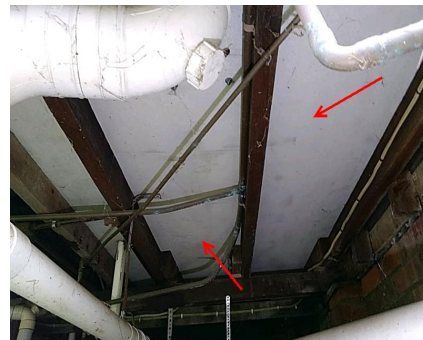
Photo No: 210823-121504
Result: Asbestos - Positive
Location-Level: Exterior - Ground Floor
Room-Location: NE elevation of the building - flooring
Feature-Material: Moulded FC
Item No - Risk Rating: 27 - Low

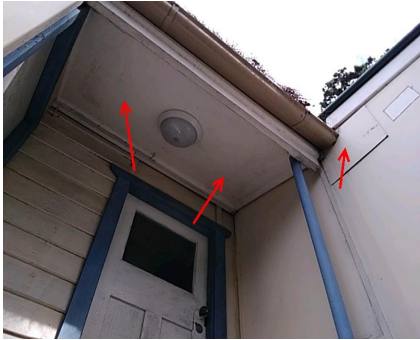
Photo No: 210823-124259
Result: Asbestos - Presumed Positive
Location-Level: Exterior - Ground Floor
Room-Location: Northern elevation of the building (next to rear entrance) - infill panel and eaves
Feature-Material: FC sheeting
Item No - Risk Rating: 28 - Low

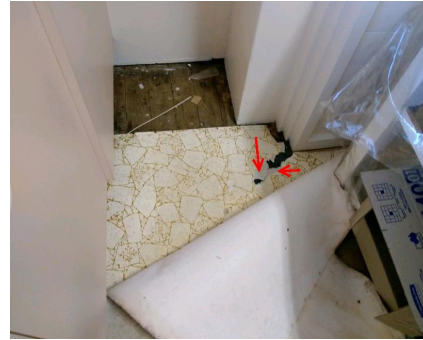
Photo No: 210915-090207
Result: Asbestos - Positive
Location-Level: Interior - Ground Floor
Room-Location: Kitchen - Floor covering
Feature-Material: (a) vinyl sheeting and backing material. (b) adhesive
Item No - Risk Rating: 29 - High

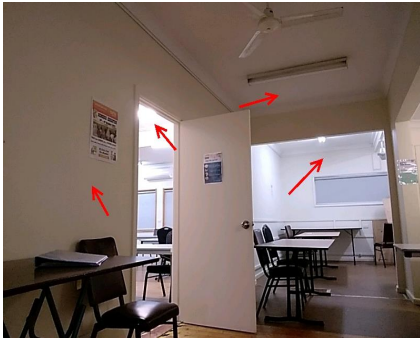
Photo No: 210811-095456
Result: Asbestos - Negative
Location-Level: Interior - Ground Floor
Room-Location: Meeting room and studio - Internal walls, dividing wall and ceilings
Feature-Material: Plaster-like material

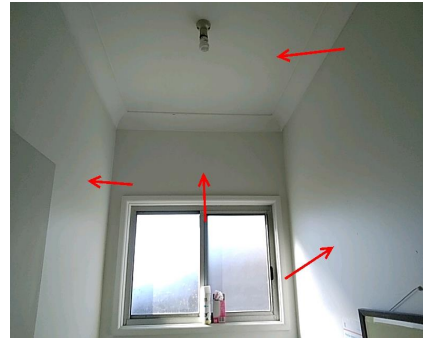
Photo No: 210811-100703
Result: Asbestos - Negative
Location-Level: Interior - Ground Floor
Room-Location: Toilet - internal walls and ceiling
Feature-Material: FC sheeting

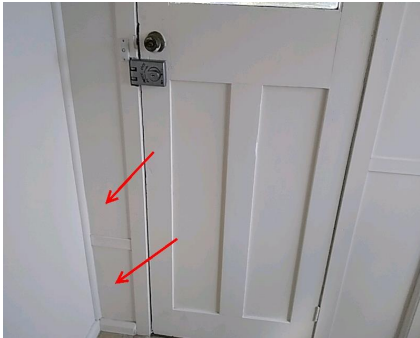
Photo No: 210811-101411
Result: Asbestos - Negative
Location-Level: Interior - Ground Floor
Room-Location: Northern exit - infill panels next to exit door
Feature-Material: FC sheeting

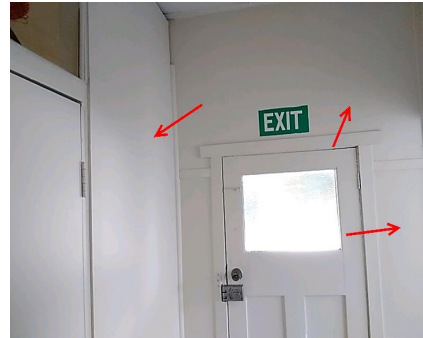
Photo No: 210811-101713
Result: Asbestos - Presumed Negative
Location-Level: Interior - Ground Floor
Room-Location: Northern exit - internal walls and ceiling
Feature-Material: Plaster-like material

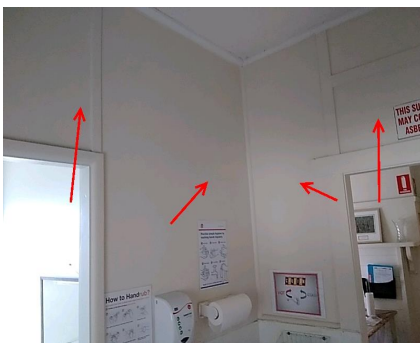
Photo No: 210811-101915
Result: Asbestos - Presumed Negative
Location-Level: Interior - Ground Floor
Room-Location: Northern exit next to toilet and kitchen - internal and dividing walls
Feature-Material: FC sheet

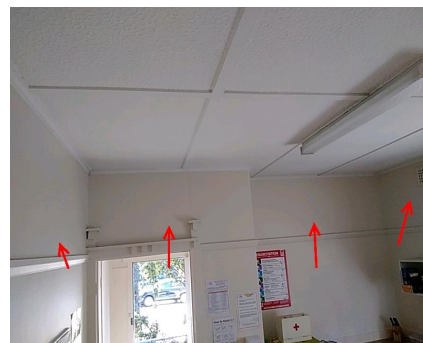
Photo No: 210811-102927
Result: Asbestos - Negative
Location-Level: Interior - Ground Floor
Room-Location: Kitchen - upper section of internal and dividing wall
Feature-Material: FC sheeting

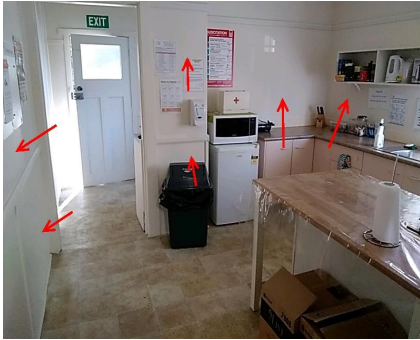
Photo No: 210811-103311
Result: Asbestos - Presumed Negative
Location-Level: Interior - Ground Floor
Room-Location: Kitchen
Feature-Material: Plaster-like material

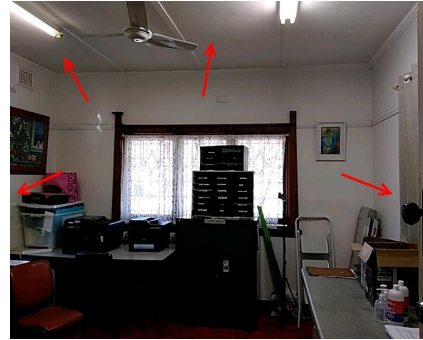
Photo No: 210811-103648
Result: Asbestos - Presumed Negative
Location-Level: Interior - Ground Floor
Room-Location: Office - internal walls and ceiling
Feature-Material: Plaster-like material

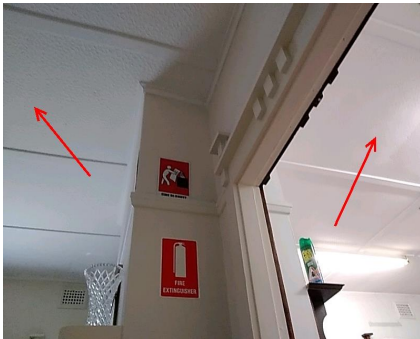
Photo No: 210811-104056
Result: Asbestos - Presumed Negative
Location-Level: Interior - Ground Floor
Room-Location: Kitchen and office - ceilings
Feature-Material: Plaster-like material

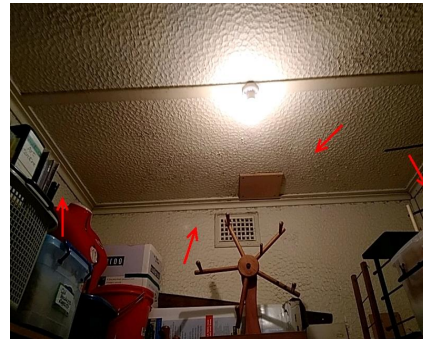
Photo No: 210811-104158
Result: Asbestos - Presumed Negative
Location-Level: Interior - Ground Floor
Room-Location: Storage room - internal walls and ceiling
Feature-Material: Plaster-like material

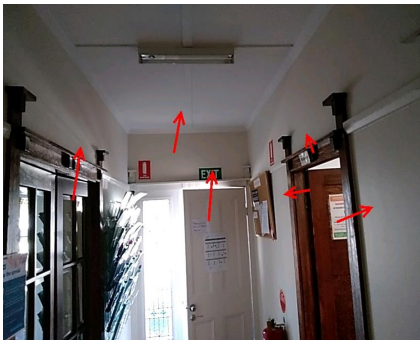
Photo No: 210811-104916
Result: Asbestos - Presumed Negative
Location-Level: Interior - Ground Floor
Room-Location: Entry lobby - internal, dividing walls and ceiling
Feature-Material: Plaster-like material

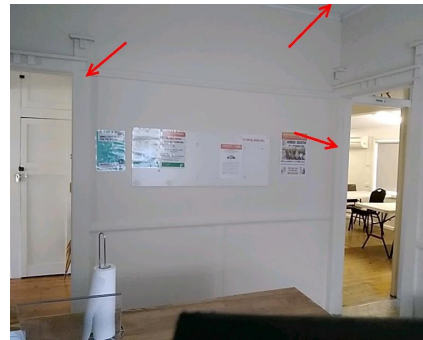
Photo No: 210811-110142
Result: Lead in Paint - Negative
Location-Level: Interior - Ground Floor
Room-Location: All elevation of the floor - door frame, walls and ceilings
Feature-Material: Lower colour paint system

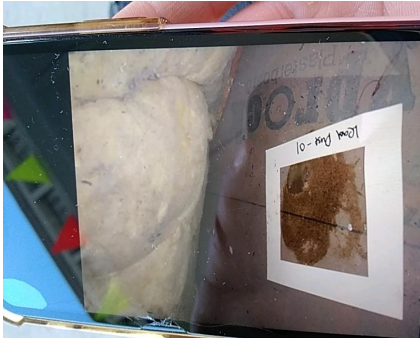
Photo No: 210811-110901
Result: Lead in Dust - Negative
Location-Level: Interior - Roof
Room-Location: Roof cavity - settled dust on ceiling lining
Feature-Material: Settled dust on wipe

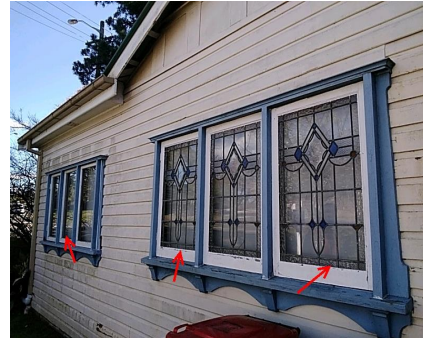
Photo No: 210811-111328
Result: Asbestos - Negative
Location-Level: Exterior - Ground Floor
Room-Location: Southern elevation of the building - windows frames sealants
Feature-Material: Mastic-like material

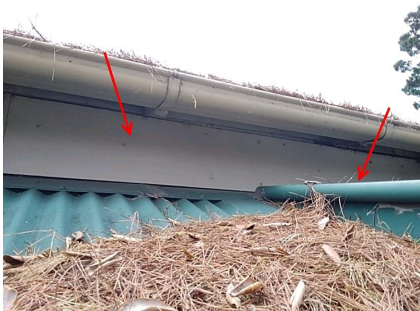
Photo No: 210823-120823
Result: Asbestos - Presumed Negative
Location-Level: Exterior - Ground Floor
Room-Location: Northern elevation of the building- infill panels above external walls
Feature-Material: Similar to 03
