Asbestos Register

On the 24th June 2018, an Asbestos Audit was conducted on the BMEE Cottage and asbestos containing materials were found to be present at the premises. Please refer Appendix I for results of products that were considered and consequently analysed but did not contain asbestos.

HAZARDOUS MATERIALS REGISTER & MANAGEMENT PLAN

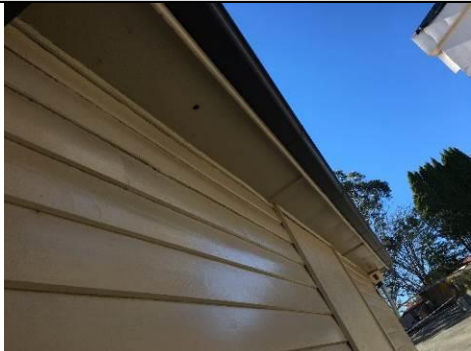
External - Eastern Aspect, Eaves Fibre Cement Approx. 8m ² 2622	Sample B18167-S10 Chrysotile, Amosite & Crocidolite Asbestos Detected. Non-Friable.	A4	Good Condition, Accessible to Tradespeople Refer to Management Plan
24 th June 2018

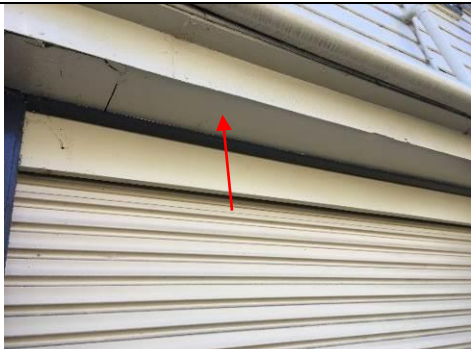
External - Southern Aspect Infill Above Roller Doors Fibre Cement Approx. 4m ² 2623	Sample B18167-S11 Chrysotile, Amosite and Crocidolite Asbestos Detected. Non-Friable.	A3	Minor Damage, Accessible to Tradespeople Refer to Management Plan

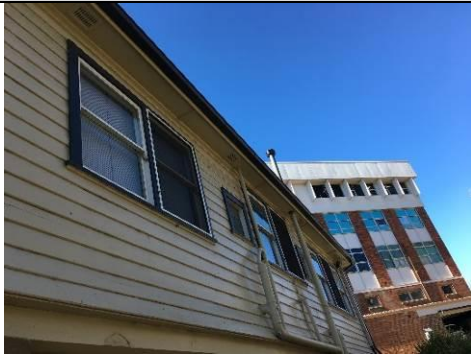
External-Southern Aspect, Eaves Fibre Cement Approx. 8m ² 2624	Similar to Sample B18167-S10 Chrysotile, Amosite and Crocidolite Asbestos Detected. Non-Friable.	A4	Good Condition, Accessible to Tradespeople Refer to Management Plan
24 th June 2018

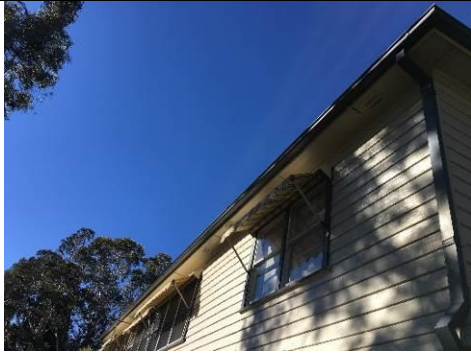
External-Western Aspect, Eaves Fibre Cement Approx. 8m ² 2625	Similar to Sample B18167-S10 Chrysotile, Amosite and Crocidolite Asbestos Detected. Non-Friable.	A4	Good Condition, Accessible to Tradespeople Refer to Management Plan

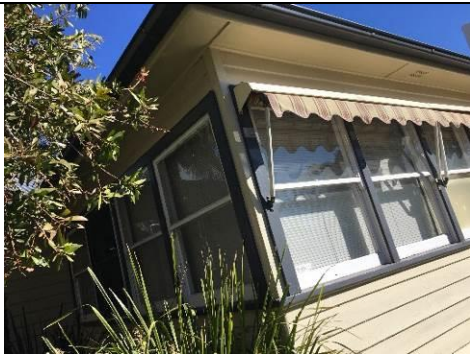
External - Northern Aspect, Eaves Fibre Cement Approx. 8m ² 2626	Similar to Sample B18167-S10 Chrysotile, Amosite and Crocidolite Asbestos Detected. Non-Friable.	A4	Good Condition, Accessible to Tradespeople Refer to Management Plan
24 th June 2018

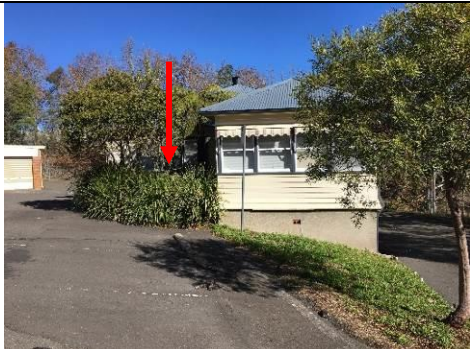
External - Northern Aspect, Utilities Cover in Garden Along North-East Section Fibre Cement Approx. 2m ² 2627	Sample B18167-S13 Chrysotile Asbestos Detected. Non-Friable.	A4	Good Condition, Accessible to Tradespeople Refer to Management Plan

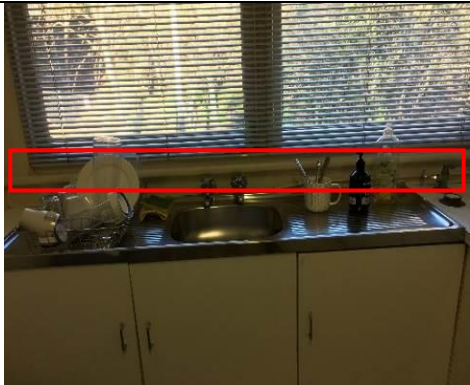
Internal - Kitchen Splashback Fibre Cement Sheet Approx. 1m ² Visible, Assume Extends Behind Sink Area and Cupboards on Southern Wall.	Sample B18167-S3 Chrysotile Asbestos Detected. Non-Friable. 2635	A4	Good Condition, Accessible to Tradespeople Refer to Management Plan
24 th June 2018

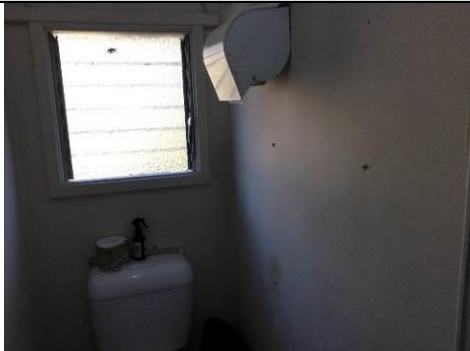
Internal - Western Toilet West and South Walls to 1800mm Fibre Cement Approx. 5m ²	Sample B18167-S4 Chrysotile and Amosite Asbestos Detected. Non-Friable. 2637	A4	Good Condition, Accessible to Tradespeople Refer to Management Plan
24 th June 2018

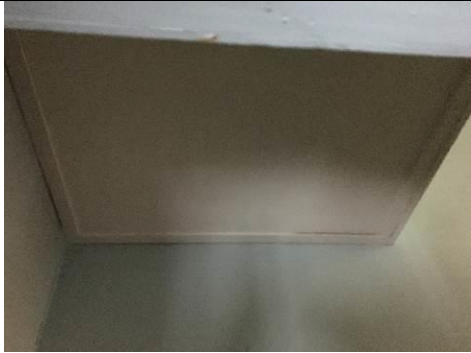
Internal - Upper Stairwell, Lower Ceiling Fibre Cement Approx. 1m ² 2646	Sample B18167-S5 Chrysotile and Amosite Asbestos Detected Non-Friable	A4	Good Condition, Accessible to Tradespeople Refer to Management Plan
24 th June 2018

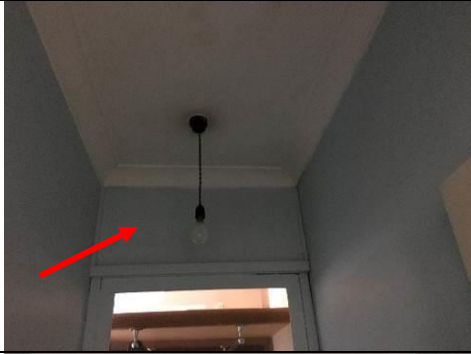
Internal - Upper Stairwell Infill above window Fibre Cement Approx. 0.5m ² 2647	Similar to Sample B18167-S5 Chrysotile and Amosite Asbestos Detected Non-Friable	A4	Good Condition, Accessible to Tradespeople Refer to Management Plan
24 th June 2018

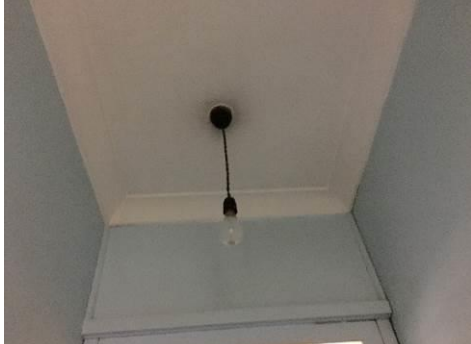
Internal - Upper Stairwell Bakelite Light Fitting 2648	No Sample Taken, Assume Contains Asbestos Non-Friable	A4	Good Condition, Accessible to Tradespeople Refer to Management Plan

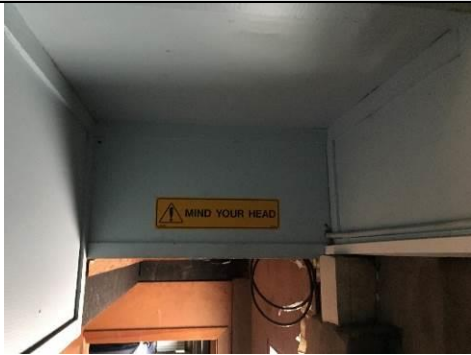
Internal - Central Section of Stairs, Ceiling and Infills Fibre Cement Approx. 2m ² 2649	Similar to Sample B18167-S5 Chrysotile and Amosite Asbestos Detected. Non-Friable.	A4	Good Condition, Accessible to Tradespeople Refer to Management Plan
24 th June 2018

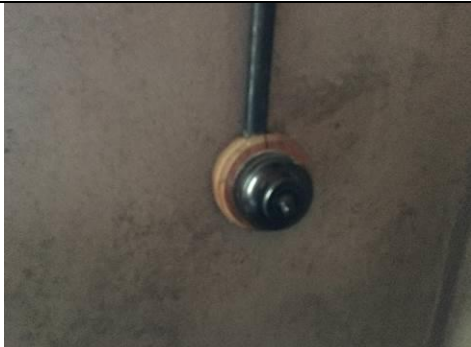
Internal - Stair Well Bakelite Switch. 2651	No Sample Taken, Assume Contains Asbestos. Non-Friable.	A4	Good Condition, Accessible to Tradespeople Refer to Management Plan

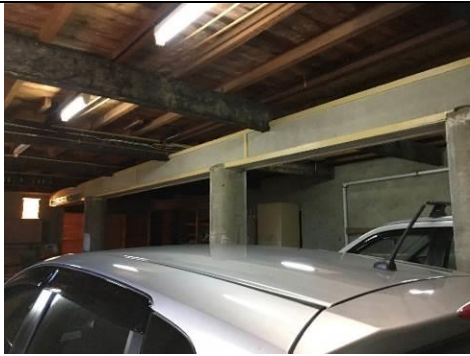
Internal - Garage, Bulk Head Running North-South. Fibre Cement Approx. 12m ²	Sample B18167-S6 Chrysotile and Amosite Asbestos Detected. Non-Friable. 2653	A3	Moderate Condition, Materials Should be Painted/Sealed, Accessible to Tradespeople Refer to Management Plan
24 th June 2018

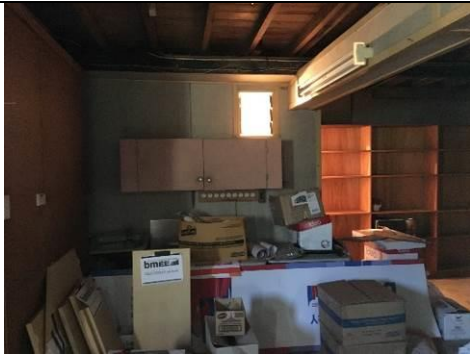
Internal - Garage, West Wall of Garage. Fibre Cement Approx. 7m ²	Similar to Sample B18167-S6 Chrysotile and Amosite Asbestos Detected. Non-Friable. 2654	A3	Moderate Condition, Materials Should be Painted/Sealed, Accessible to Tradespeople Refer to Management Plan

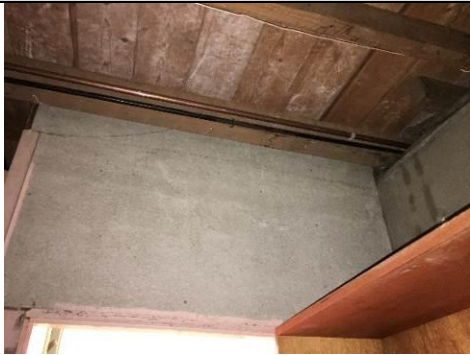
Internal - Garage Infill Panel Above Toilet Door. Fibre Cement 1m ² 2655	Similar to Sample B18167-S6 Chrysotile and Amosite Asbestos Detected. Non-Friable.	A3	Moderate Condition, Materials Should be Painted/Sealed, Accessible to Tradespeople Refer to Management Plan
24 th June 2018

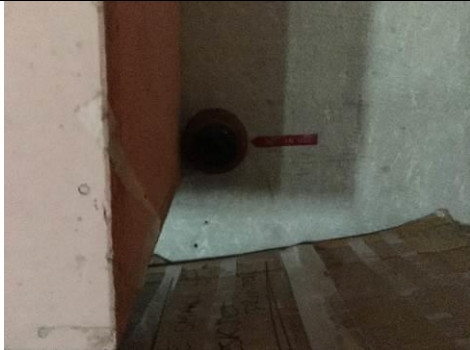
Internal - Garage West Wall Bakelite Switch. 2656	No Sample Taken, Assume Contains Asbestos. Non-Friable.	A4	Good Condition, Accessible to Tradespeople Refer to Management Plan
24 th June 2018

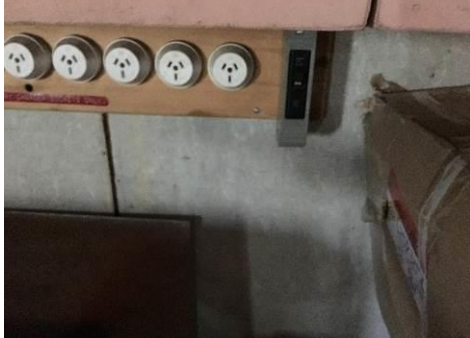
Internal Garage, West Wall Mains Switch. 2657	No Sample Taken, Assume Contains Asbestos. Non-Friable.	A4	Good Condition, Accessible to Tradespeople Refer to Management Plan

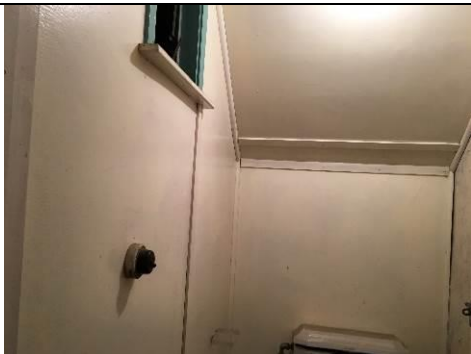
Internal - Toilet in Garage East, West and Southern Walls and Ceiling Fibre Cement Sheet 8m ² 2658	Sample B18167-S7 Chrysotile and Amosite Asbestos Detected. Non-Friable.	A4	Good Condition, Accessible to Tradespeople Refer to Management Plan
24 th June 2018

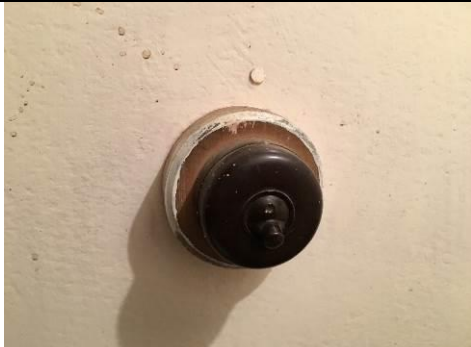
Internal-Toilet in Garage. Bakelite Switch 2659	No Sample Taken, Assume Contains Asbestos. Non-Friable.	A4	Good Condition, Accessible to Tradespeople Refer to Management Plan

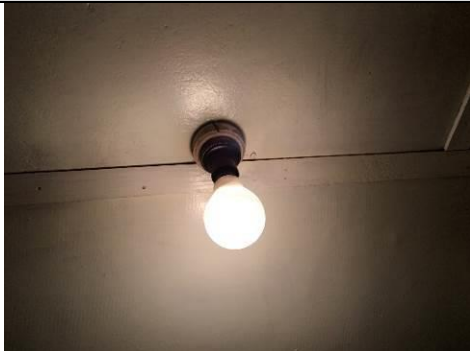
Internal-Toilet in Garage. Bakelite Fitting 2660	No Sample Taken, Assume Contains Asbestos. Non-Friable.	A4	Good Condition, Accessible to Tradespeople Refer to Management Plan
24 th June 2018

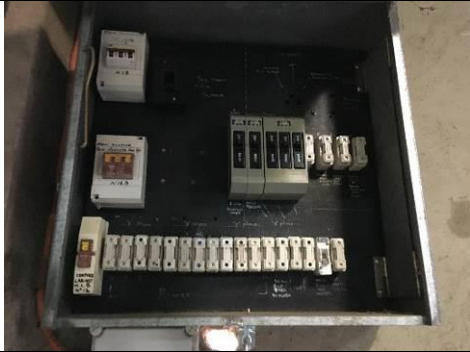
Internal-Meter Box in Garage. Bakelite Backing Board 0.5m ² 2661	No Sample Taken, Assume Contains Asbestos. Non-Friable.	A4	Good Condition, Accessible to Tradespeople Refer to Management Plan
24 th June 2018

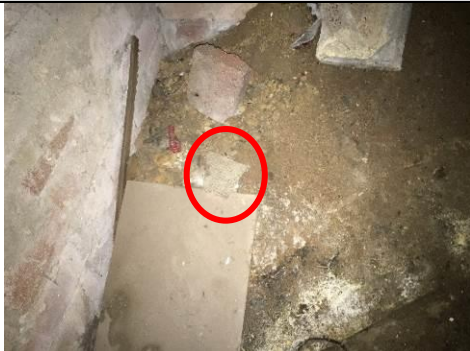
Subfloor-Northern Subfloor Fibre Cement Debris. 2666	Sample B18167-S8 Chrysotile, Amosite and Crocidolite Asbestos Detected. Non-Friable.	A2	Poor Condition, Accessible to Tradespeople Refer to Management Plan
24 th June 2018

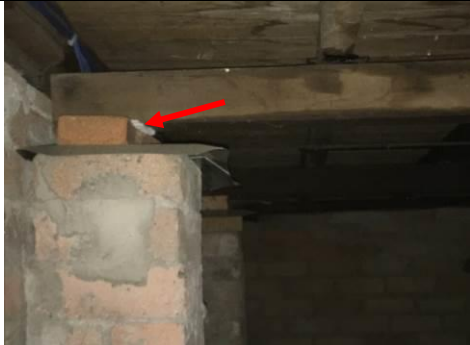
Subfloor-Northern Subfloor Fibre Cement Packers. 2667	No Sample Taken, Assume Contains Asbestos. Non-Friable.	A4	Moderate Condition, Accessible to Tradespeople Refer to Management Plan

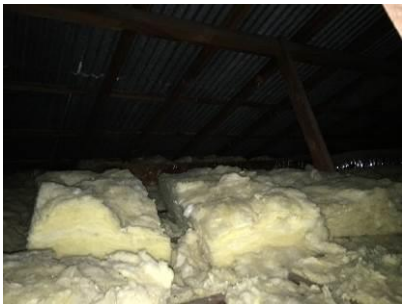
Ceiling Space- New Yellow Batt Insulation	Visual Inspection	A4	Good Bonded, Not High Risk
24 th June 2018

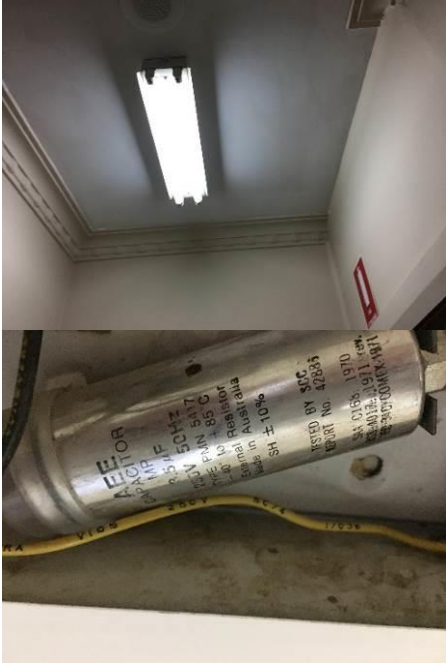
East to West Hallway Double Short Light Fluorescent Lights AEE Capacitor Type PMN 5417 PCB's Observed	Visual Inspection	A4	Good Condition, No Evidence of Leaks. Refer to Management Plan
24 th June 2018

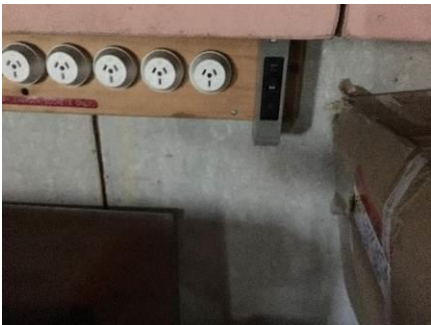
Mains Switch in Garage	Assume Contains Phenols, Visual Inspection	A4	Good Condition, Refer to Management Plan
