Asbestos Register

HAZARDOUS MATERIALS REGISTER

Regional EnviroScience Pty Ltd was requested by Mr. Jason Adams of Blue Mountains City Council to undertake a Hazardous Building Materials Register and to prepare a Hazardous Materials Management Plan of the property known as the Blue Mountains City Council Headquarters, 2-6 Civic Place, Katoomba, NSW, 2780. The purpose of the audit was to locate and identify asbestos based building materials and product within the building in accordance with the *NSW Work Health and Safety Act 2011* and *NSW Work Health and Safety Regulation 2017* and the *Code of Practice: How to Manage and Control Asbestos in the Workplace [Safe Work Australia: 2016]* and the *Code of Practice: How to Safely Remove Asbestos [Safe Work Australia: 2016]*.

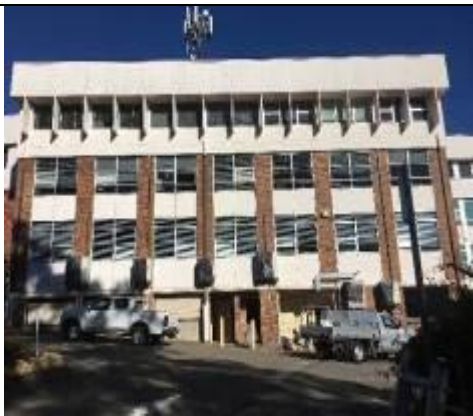
External-Northern Aspect Fibre Cement Fascia, Fibre Cement Soffit, Fibre Cement Shade Panels, Brick and Concrete Construction, Metal Spandrel Panels 2288	Similar to Sample B18780-S1 & B18780-S2 Chrysotile and Amosite Asbestos Detected Non-Friable	A4	Good Condition, Accessible to Tradespeople Refer to Management Plan
24 th June 2018

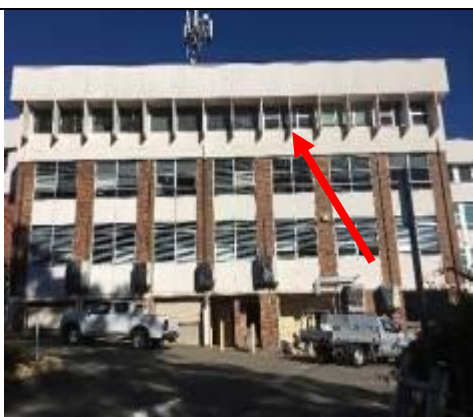
External-Northern Aspect Fibre Cement Shade Panels 2289	Assume Similar to Sample B18780-S1 & B18780-S2 Chrysotile and Amosite Asbestos Detected Non-Friable	A4	Good Condition, Accessible to Tradespeople Refer to Management Plan

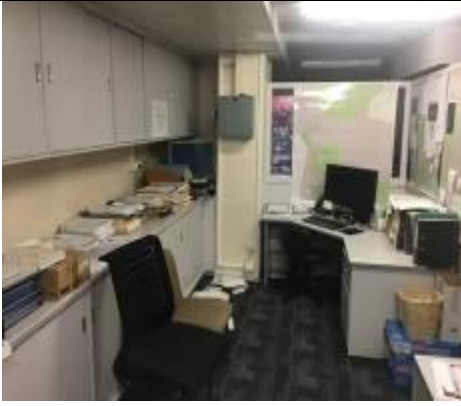
Lower Ground Floor M Bronotte's Office Timber Infill and Glass Partition Walls, Aluminium and SMF Ceiling Panels, Carpet on Vinyl Tile Floor. Vinyl Coverage to be Determined Once Carpet is Removed	Similar to Sample B18780-S12 Chrysotile Asbestos Detected Non-Friable 2296	A4	Poor Condition, Encapsulated by Carpet Tiles Accessible to Tradespeople Refer to Management Plan

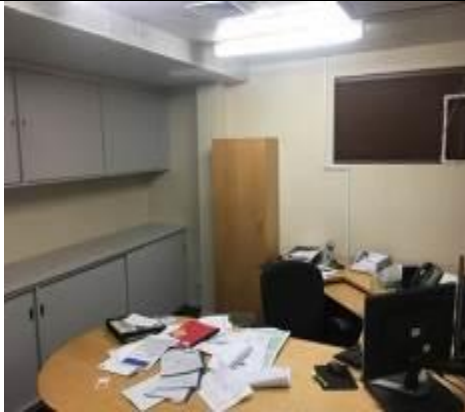
Lower Ground Floor Team Leader GIS Timber and Glass Partitions, Concrete Render Walls, Carpet on Concrete, Aluminium and SMF Ceiling Panels, Carpet Tiles on Green Vinyl. Vinyl Coverage to be Determined Once Carpet is Removed	Similar to Sample B18780-S12 Chrysotile Asbestos Detected Non-Friable 2297	A4	Poor Condition, Encapsulated by Carpet Tiles Accessible to Tradespeople Refer to Management Plan
24 th June 2018

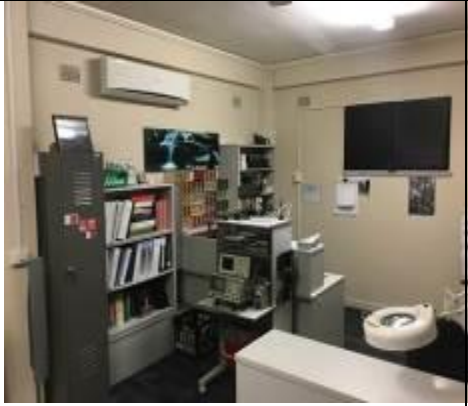
Lower Ground Floor Radio Workshop Concrete Render Walls / Ceiling, Timber Architraves, Carpet Tiles on Green Vinyl Tiles. Vinyl Coverage to be Determined Once Carpet is Removed	Similar to Sample B18780-S12 Chrysotile Asbestos Detected Non-Friable 2299	A4	Good Condition, Encapsulated by Carpet Tiles Accessible to Tradespeople Refer to Management Plan
24 th June 2018

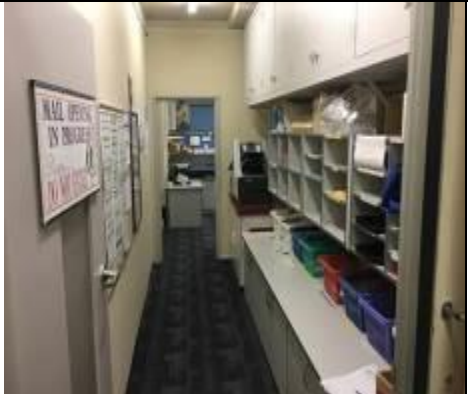
Lower Ground Floor-Pigeon Hole Room Vermiculite Ceiling, Rendered Concrete and Plasterboard Walls, Cream Vinyl Tile Under Carpet. Approx. 20m ²	Similar to Sample B18780-S13 Chrysotile Asbestos Detected Non-Friable 2301	A4	Good Condition, Encapsulated by Carpet Tiles Accessible to Tradespeople Refer to Management Plan

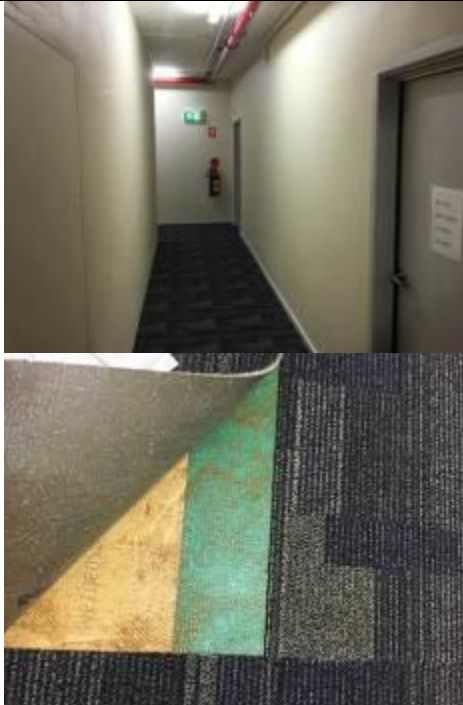
<p>Lower Ground Floor-Hallway</p> <p>Concrete Render Ceiling and Walls, Timber Architrave / Doors / Frames, Carpet on Green and Cream Vinyl Tiles.</p> <p>Vinyl Coverage to be Determined Once Carpet is Removed</p>	<p>Similar to Sample B18780-S13 & B18780-S12</p> <p>Chrysotile Asbestos Detected</p> <p>Non-Friable</p> <p>2304</p>	A4	<p>Good Condition, Encapsulated by Carpet Tiles Accessible to Tradespeople</p> <p>Refer to Management Plan</p>
24 th June 2018

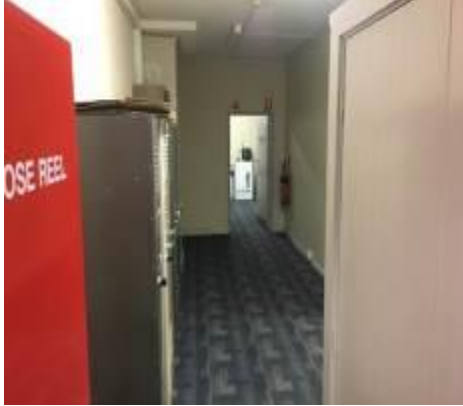
<p>Lower Ground Floor</p> <p>Hallway to Girls Toilet</p> <p>Concrete Render, Ceiling / Walls, Timber Architrave Doors / Frames, Carpet on Green and Cream Vinyl Tiles.</p> <p>Vinyl Coverage to be Determined Once Carpet is Removed</p>	<p>Similar to Sample B18780-S13 & B18780-S12</p> <p>Chrysotile Asbestos Detected</p> <p>Non-Friable</p> <p>2305</p>	A4	<p>Good Condition, Encapsulated by Carpet Tiles Accessible to Tradespeople</p> <p>Refer to Management Plan</p>

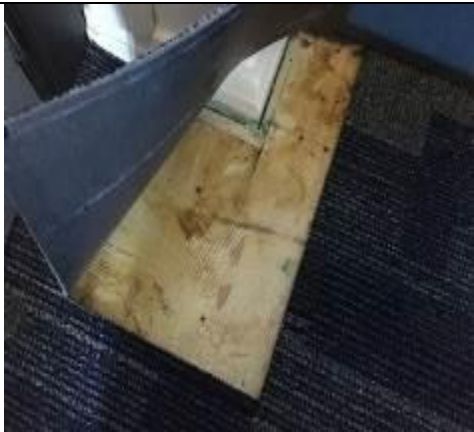
Ground Floor Cream Vinyl Tiles in Group Manager's Office Vinyl Tile NOTE: Approximately 500m ² , in Total of Floor Area Covered by Carpet Tiles, has Asbestos Vinyl Tiles Below.	Sample B18780-S35 Chrysotile Asbestos Detected Non-Friable 2363	A4	Good Condition, Encapsulated by Carpet tiles Accessible to Tradespeople Refer to Management Plan

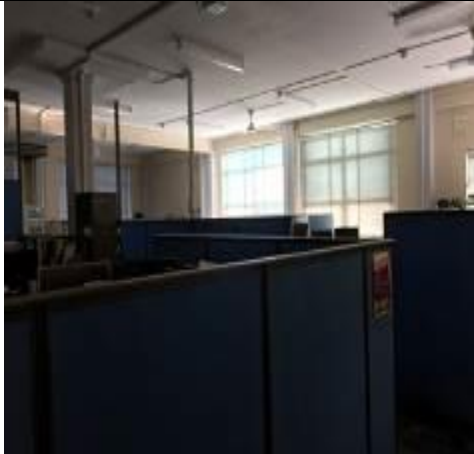
Ground Floor Health and Compliance Services Carpet Tiles, Concrete and Plasterboard Walls, Timber Infills, Concrete Ceiling, Timber Skirting, Plasterboard Beam Across Room, Vinyl tiles under carpet Approx. 190m ²	Similar to Sample B18780-S35 Chrysotile Asbestos Detected Non-Friable 2364	A4	Good Condition, Encapsulated by Carpet tiles Accessible to Tradespeople Refer to Management Plan
23 rd June 2018

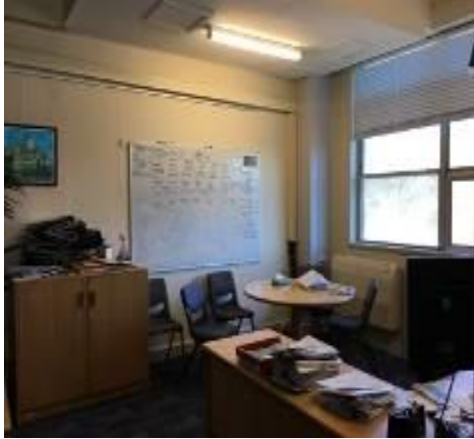
Ground Floor Executive Principal Building and Construction Services Carpet Tiles, Concrete Walls and Glass/Modern Acoustic Panel Partition Walls with Timber Infills, Vinyl tiles under carpet Approx. 10m ²	Similar to Sample B18780-S35 Chrysotile Asbestos Detected Non-Friable 2365	A4	Good Condition, Encapsulated by Carpet tiles Accessible to Tradespeople Refer to Management Plan

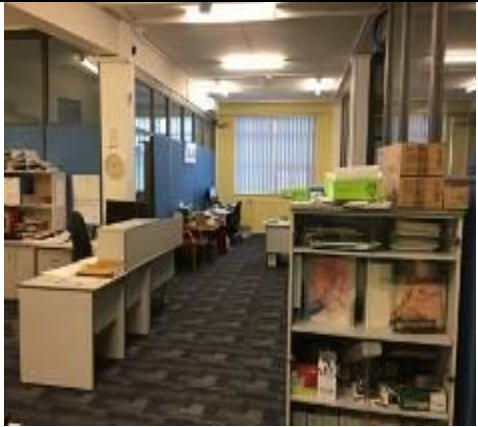
Ground Floor Development Health and Customer Service Area Timber Skirting Plasterboard and Cement Walls, Acoustic Panel/ Glass Partitions, Concrete Ceiling, Carpet Tiles, Vinyl tiles under carpet Approx. 48m ²	Similar to Sample B18780-S35 Chrysotile Asbestos Detected Non-Friable 2367	A4	Good Condition, Encapsulated by Carpet tiles Accessible to Tradespeople Refer to Management Plan

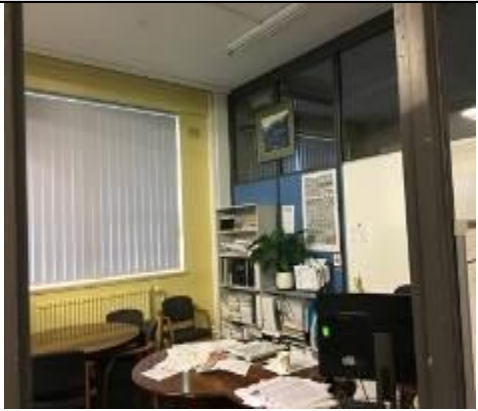
Ground Floor Building and Compliance Services Manager Office Concrete Walls, Acoustic Panel/Glass Partition Walls, Concrete Ceiling Carpet Tiles, Vinyl tiles under carpet Approx. 12m ²	Similar to Sample B18780-S35 Chrysotile Asbestos Detected Non-Friable 2368	A4	Good Condition, Encapsulated by Carpet tiles Accessible to Tradespeople Refer to Management Plan
23 rd June 2018

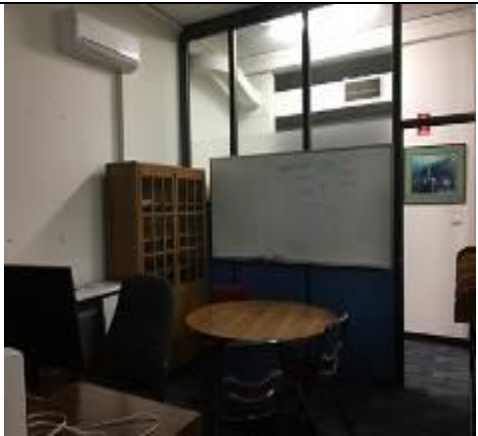
Ground Floor Development and Planning Manager Concrete Ceiling, Concrete Walls, Acoustic Panel/Glass Partition Walls, Metal Piping, Timber Infills, Carpet Tiles, Vinyl tiles under carpet Approx. 10m ²	Similar to Sample B18780-S35 Chrysotile Asbestos Detected Non-Friable 2369	A4	Good Condition, Encapsulated by Carpet tiles Accessible to Tradespeople Refer to Management Plan

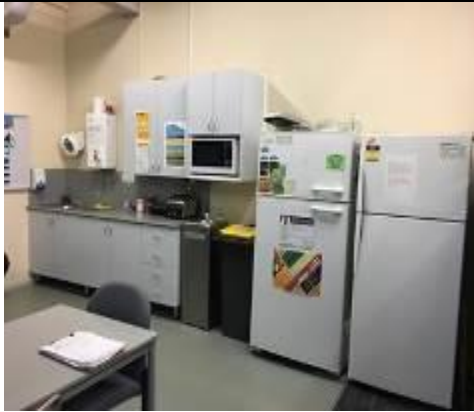
Ground Floor Kitchen Concrete Walls and Acoustic Panel/Glass Partitions, Timber Skirting and Architraves, Modern Green Sheet Vinyl and Carpet Tiles, Vinyl Tiles under carpet Approx. 12m ²	Similar to Sample B18780-S35 Chrysotile Asbestos Detected Non-Friable 2371	A4	Good Condition, Encapsulated by Carpet tiles Accessible to Tradespeople Refer to Management Plan

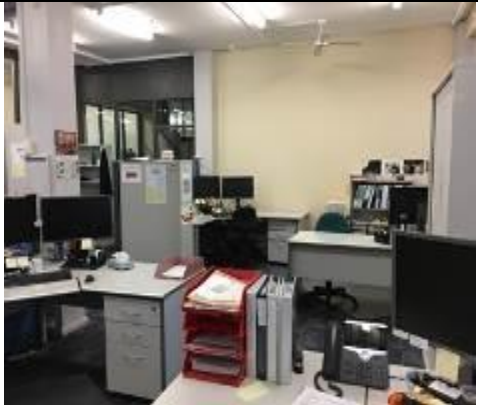
Ground Floor OH&S Area Plasterboard Ceiling, Concrete and Plasterboard Walls, Concrete Bulkhead, Timber Skirt and Window Sills, Timber Skirting, Carpet Tiles, Vinyl Tiles under carpet Approx. 28m ²	Similar to Sample B18780- S35 Chrysotile Asbestos Detected Non- Friable	A4	Good Condition, Encapsulated by Carpet tiles Accessible to Tradespeople Refer to Management Plan 2373

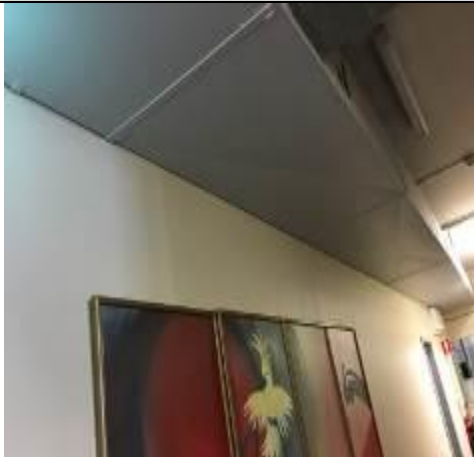
Ground Floor East to West Hallway off Customer Service Area Carpet Tiles on Floor, Concrete Ceiling, Concrete Walls, Timber Skirtings and Architraves, Aluminium Ducting, Vinyl tiles under carpet Approx. 20m ²	Similar to Sample B18780-S35, B18780-S6 & B18780-S37 Chrysotile Asbestos Detected Non-Friable 2378	A4	Good Condition, Encapsulated by Carpet tiles Accessible to Tradespeople Refer to Management Plan
23 rd June 2018

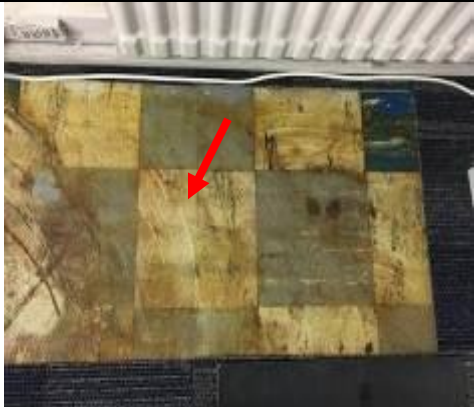
Ground Floor HR Services White Vinyl Tile 2379	Sample B18780-S38 Chrysotile Asbestos Detected Non-Friable	A4	Good Condition, Encapsulated by Carpet tiles Accessible to Tradespeople Refer to Management Plan

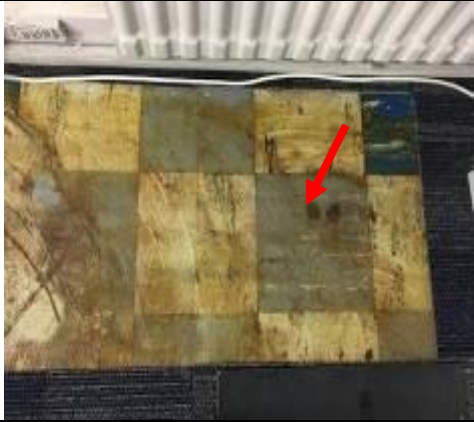
Ground Floor HR Services Grey Vinyl Tile 2380	Sample B18780-S39 Chrysotile Asbestos Detected Non-Friable	A4	Good Condition, Encapsulated by Carpet tiles Accessible to Tradespeople Refer to Management Plan
23 rd June 2018

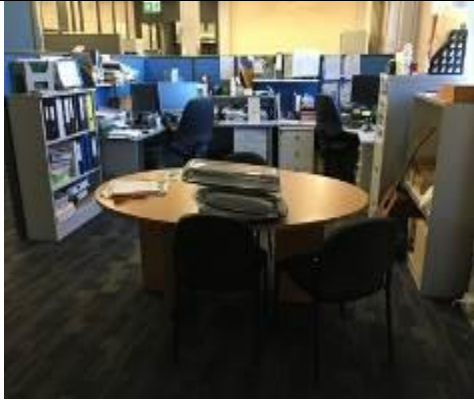
Ground Floor HR Services Concrete Walls, Concrete Ceiling, Timber Skirting and Window Sill, Carpet Tiles, Vinyl tiles under carpet Approx. 28m ² 2381	Similar to Sample B18780-S38, B18780-S39, B18780-S40 Chrysotile Asbestos Detected Non-Friable	A4	Good Condition, Encapsulated by Carpet tiles Accessible to Tradespeople Refer to Management Plan

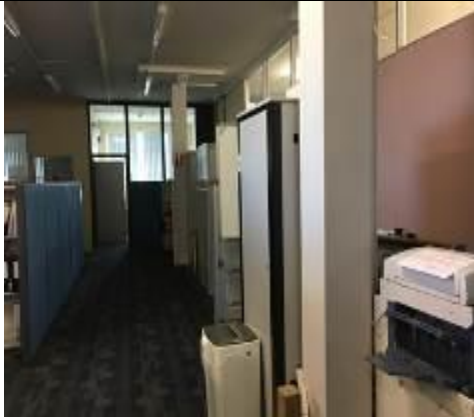
Ground Floor Corporate Human Resources Concrete Walls with Timber Infill, Plasterboard Partitions, Concrete Ceiling, Carpet Tiles on Floor on Grey and White Vinyl Tiles Approx. 26m ²	Similar to Sample B18780-S38 and B1870S39 Chrysotile Asbestos Detected Non-Friable 2382	A4	Good Condition, Encapsulated by Carpet tiles Accessible to Tradespeople Refer to Management
23 rd June 2018

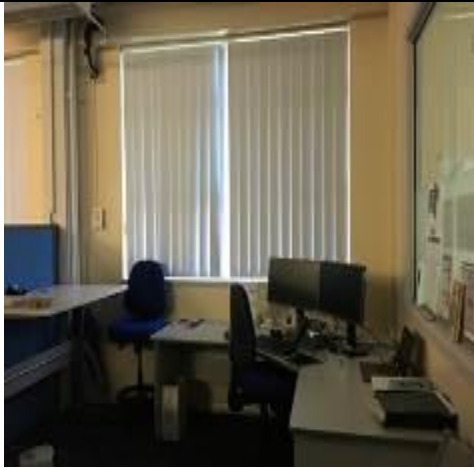
Ground Floor G Balyck's Office Concrete and Plasterboard Walls, Concrete Ceiling, Timber Skirting Boards, Acoustic Panel/Glass Partitions, Carpet Tiles on Floor on Grey and White Vinyl Tiles Approx. 10m ²	Similar to Sample B18780-S38 and B1870S39 Chrysotile Asbestos Detected Non-Friable 2383	A4	Good Condition, Encapsulated by Carpet tiles Accessible to Tradespeople Refer to Management

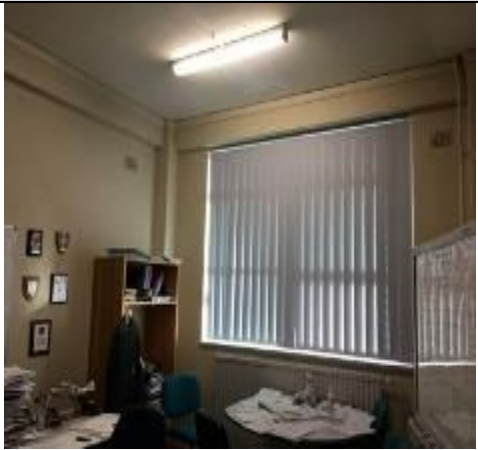
Ground Floor Grant McKay's Office Concrete and Plasterboard Walls, Concrete Ceiling, Timber Skirting Boards, Acoustic Panel/Glass Partitions, Carpet Tiles on Floor on Grey and White Vinyl Tiles Approx. 10m ²	Similar to Sample B18780-S38 and B1870S39 Chrysotile Asbestos Detected Non-Friable 2384	A4	Good Condition, Encapsulated by Carpet tiles Accessible to Tradespeople Refer to Management
23 rd June 2018

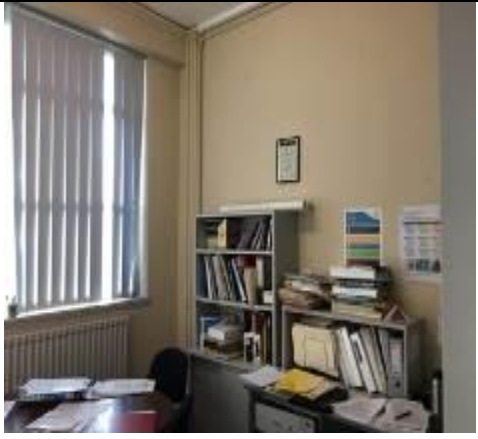
Ground Floor M. Tebay's Office Concrete and Plasterboard Walls, Concrete Ceiling, Timber Skirting Boards, Acoustic Panel/Glass Partitions, Carpet Tiles on Floor on Grey and White Vinyl Tiles Approx 10m ²	Similar to Sample B18780-S38 and B1870S39 Chrysotile Asbestos Detected Non-Friable 2385	A4	Good Condition, Encapsulated by Carpet tiles Accessible to Tradespeople Refer to Management

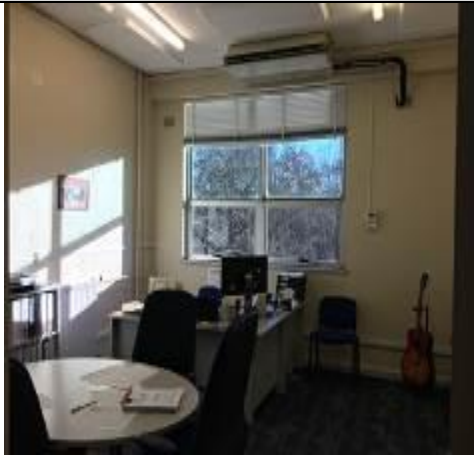
Ground Floor Director City Services Concrete and Plasterboard Walls, Concrete Ceiling, Timber Skirting Boards, Acoustic Panel/Glass Partitions, Carpet Tiles on Floor on Grey and White Vinyl Tiles Approx. 10m ²	Similar to Sample B18780-S38 and B1870S39 Chrysotile Asbestos Detected Non-Friable 2386	A4	Good Condition, Encapsulated by Carpet tiles Accessible to Tradespeople Refer to Management
23 rd June 2018

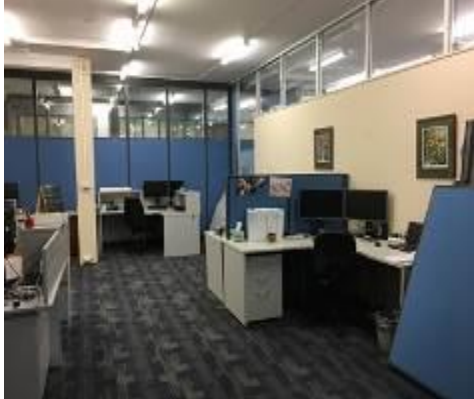
Ground Floor City Services Plasterboard Walls with Timber Infills and Timber Skirting Boards, Acoustic Panel/Glass Partitions, Carpet Tiles on Blue Vinyl Tiles Approx. 36m ²	Similar to Sample B18780-S40 Chrysotile Asbestos Detected Non-Friable 2388	A4	Good Condition, Encapsulated by Carpet tiles Accessible to Tradespeople Refer to Management

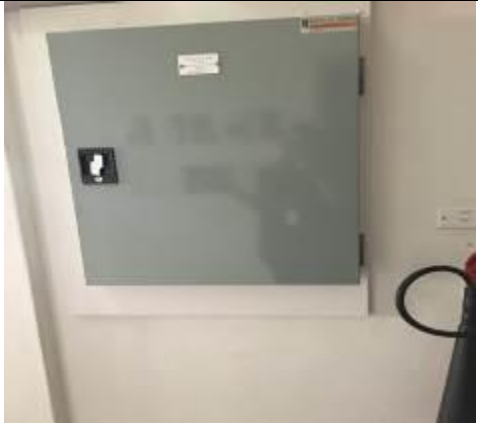
Ground Floor Customer Service/ Waiting Area Distribution Board Nil Access 2389	No Access, Assume Contains Asbestos Backing Board Non- Friable	A5	Good Condition, No Damage Accessible to Tradespeople Refer to Management Plan
23 rd June 2018

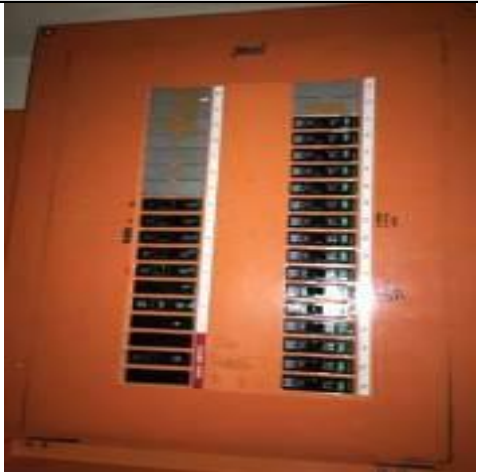
Ground Floor Switch Panel in Cleaner's Storeroom 2392	No Sample Taken Assume Contains Asbestos Non-Friable	A4	Good Condition, Accessible to Tradespeople Refer to Management Plan
23 rd June 2018

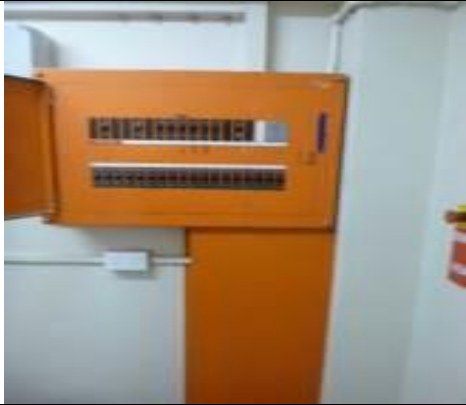
Internal - First Floor Cleaners Room DB1 Distribution Board. Approximately 1m ² 2434	No Sample Taken Sealed Board Assume Asbestos Containing Backing Board Non-Friable	A4	Unknown Condition Accessible to Tradespeople Refer to Asbestos Management Plan
23 rd June 2018
