Katoomba Girl Guides Hall

# **Asbestos/Lead Register & Management Plan**

Blue Mountains City Council conducted Hazardous Materials Management Register for the workplace located at 17 Station Street Katoomba NSW 2780.

The inspection was conducted on 27/09/2022, and the following items were identified:

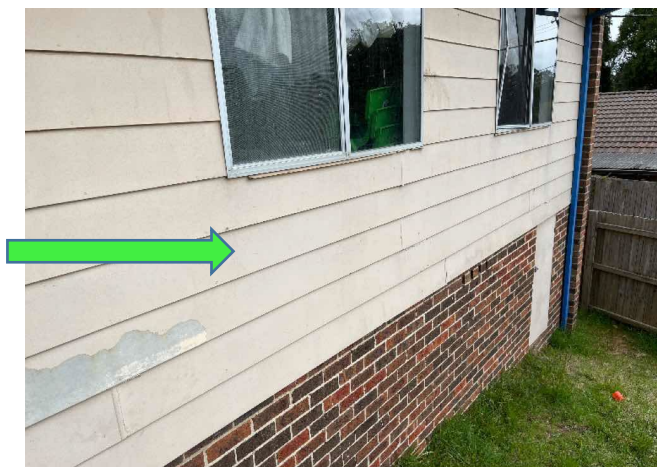
External, GF, Exterior, External cladding and flagpole - Cream - Topcoat, Lead Not Detected (0.002%w/w), 433799/LP01

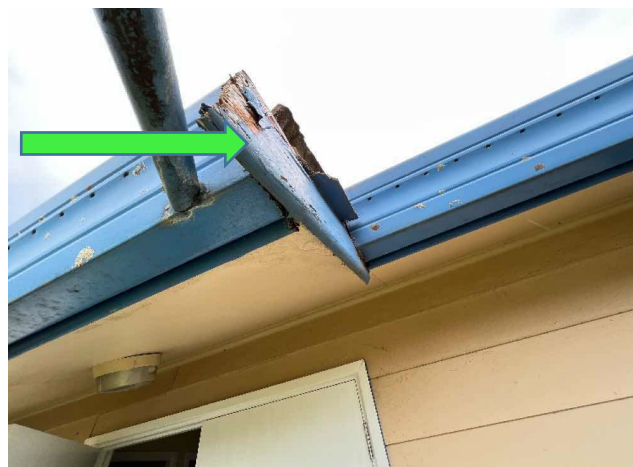
External, GF, Exterior, External fascia boards - Blue - Topcoat, Lead Not Detected (0.001%w/w), 433799/LP02

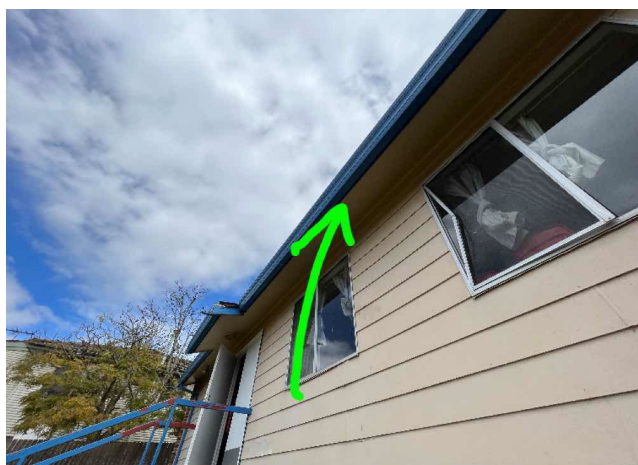
External, GF, Exterior, Perimeter eave linings - Fibreboard, No Asbestos identified, 37272-31

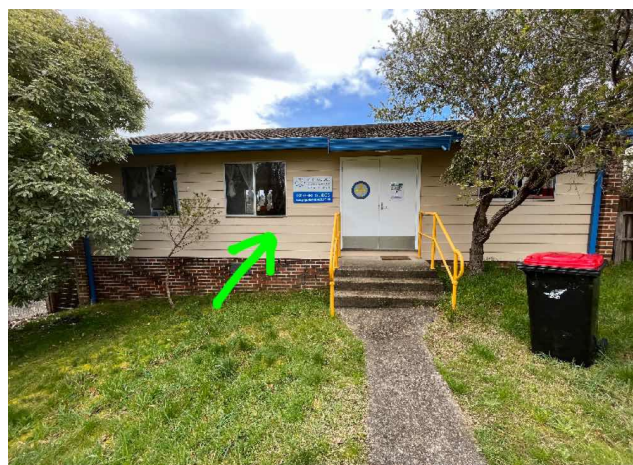
External, GF, Exterior, Wall cladding - Fibreboard, No Asbestos identified, 37272-32
