ASBESTOS CONTAINING BUILDING MATERIALS RESURVEY REPORT

4 Station Street
Katoomba NSW 2780

Report Number 610.17816.00000.0690-R01-ASR

16 August 2018

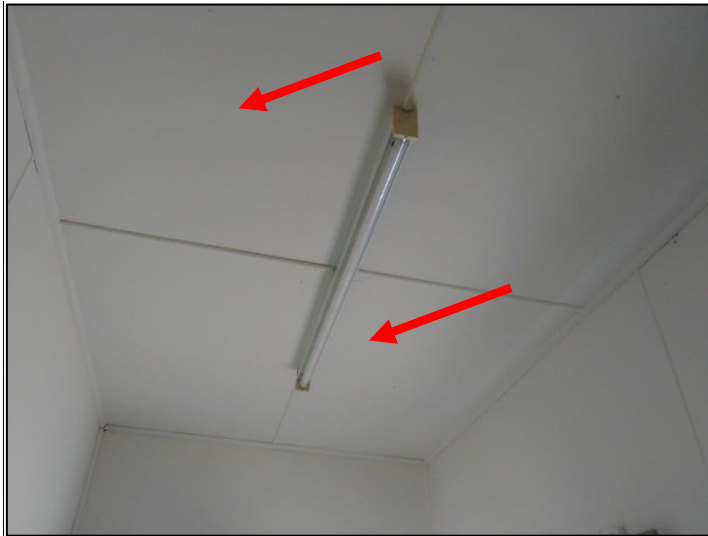
Photograph 1

Northern eastern store room, ceiling lining

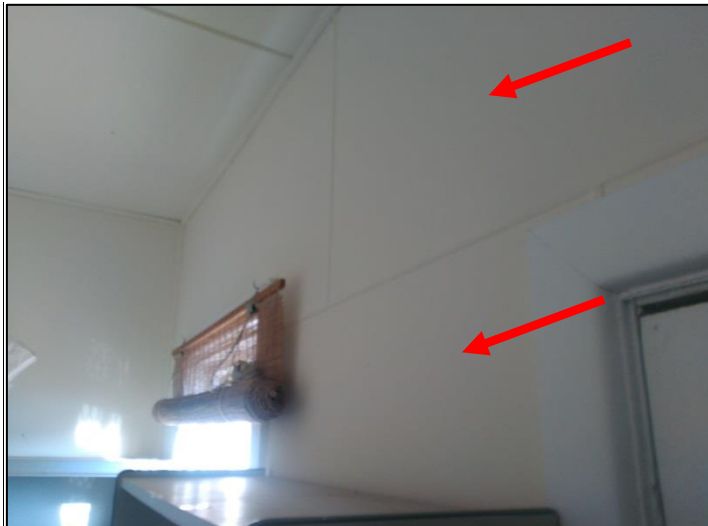
Photograph 2

Northern eastern store room, wall cladding

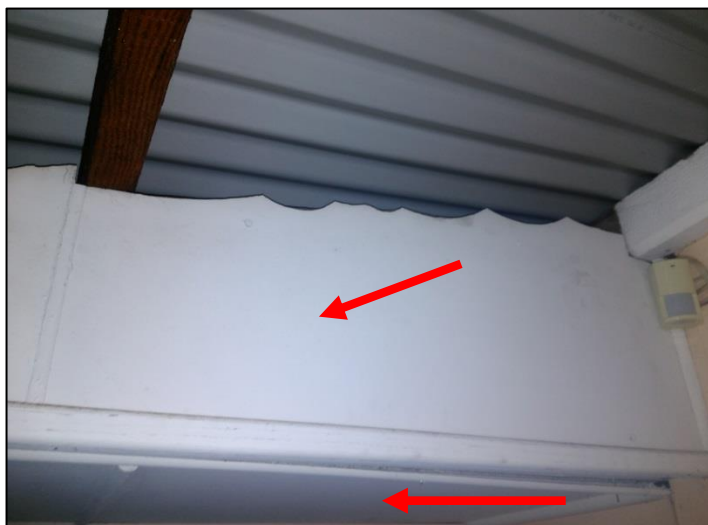
Photograph 3

Archives room, bulkhead lining

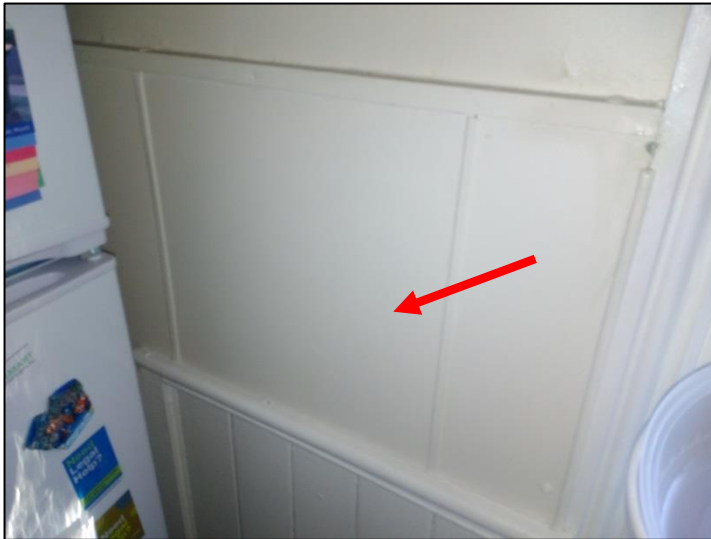
Photograph 4

North west corner of Kitchen, lower wall cladding (extends behind fridge)

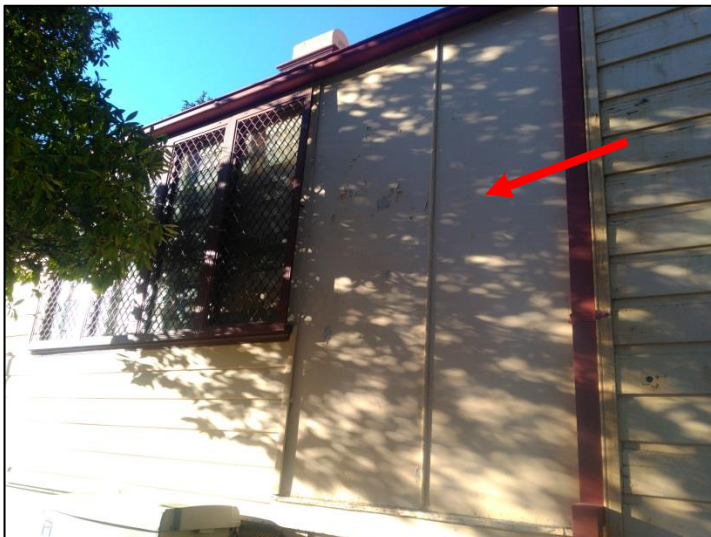
Photograph 5

- The condition of the ACMs is generally the same as last assessed, with the exception of minor damage to individual panels of FCS sheeting to the exterior of the building (small cracks), which were made safe with a sealant by the surveyor at the time of the inspection. This does not change overall risk ratings.

External, north side, FCS panels

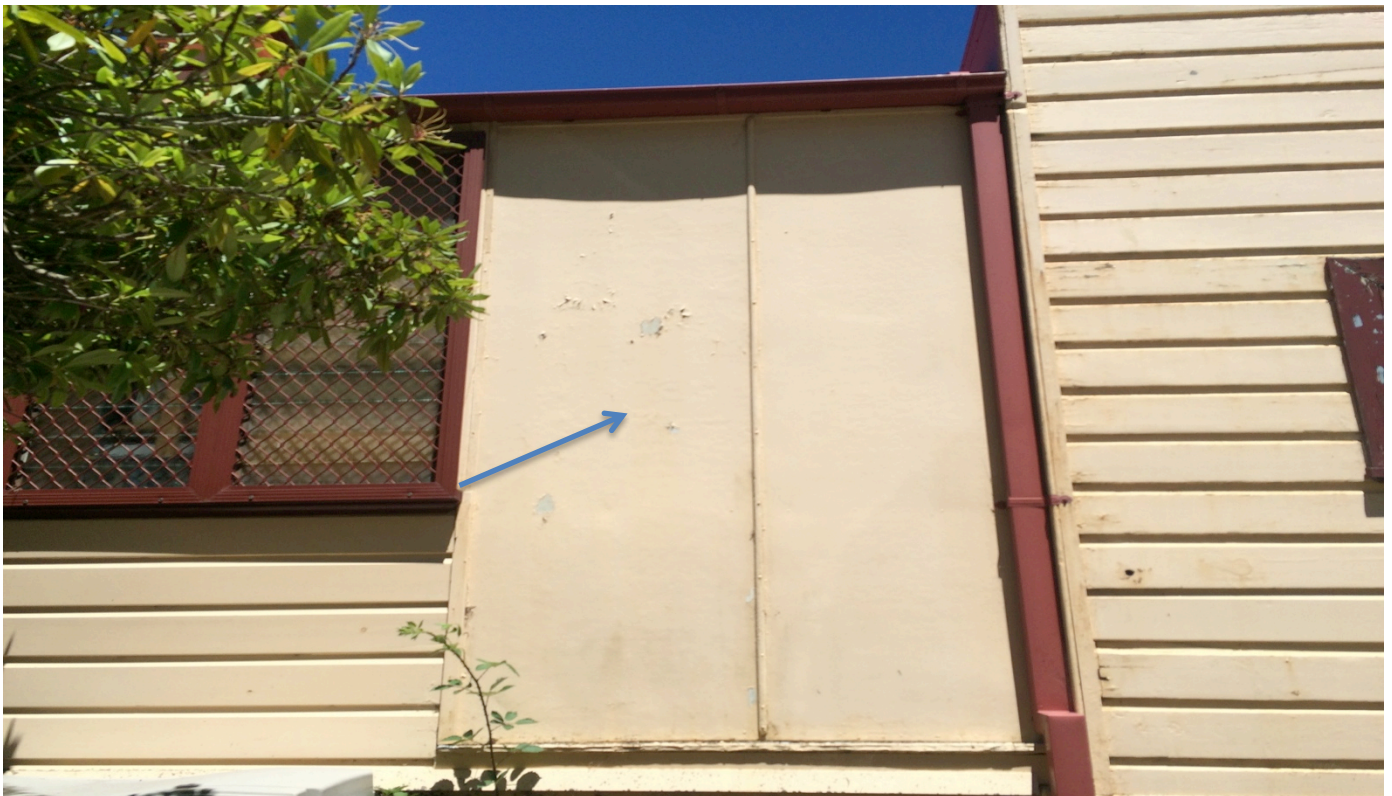
Photo 166: Asbestos cement sheet external wall panels on the northern perimeter of the Katoomba Community Legal Centre.

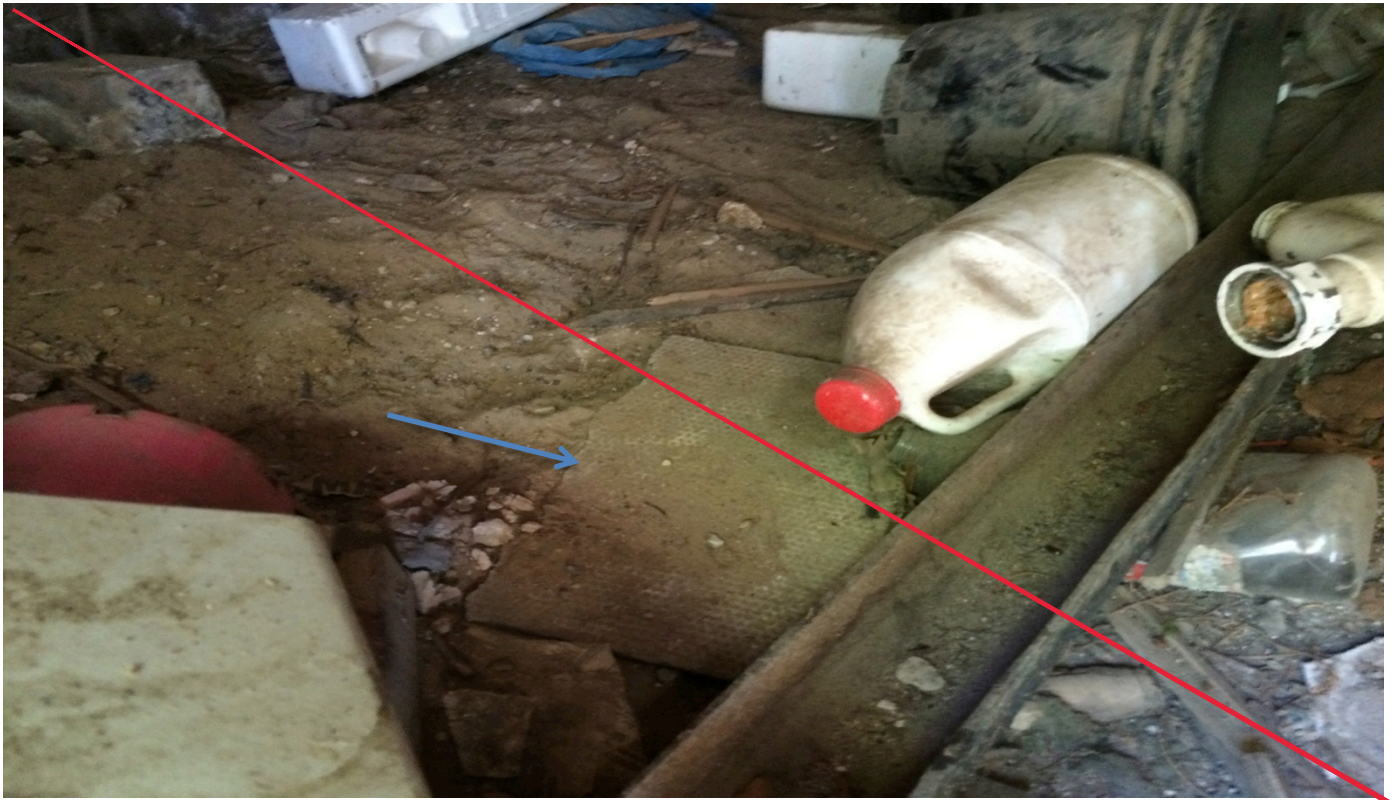
Photo 167: Asbestos cement sheet debris on the north-western area of the sub-floor of the Katoomba Community Legal Centre.

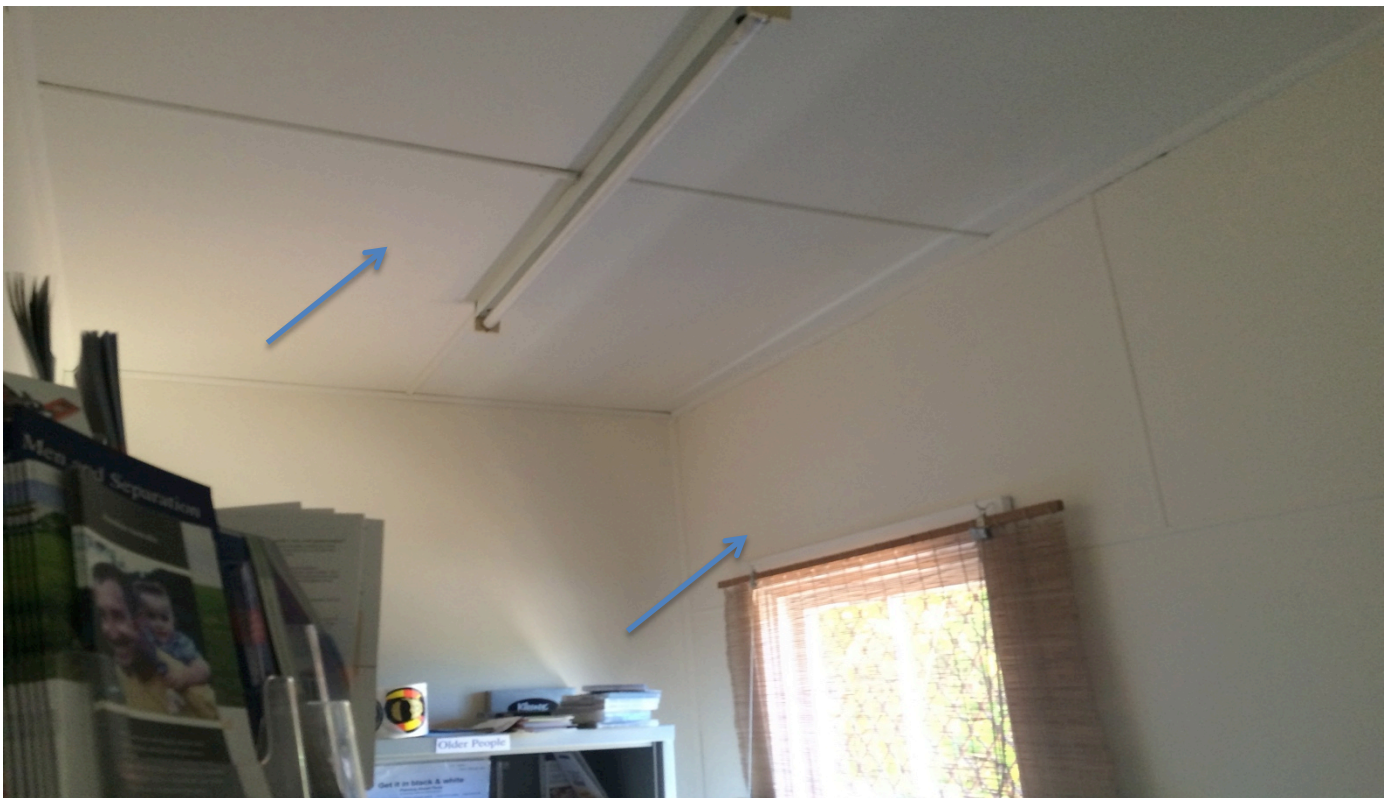
Photo 168: Asbestos cement sheet ceiling lining and internal walls of the north-eastern storeroom of the Katoomba Community Legal Centre.

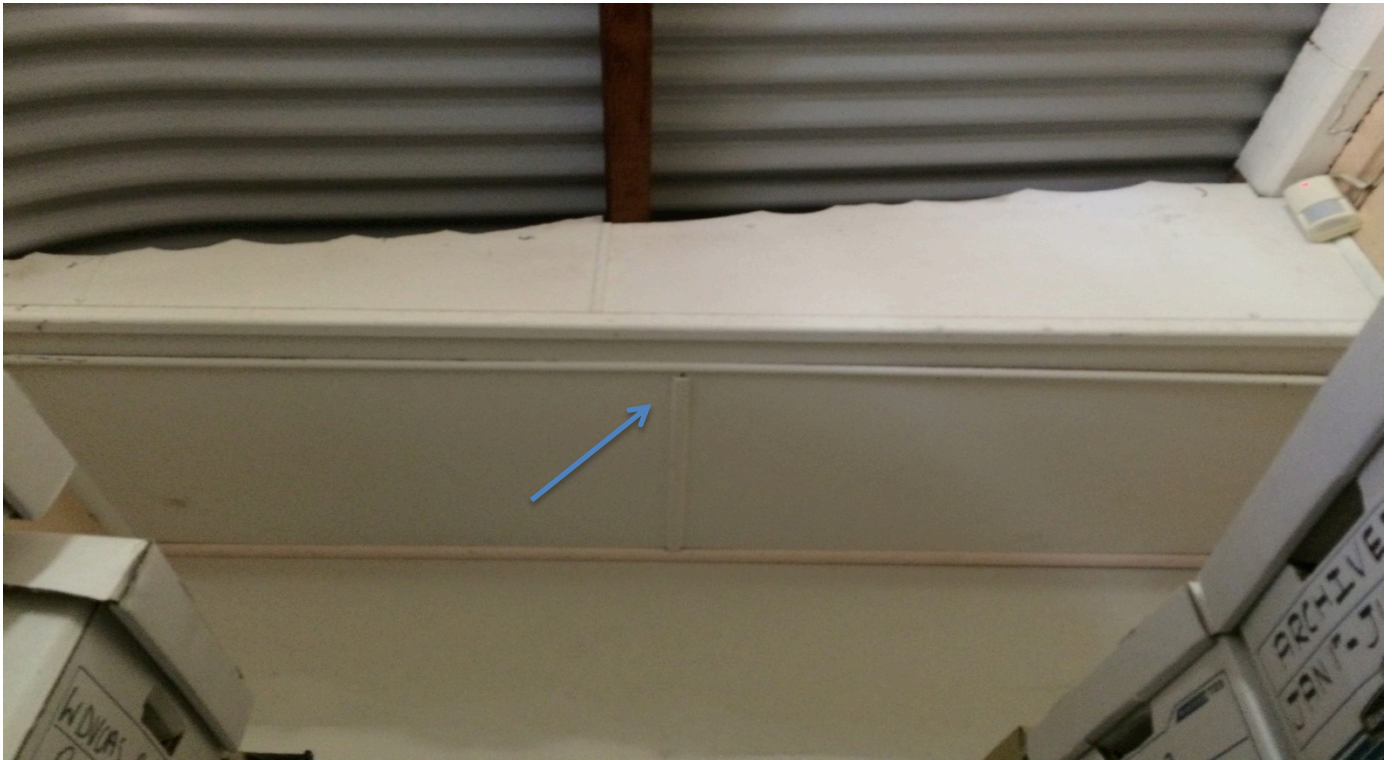
Photo 169: Asbestos cement sheet bulkhead lining Archive room in the Katoomba Community Legal Centre.

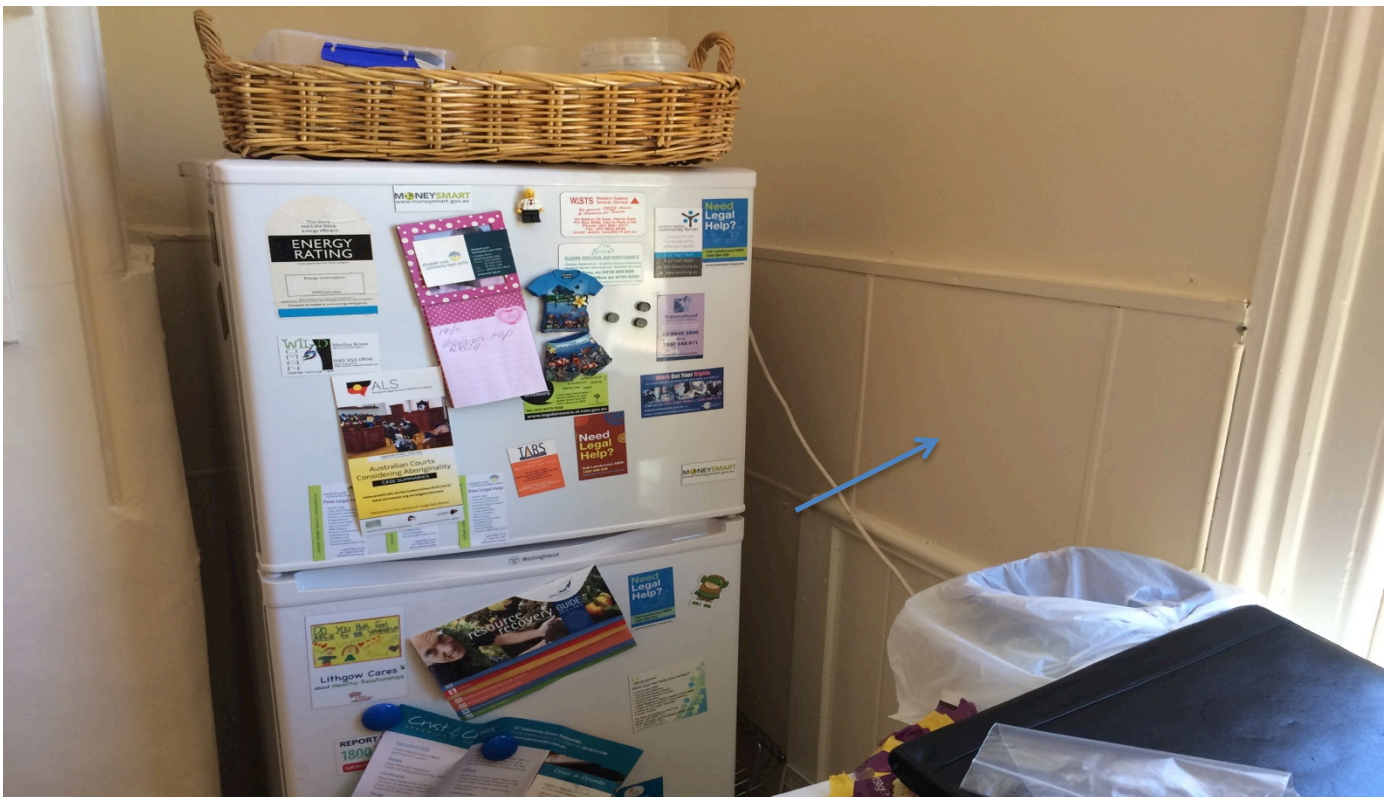
Photo 170: Asbestos cement sheet internal wall linings behind the fridge and on the northern perimeter wall in the Kitchen in the Katoomba Community Legal Centre.
