Springwood Tennis Courts

Asbestos/Lead Register & Management Plan

Blue Mountains City Council conducted Hazardous Materials Management Register for the workplace located at 32 Spring Street Springwood NSW 2777.

The inspection was conducted on 16/09/2022, and the following items were identified:

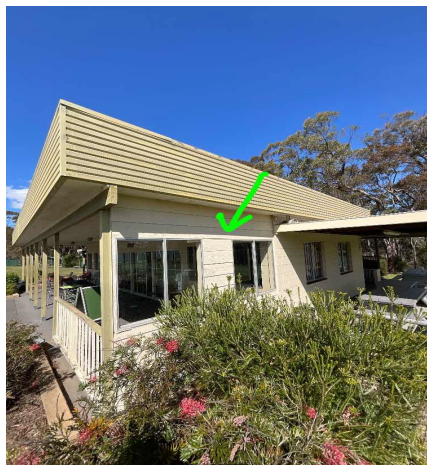
External, GF, Exterior, Canteen Area Partition Wall External Wall Cladding - Fibreboard, No Asbestos identified, 28781-50- 3

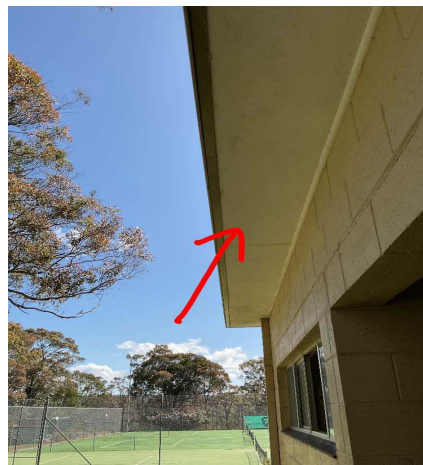
External, GF, Exterior, Eave Linings throughout - Fibreboard, Chrysotile, 28781-50-1

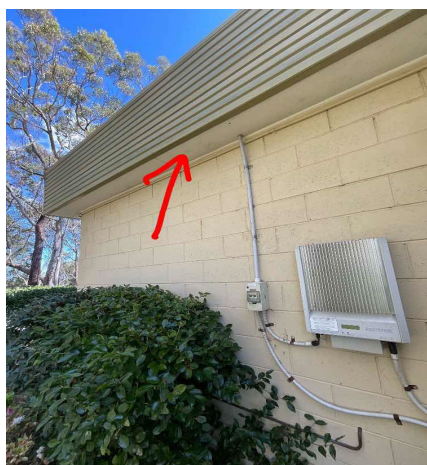
External, GF, Exterior, Eave Linings throughout - Fibreboard, Chrysotile, 28781-50-1

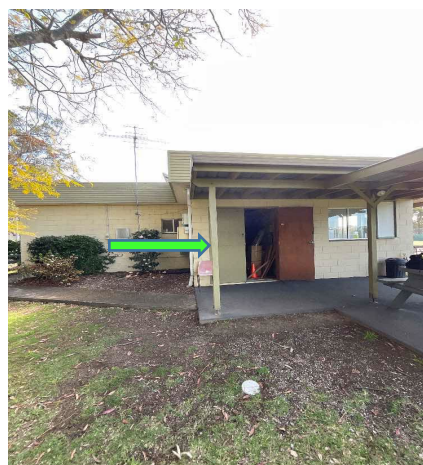
External, GF, Exterior, Fascia, awning and posts - Green (Light) - Topcoat, Lead Not Detected (0.002%w/w), 431102/LP01

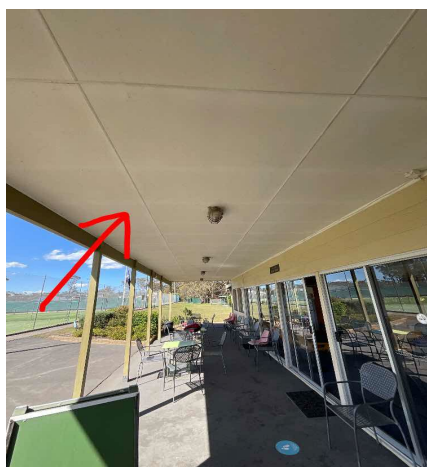
External, GF, Exterior, Front Awning Lining - Fibreboard, Assumed Positive, Similar to 28781-50-1 - Assumed Chrysotile

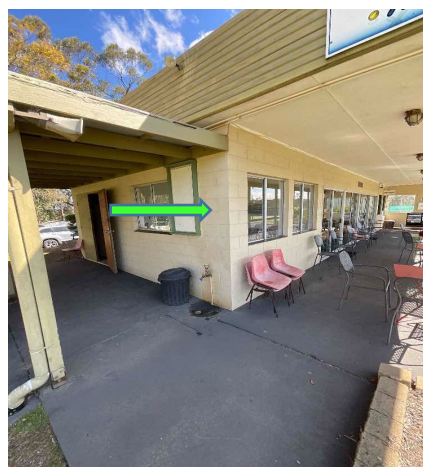
External, GF, Exterior, Internal & External walls - Cream - Topcoat, Lead Not Detected (<0.001%w/w), 431102/LP02

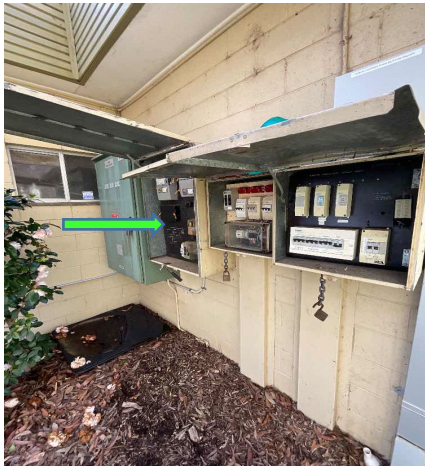
External, GF, Exterior, Rear Electrical backing boards - Electrical backing boards, No Asbestos Detected, 431102/AS01

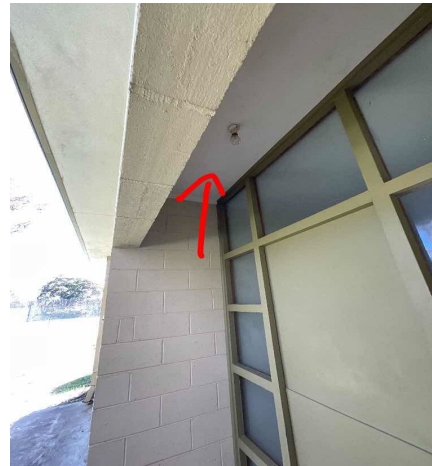
External, GF, Exterior, Rear Entrance Ceiling Lining - Fibreboard, Chrysotile, 28781-50-2

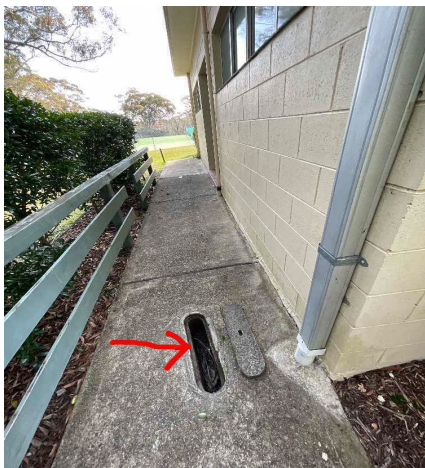
External, GF, Exterior, Sub-surface, Rear access pathway - Telecom pit, Chrysotile Asbestos, 431102/AS02

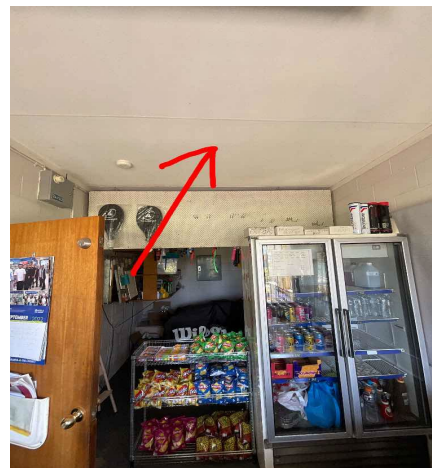
Internal, GF, Canteen/Storeroom, Ceiling Lining - Fibreboard, Assumed Positive, Similar to 28781-50-4 - Assumed Chrysotile

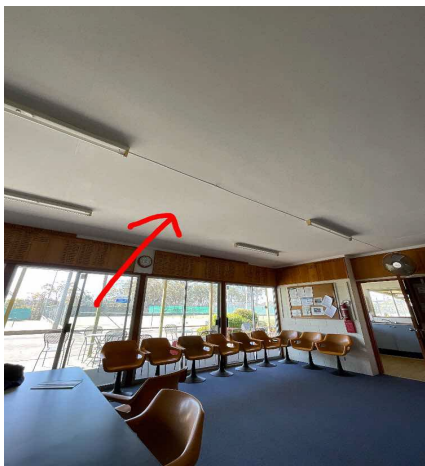
Internal, GF, Clubhouse, Ceiling Lining - Fibreboard, Chrysotile, 28781-50-4

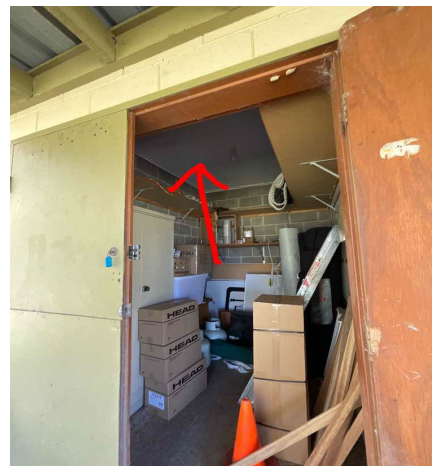
Internal, GF, External Storeroom, South West, Ceiling - Fibreboard, Assumed Positive, Similar to 28781-50-4 - Assumed Chrysotile

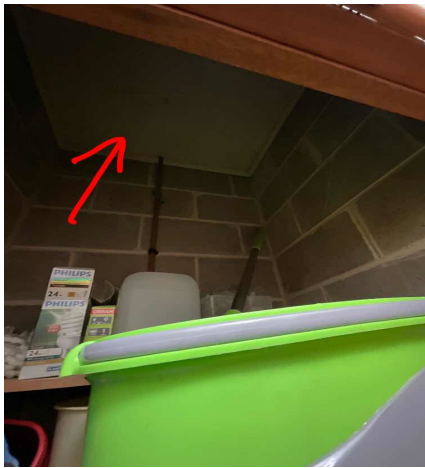
Internal, GF, Female toilets Hot water cupboard adjacent, East, Ceiling - Fibre Cement Sheet, Chrysotile Asbestos, Similar to 28781-50-6 - Assumed Chrysotile

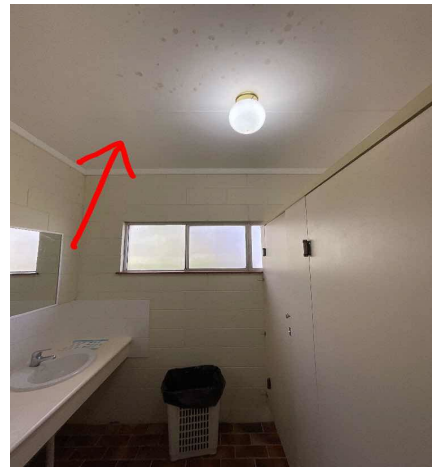
Internal, GF, Female Toilets, Ceiling Lining - Fibreboard, Assumed Positive, Similar to 28781-50-5 - Assumed Chrysotile

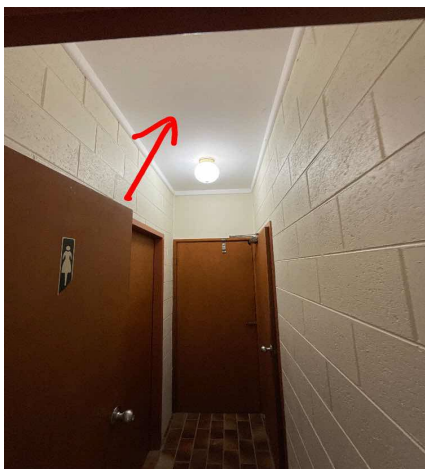
Internal, GF, Female Toilets Entrance Room, East, Ceiling Lining - Fibreboard, Assumed Positive, Similar to 28781-50-6 - Assumed Chrysotile

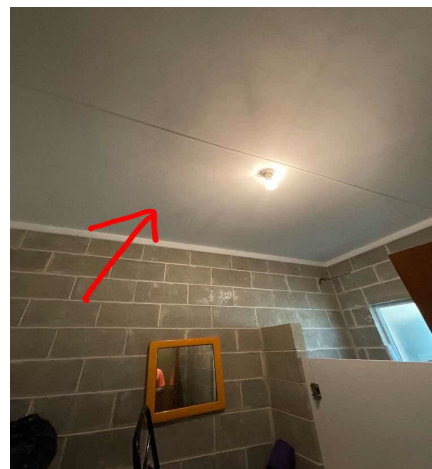
Internal, GF, Female Toilets Storeroom/disused shower, Ceiling Lining - Fibreboard, Assumed Positive, Similar to 28781-50-6 - Assumed Chrysotile

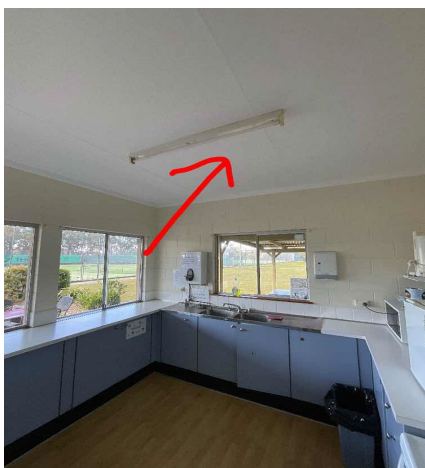
Internal, GF, Kitchen, Ceiling Lining - Fibreboard, Assumed Positive, Similar to 28781-50-4 - Assumed Chrysotile

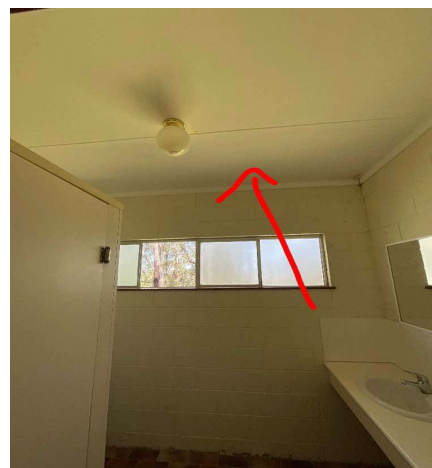
Internal, GF, Male Toilets, Ceiling Lining - Fibreboard, Chrysotile, 28781-50-5

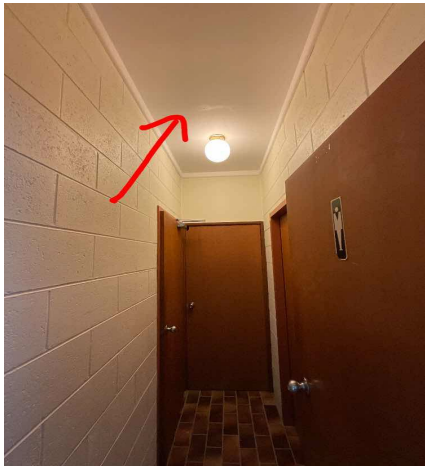
Internal, GF, Male Toilets Entrance Room, Ceiling Lining - Fibreboard, Chrysotile, 28781-50-6

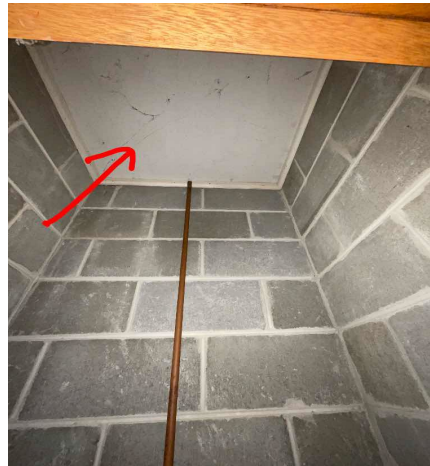
Internal, GF, Male Toilets Hot Water Cupboard adjacent, Ceiling Lining - Fibreboard, Assumed Positive, Similar to 28781 -50-6 - Assumed Chrysotile

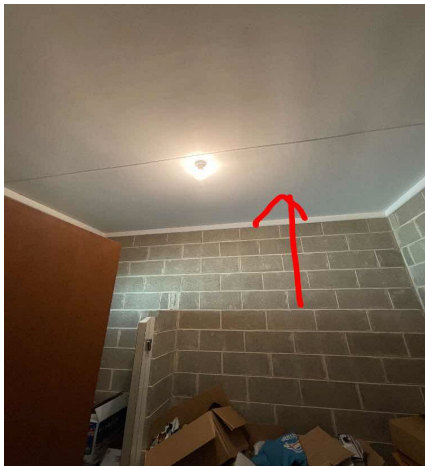
Internal, GF, Male Toilets Storeroom/disused shower, North West, Ceiling Lining - Fibreboard, Assumed Positive, Similar to 28781-50- 6 - Assumed Chrysotile

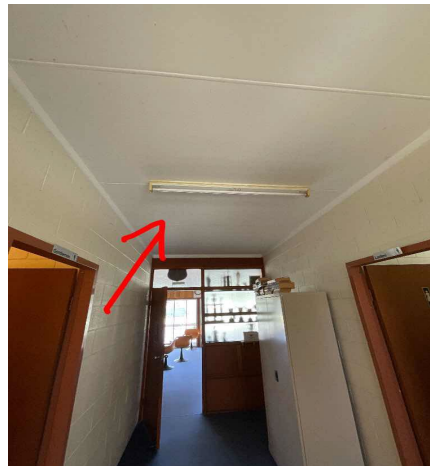
Internal, GF, Rear Entrance, Ceiling Lining - Fibreboard, Assumed Positive, Similar to 28781-50- 4 - Assumed Chrysotile
