Asbestos Register & Management Plan

Glenbrook Oval,
6 Moore Street, GLENBROOK NSW 2773

Asbestos Register and Management Plan

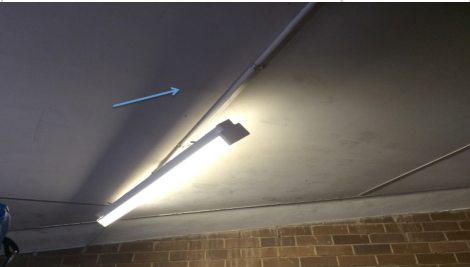
Ref No.	Date Identified	Clearance Cert Date	Onsite Register	Last Inspection Date	Next Inspection Date
	1445	19/12/2014		Yes	16-May-2019	16-May-2024
	Accessibility	Material	Extent	Result		
	Accessible	Fibreboard	>20m2	Chrysotile		
	Friability	Sealed / Surface Treatment	Risk Assessment	Control Actions	Labels Affixed	
	Non Friable	Sealed	RA04 - Very Low	No Remedial Action - Reinspect Periodically	No	
	Specific Location					
		Glenbrook Oval - Amenities Block - Internal Machinery Storeroom Ceiling Lining				
		Additional Comments				GPS Lat,Long
		Sample - 25132-6-1

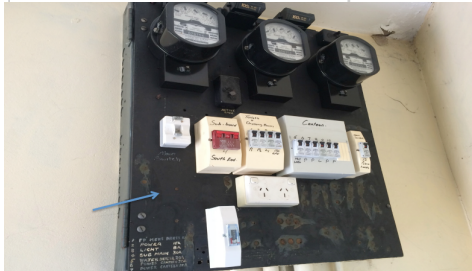
Ref No.	Date Identified	Clearance Cert Date	Onsite Register	Last Inspection Date	Next Inspection Date
	1449	19/12/2014		Yes	16-May-2019	16-May-2024
	Accessibility	Material	Extent	Result		
	Accessible	Bituminous backing board	.5m2	Chrysotile		
	Friability	Sealed / Surface Treatment	Risk Assessment	Control Actions	Labels Affixed	
	Non Friable	Sealed	RA04 - Very Low	No Remedial Action - Reinspect Periodically	No	
	Specific Location					
	Glenbrook oval - Amenities Block - Internal Electrical Switchroom Electrical Backing board					
	Additional Comments					GPS Lat,Long
	Sample - 25132-6-2					
Status: Closed						
	Ref No.	Date Identified	Clearance Cert Date	Onsite Register	Last Inspection Date	Next Inspection Date
	1451	19/12/2014		Yes	16-May-2019	
	Accessibility	Material	Extent	Result		
		Timber		No Asbestos identified		
	Friability	Sealed / Surface Treatment	Risk Assessment	Control Actions	Labels Affixed

No Action Required - No ACM Identified		
	Specific Location					
	Glenbrook Oval - Amenities Block - Internal Storeroom Electrical Box – Eelectrical Box					
	Additional Comments					GPS Lat,Long
