# BLUE MOUNTAINS CITY COUNCIL

## ASBESTOS REGISTER

GLENBROOK/LAPSTONE BRIGADE  
STATION

### 3.1.27 Glenbrook Rural Fire Service Bushfire Station

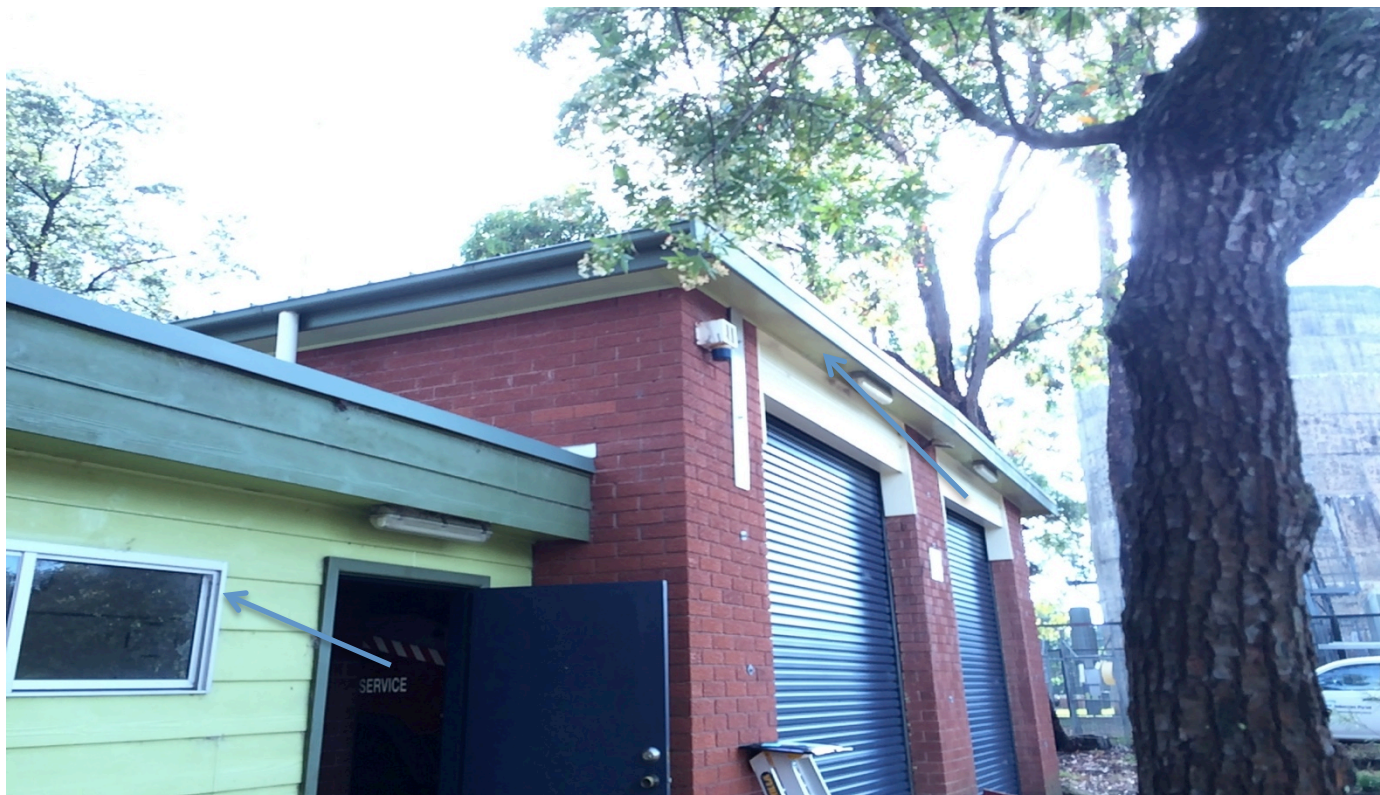
| Location | Material | Sample ID | Sample Status | Photo No. | Asbestos Classification | Condition | Accessibility | Re-inspect | Current Label | Control Measure | Record of Works Undertaken |
|---|---|---|---|---|---|---|---|---|---|---|---|
| Eave linings<br><b>1479</b> | Fibreboard | 25132-27-1 | Positive | 104 | Bonded | Stable | Low | December 2019 | Not labeled | 4 | |
| External wall cladding (in-between garages)<br><b>1480</b> | Fibreboard | 25132-27-2 | Positive | 104 | Bonded | Stable | Medium | December 2019 | Not labeled | 4 | |

| 25132-27-1 | Glenbrook Rural Fire Service Bushfire Station – External – eave linings | 8x3x1mm fibreboard fragment | Chrysotile asbestos detected<br>[Organic fibres detected] |
| 25132-27-2 | Glenbrook Rural Fire Service Bushfire Station – External – external wall cladding (in-between garages) | 13x9x2mm fibreboard fragment | Chrysotile asbestos detected<br>[Organic fibres detected] |

**Photo 104:** Fibreboard containing asbestos eave linings and external wall cladding of the Glenbrook Rural Fire Service Bushfire Station.

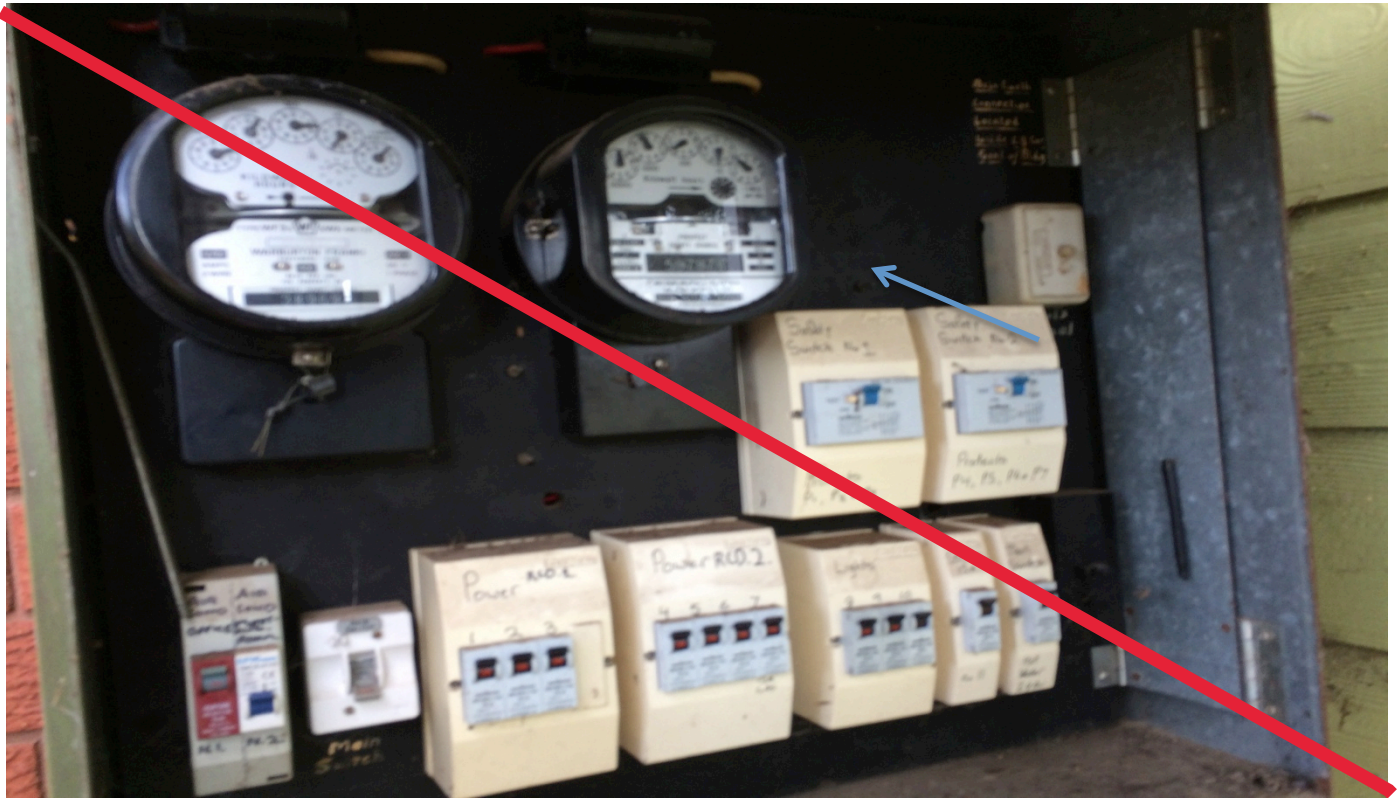
| Location | Material | Sample ID | Sample Status | Photo No. | Asbestos Classification | Condition | Accessibility | Re-inspect | Current Label | Control Measure | Record of Works Undertaken |
|---|---|---|---|---|---|---|---|---|---|---|---|
| <del>Southern Perimeter – adjacent entrance – electrical box – electrical backing board</del><br><b>1481</b> | <del>Bituminous backing board</del> | 25132-27-3 | Positive | 105 | Bonded | Stable | Low | December 2019 | Not labeled | 4 | Pacific HazMat CC<br>#S04243 18/103072 -<br>27/4/18 |

| 25132-27-3 | Glenbrook Rural Fire Service Bushfire Station – External – Southern Perimeter – adjacent entrance – electrical box – electrical backing board | 4x3x2mm bituminous backing board fragment | Chrysotile asbestos detected |

**Photo 105:** Electrical backing board containing asbestos on the southern perimeter of the Glenbrook Rural Fire Service Bushfire Station.

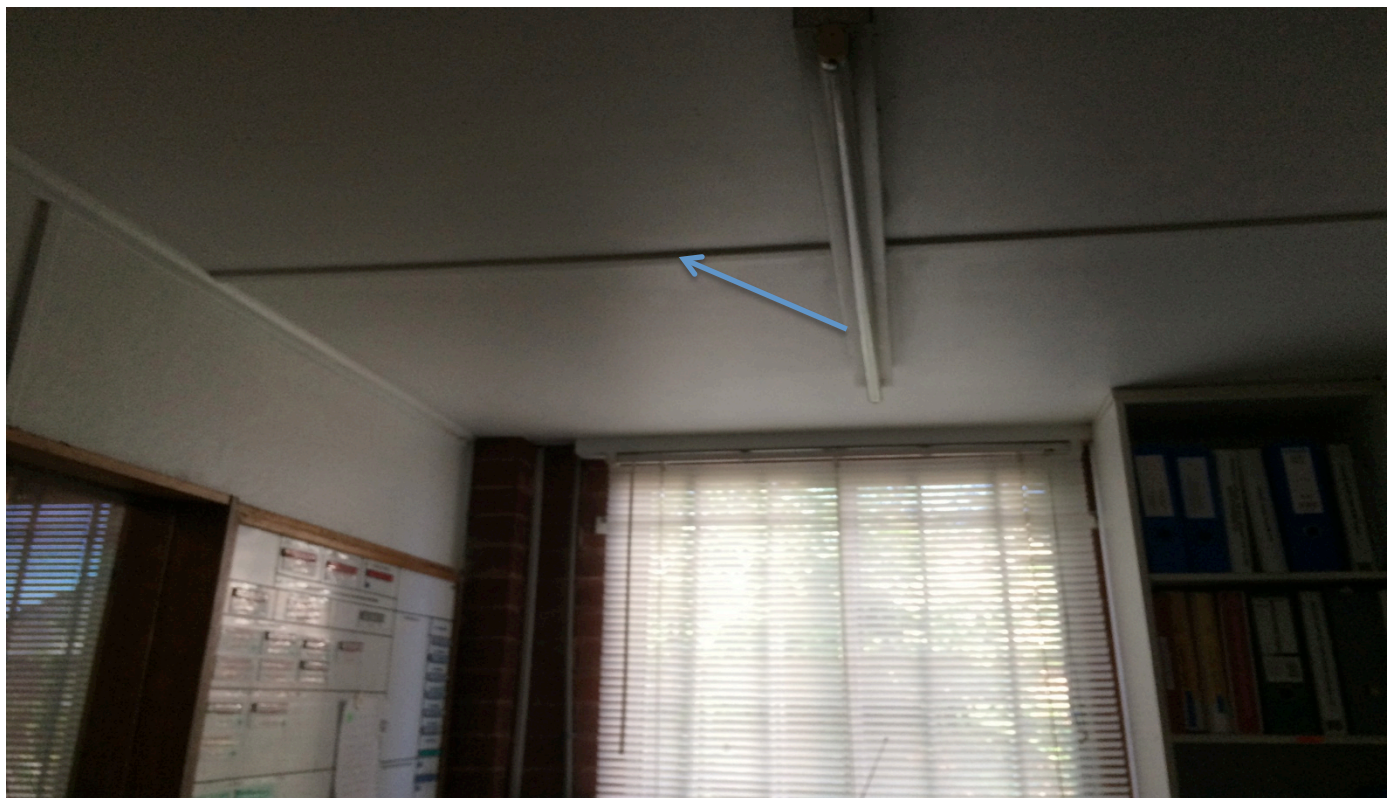
| Location | Material | Sample ID | Sample Status | Photo No. | Asbestos Classification | Condition | Accessibility | Re-inspect | Current Label | Control Measure | Record of Works Undertaken |
|---|---|---|---|---|---|---|---|---|---|---|---|
| Western Garage – Office – ceiling lining<br><b>1483</b> | Fibreboard | Similar to 25132-27-6 | Assumed Positive | 106 | Bonded | Stable | Low | December 2019 | Not labeled | 4 | |

**Photo 106:** Fibreboard ceiling lining assumed to contain asbestos in the Office in the western garage of the Glenbrook Rural Fire Service Bushfire Station.

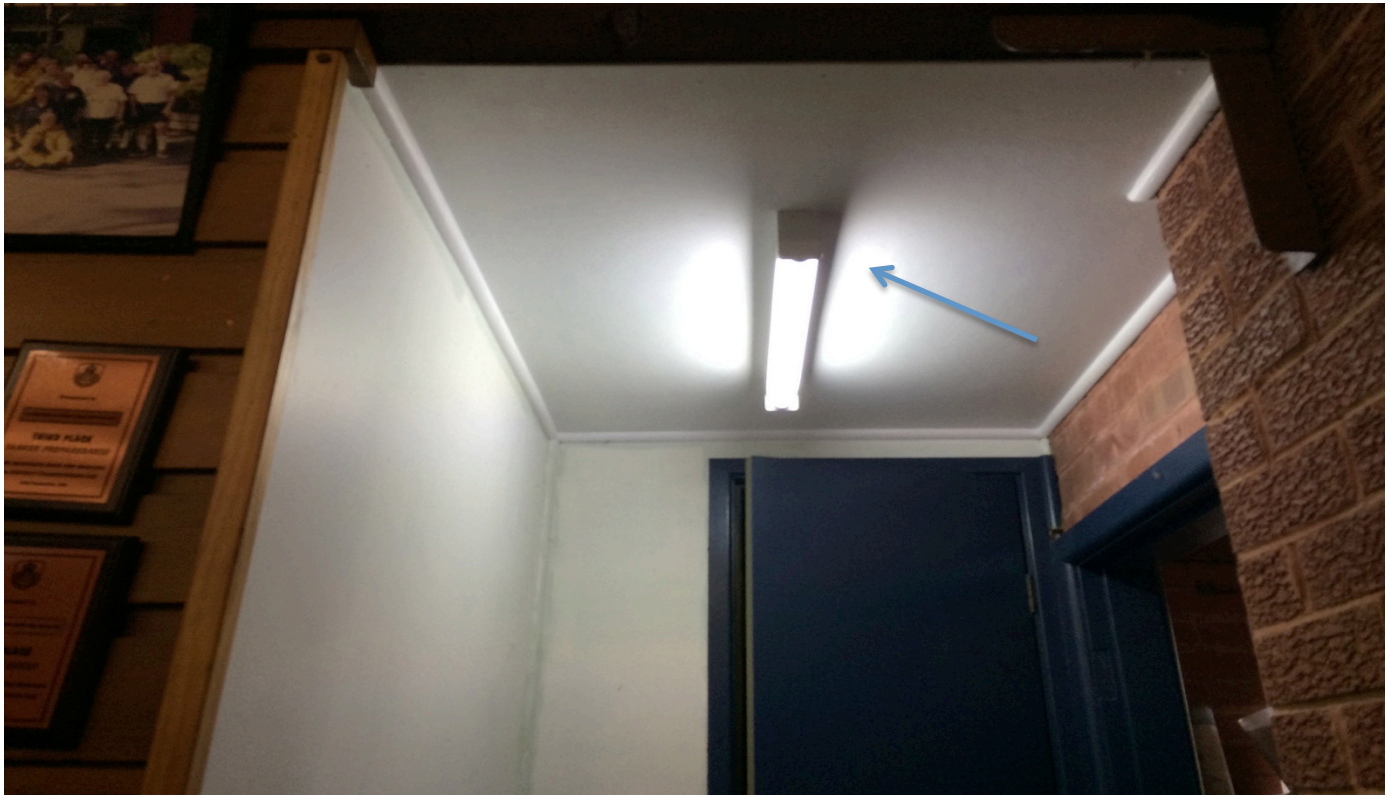
| Location | Material | Sample ID | Sample Status | Photo No. | Asbestos Classification | Condition | Accessibility | Re-inspect | Current Label | Control Measure | Record of Works Undertaken |
|---|---|---|---|---|---|---|---|---|---|---|---|
| Western Garage – outside Jacket Storeroom – ceiling panel<br><b>1486</b> | Fibreboard | Similar to 25132-27-6 | Assumed Positive | 107 | Bonded | Stable | Low | December 2019 | Not labeled | 4 | |

**Photo 107:** Fibreboard ceiling panel assumed to contain asbestos outside the Jacket Storage cupboard in the western garage of the Glenbrook Rural Fire Service Bushfire Station.

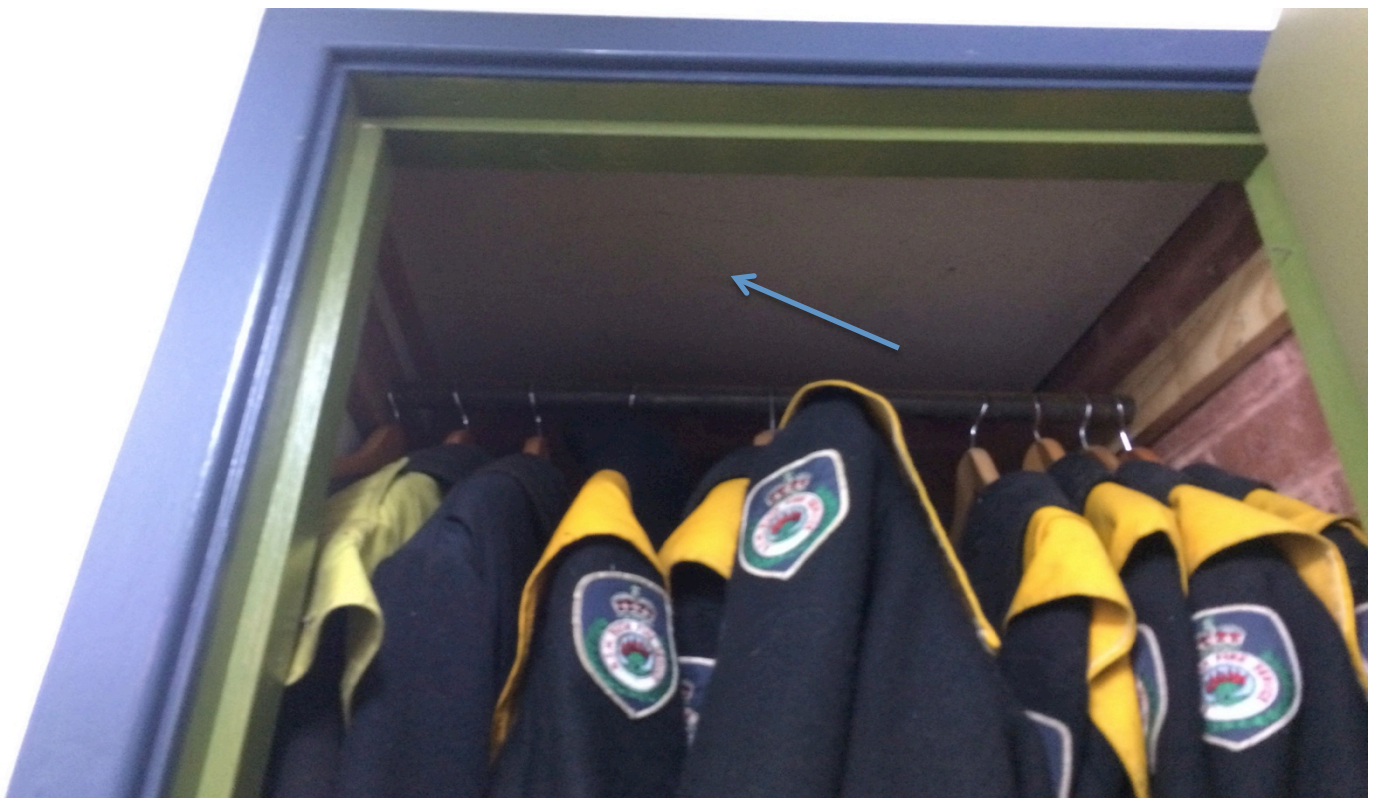
| Location | Material | Sample ID | Sample Status | Photo No. | Asbestos Classification | Condition | Accessibility | Re-inspect | Current Label | Control Measure | Record of Works Undertaken |
|---|---|---|---|---|---|---|---|---|---|---|---|
| Western Garage – Jacket Storeroom – ceiling panel<br><b>1487</b> | Fibreboard | Similar to 25132-27-6 | Assumed Positive | 108 | Bonded | Stable | Low | December 2019 | Not labeled | 4 | |

**Photo 108:** Fibreboard ceiling panel assumed to contain asbestos in the Jacket Storage cupboard in the western garage of the Glenbrook Rural Fire Service Bushfire Station.

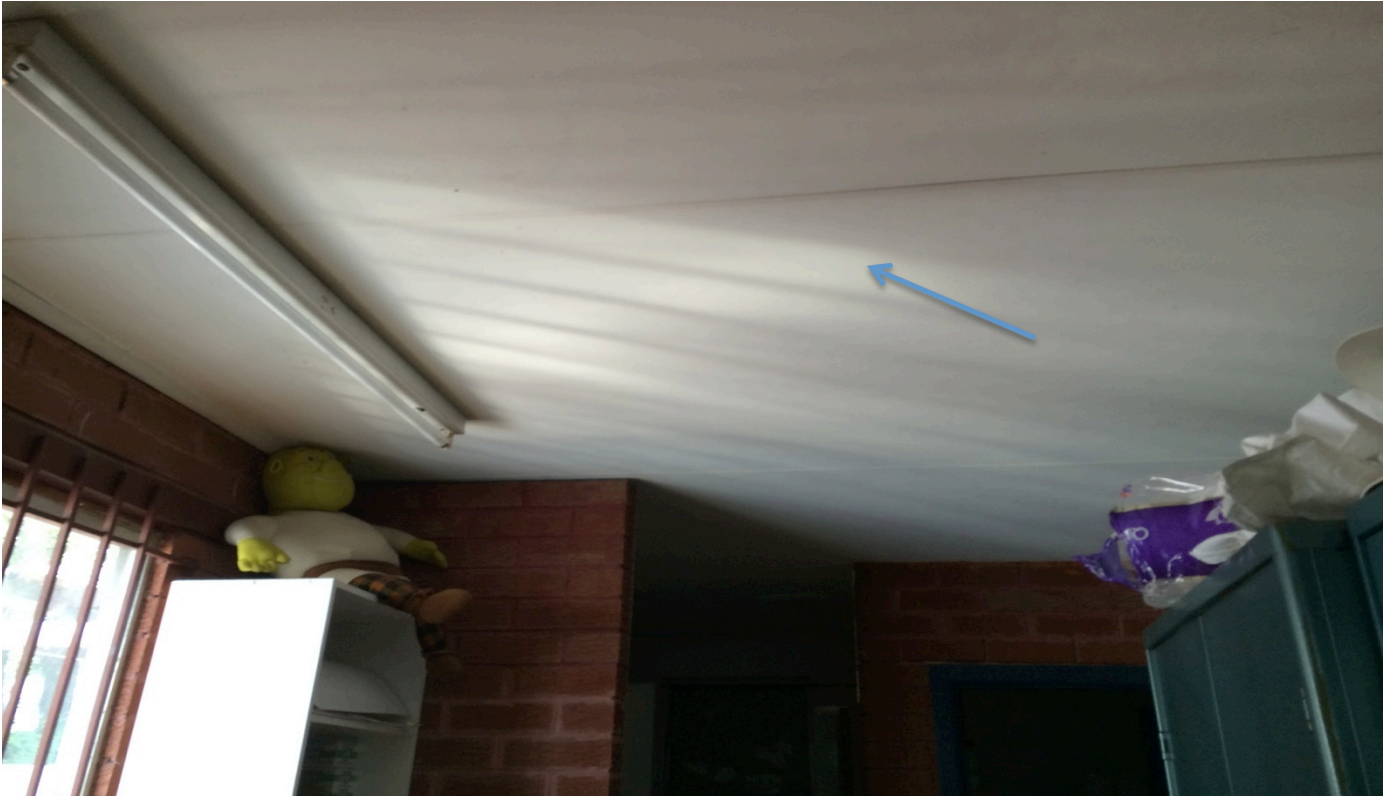
| Location | Material | Sample ID | Sample Status | Photo No. | Asbestos Classification | Condition | Accessibility | Re-inspect | Current Label | Control Measure | Record of Works Undertaken |
|---|---|---|---|---|---|---|---|---|---|---|---|
| Western Garage – Storage Area – ceiling lining<br><b>1489</b> | Fibreboard | 25132-27-6 | Positive | 109 | Bonded | Stable | Low | December 2019 | Not labeled | 4 | |
| Western Garage – Shower – ceiling lining<br><b>1490</b> | Fibreboard | Similar to 25132-27-6 | Assumed Positive | 109 | Bonded | Stable | Low | December 2019 | Not labeled | 4 | |
| Western Garage – Toilet – ceiling lining<br><b>1491</b> | Fibreboard | Similar to 25132-27-6 | Assumed Positive | 109 | Bonded | Stable | Low | December 2019 | Not labeled | 4 | |

| 25132-27-6 | Glenbrook Rural Fire Service Bushfire Station – Internal – Western Garage – Storage Area – ceiling lining | 7x5x1mm fibreboard fragment | Chrysotile asbestos detected<br>[Organic fibres detected] |

**Photo 109:** Fibreboard containing asbestos ceiling lining Storage Area and Toilet/Shower area in the western garage of the **Glenbrook Rural Fire Service Bushfire Station**.

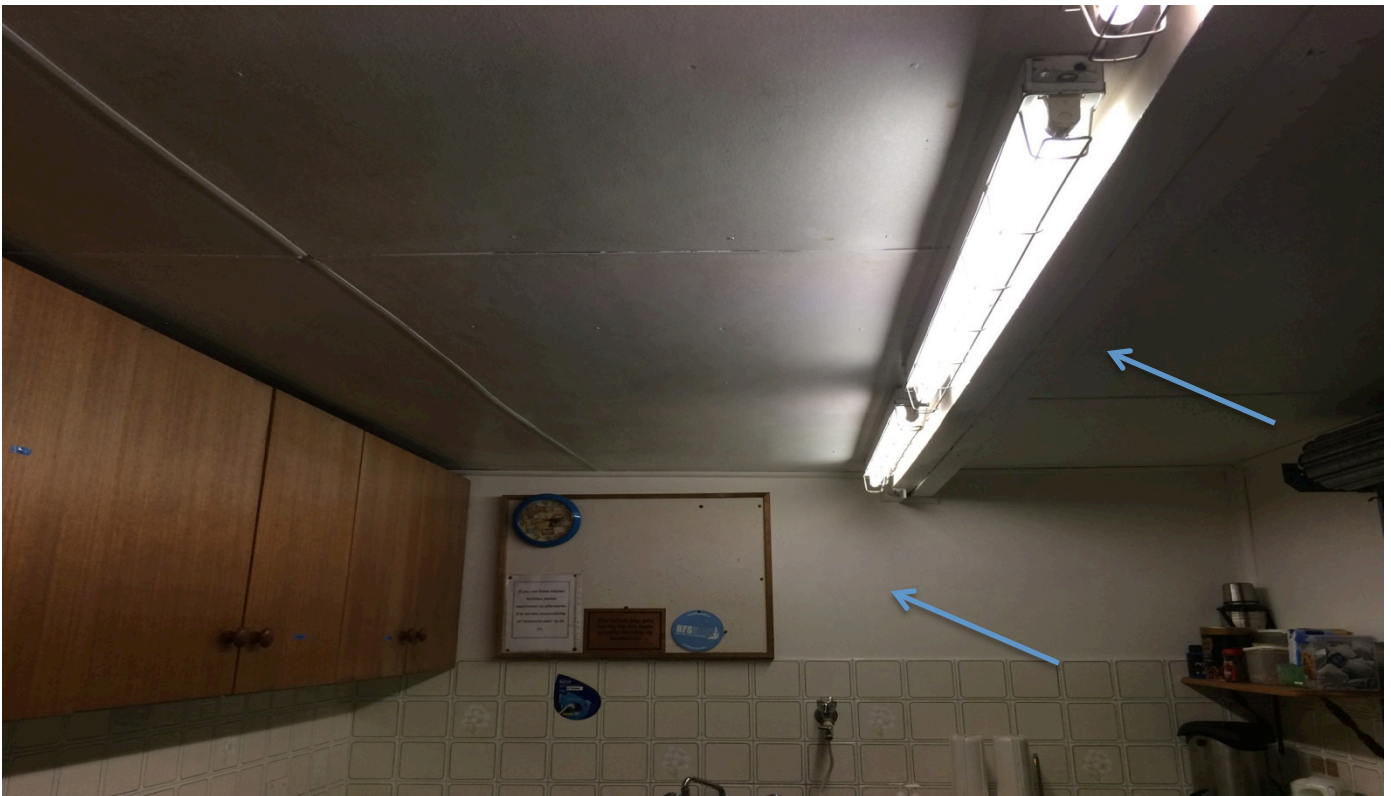
| Location | Material | Sample ID | Sample Status | Photo No. | Asbestos Classification | Condition | Accessibility | Re-inspect | Current Label | Control Measure | Record of Works Undertaken |
|---|---|---|---|---|---|---|---|---|---|---|---|
| Western Garage – Kitchen – ceiling lining<br><b>1492</b> | Fibreboard | Similar to 25132-27-6 | Assumed Positive | 110 | Bonded | Stable | Low | December 2019 | Not labeled | 4 | |
| Western Garage – Kitchen – internal wall cladding<br><b>1493</b> | Fibreboard | Similar to 25132-27-4 | Assumed Positive | 110 | Bonded | Stable | Medium | December 2019 | Not labeled | 4 | |

**Photo 110:** Fibreboard ceiling lining and internal wall cladding assumed to contain asbestos in the Kitchen in the western garage of the **Glenbrook Rural Fire Service Bushfire Station**.

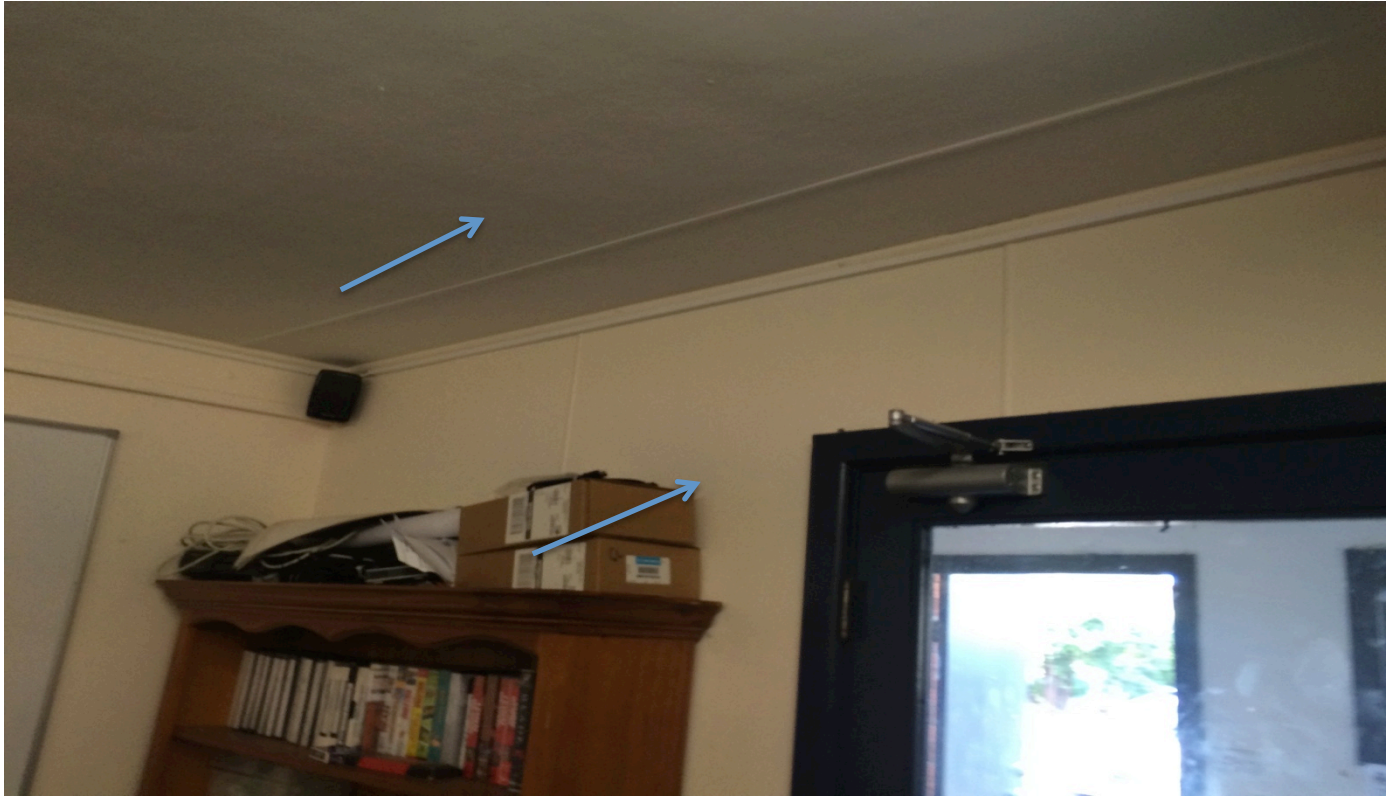
| Location | Material | Sample ID | Sample Status | Photo No. | Asbestos Classification | Condition | Accessibility | Re-inspect | Current Label | Control Measure | Record of Works Undertaken |
|---|---|---|---|---|---|---|---|---|---|---|---|
| Central Meeting Room – ceiling lining<br><b>1496</b> | Fibreboard | Similar to 25132-27-6 | Assumed Positive | 111 | Bonded | Stable | Low | December 2019 | Not labeled | 4 | |
| Central Meeting Room – southern internal wall cladding<br><b>1497</b> | Fibreboard | Similar to 25132-27-4 | Assumed Positive | 111 | Bonded | Stable | Medium | December 2019 | Not labeled | 4 | |

**Photo 111:** Fibreboard ceiling lining and southern internal wall cladding assumed to contain asbestos in the central meeting room in the western garage of the **Glenbrook Rural Fire Service Bushfire Station.**
