## ASBESTOS REGISTER

WOODFORD MEMORIAL PARK –  
SHELTER SHED

**Blue Mountains City  
Council – Stage 3**

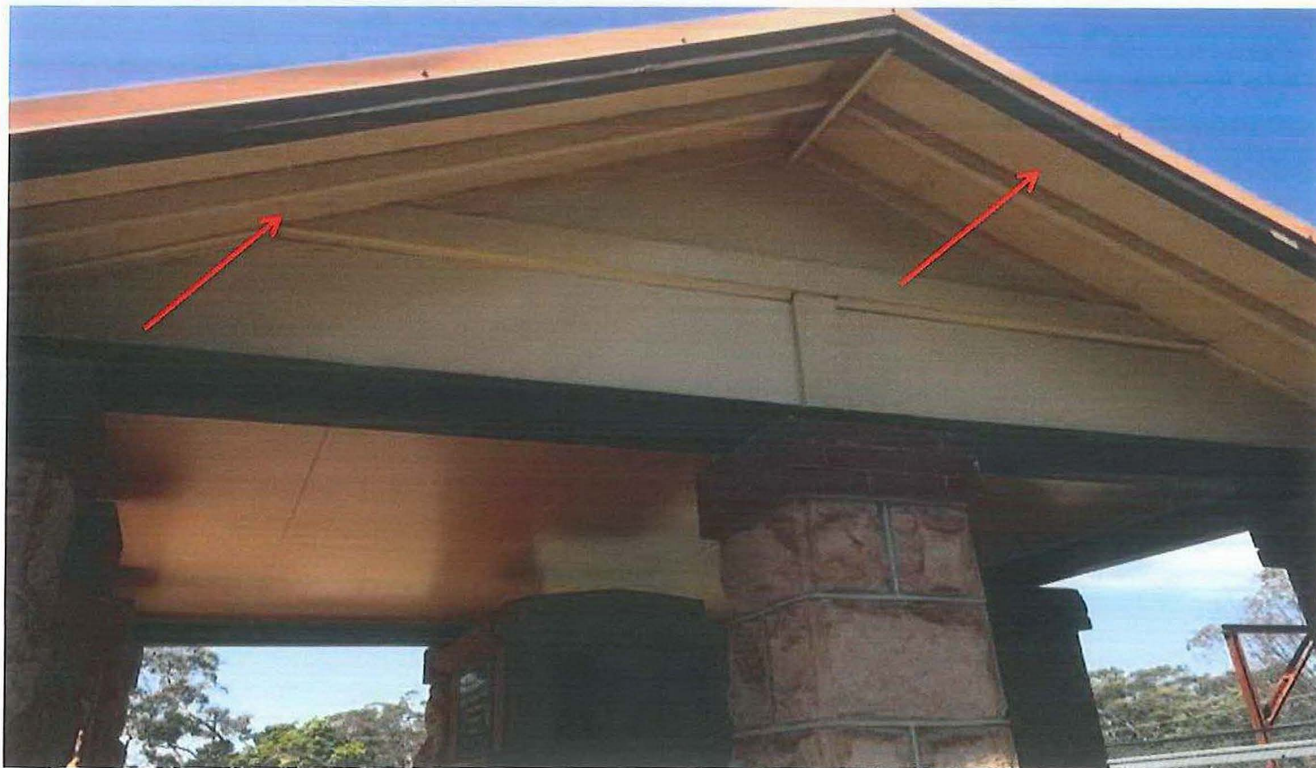
Location	Material	Sample ID	Sample Status	Photo No.	Asbestos Classification	Condition	Accessibility	Re-inspect	Current Label	Control Measure	Record of Works Undertaken
<b>Asset E00189 – Woodford Memorial Shelter</b>											
<b>External/Internal</b>											
Gable ends <b>3129</b>	Fibreboard	28781-56-1	Negative	-	-	-	-	-	-	-	-
Eave linings <b>969</b>	Fibreboard	28781-56-2	Positive	171	Bonded	Stable	Low	November 2020	Not labeled	4	
Ceiling lining <b>3130</b>	Fibreboard	28781-56-3	Negative	-	-	-	-	-	-	-	-

**Photo 171:** Asset E00189 – **Woodford Memorial Shelter** – Fibreboard containing asbestos eave linings.
