HAZARDOUS BUILDING MATERIALS

SURVEY REPORT

Springwood Library
104 Macquarie Road
Springwood NSW 2777

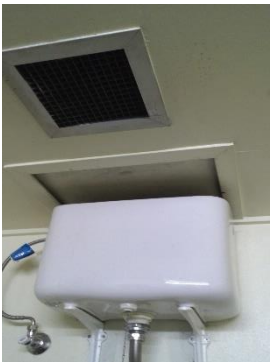
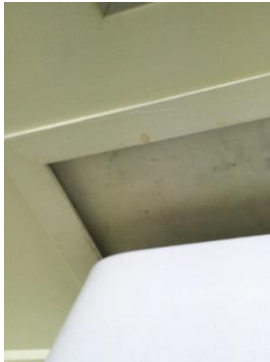
Location:	Springwood Library, Ground Floor	Material Application	Ceiling hatch panel, Fibrous Cement	Extent:	1 m ²	Sample Number	AS03
Main Photo		Close Up Photo		Product Type	Asbestos reinforced composites etc. (1)	Material Score

Condition	Fair (1)	4	
				Surface Treatment	Sealed (1)	Risk	
				Asbestos Type	Chrysotile (1)	Very Low	
				Recommendation:	Manage and Label

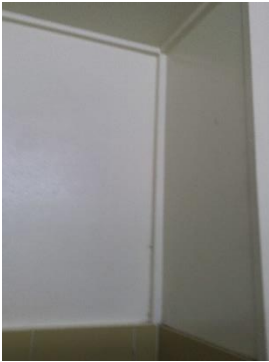
Location:	Springwood Library, Ground Floor Ground floor, male toilets	Material Application	Wall panels adjacent urinal, Fibrous Cement	Extent:	3 m ²	Sample Number	AS06
Main Photo		Close Up Photo		Product Type	Asbestos reinforced composites etc. (1)	Material Score

Condition	Good (0)	4	
				Surface Treatment	Sealed (1)	Risk	
				Asbestos Type	Amosite, Chrysotile (2)	Very Low	
				Recommendation:	Manage and Label

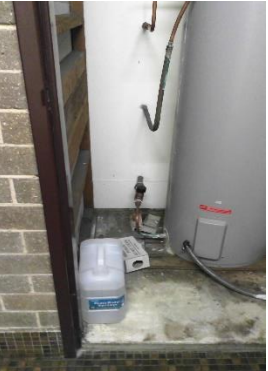
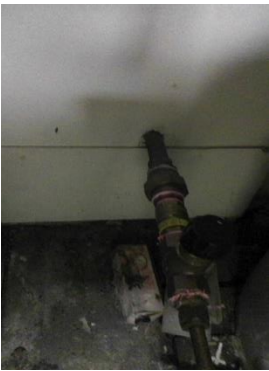
Location:	Springwood Library, Ground Floor Ground floor, fire safety cupboard	Material Application	Panel, Fibrous Cement	Extent:	0.5 m ²	Sample Number	AS05
Main Photo		Close Up Photo		Product Type	Asbestos reinforced composites etc. (1)	Material Score

Condition	Good (0)	3	
				Surface Treatment	Sealed (1)	Risk	
				Asbestos Type	Chrysotile (1)	Very Low	
				Recommendation:	Manage and Label
