## ASBESTOS REGISTER

### WARRIMOO BRIGADE STATION

3 ELEY HAWKINS DRIVE, WARRIMOO

## **ASBESTOS REGISTER**

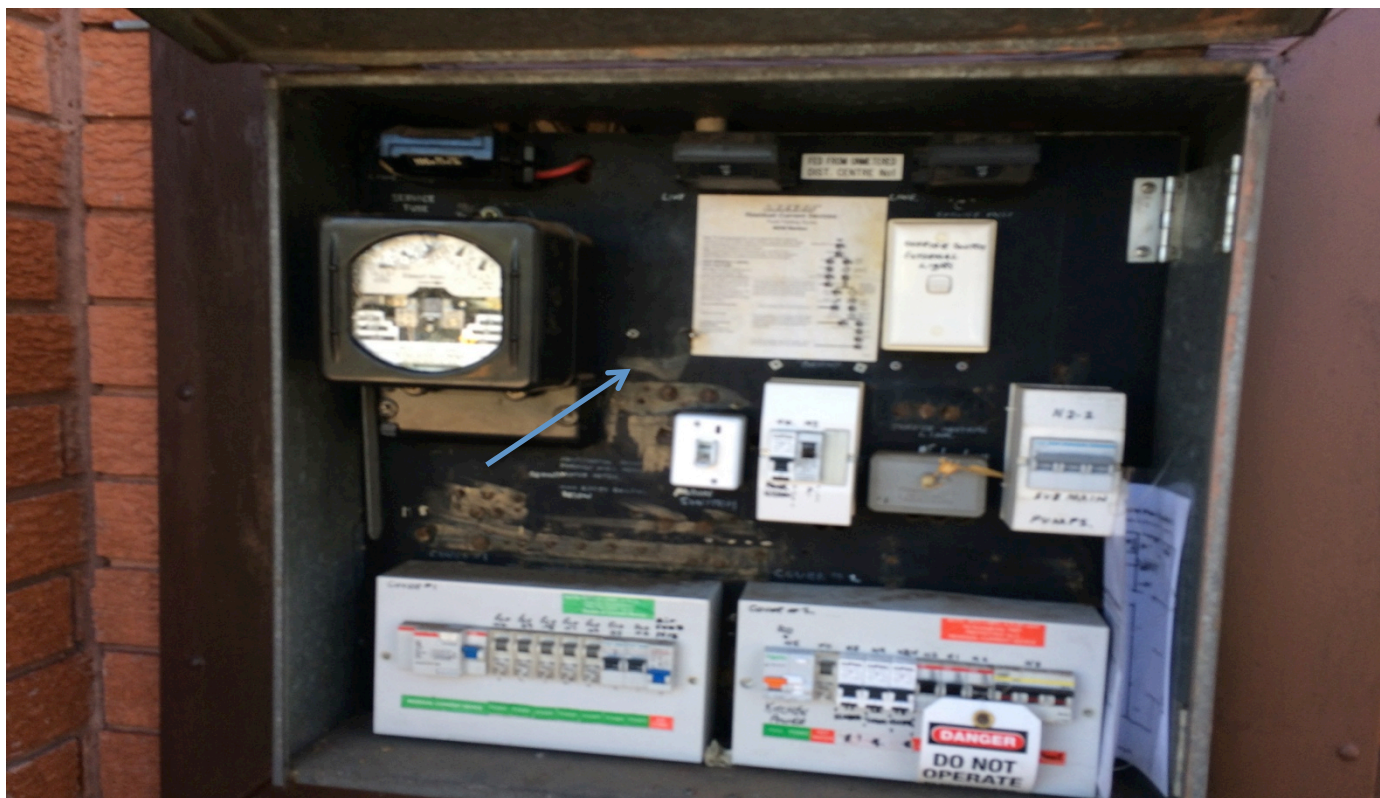
| Location | Material | Sample ID | Sample Status | Photo No. | Asbestos Classification | Condition | Accessibility | Re-inspect | Current Label | Control Measure | Record of Works Undertaken |
|---|---|---|---|---|---|---|---|---|---|---|---|
| South-western Perimeter – electrical box – electrical backing board<br><b>325</b> | Bituminous backing board | 25132-37-3 | Positive | 128 | Bonded | Stable | Low | December 2019 | Not labeled | 4 | |

| 25132-37-3 | Warrimoo Rural Fire Service Bushfire Station – External – south-western perimeter – electrical box – electrical backing board | 5x3x3mm bituminous backing board fragment | Chrysotile asbestos detected |

**Photo 128:** Electrical backing board containing asbestos on the south-western perimeter of the Warrimoo Rural Fire Service Bushfire Brigade.

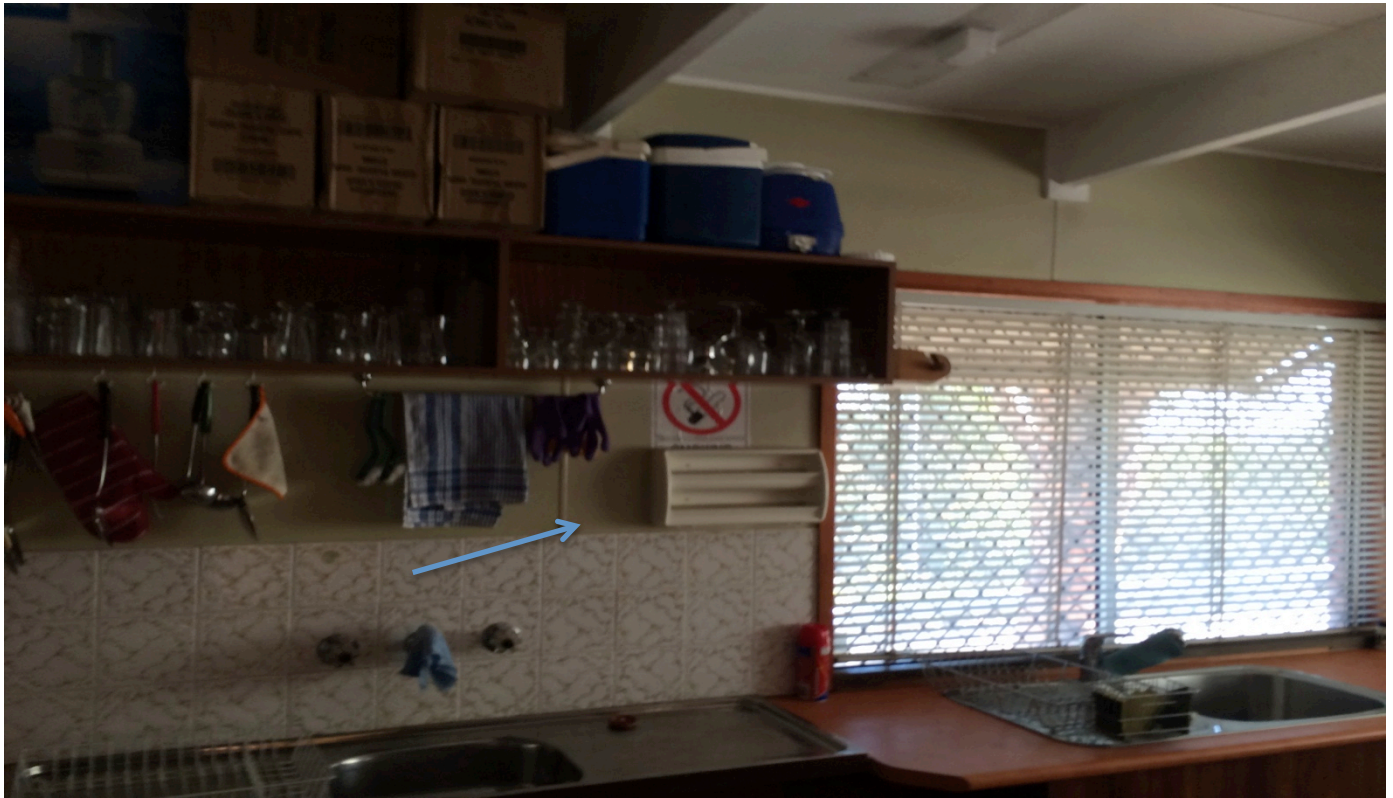
| Location | Material | Sample ID | Sample Status | Photo No. | Asbestos Classification | Condition | Accessibility | Re-inspect | Current Label | Control Measure | Record of Works Undertaken |
|---|---|---|---|---|---|---|---|---|---|---|---|
| Kitchen – internal wall cladding<br><b>326</b> | Fibreboard | 25132-37-4 | Positive | 129 | Bonded | Stable | Medium | December 2019 | Not labeled | 4 | |

| 25132-37-4 | Warrimoo Rural Fire Service Bushfire Station – Internal – Kitchen – internal wall cladding | 8x4x1mm fibreboard fragment | Chrysotile asbestos detected<br>[Organic fibres detected] |

**Photo 129:** Fibreboard containing asbestos internal wall cladding of the Kitchen in the Warrimoo Rural Fire Service Bushfire Brigade.

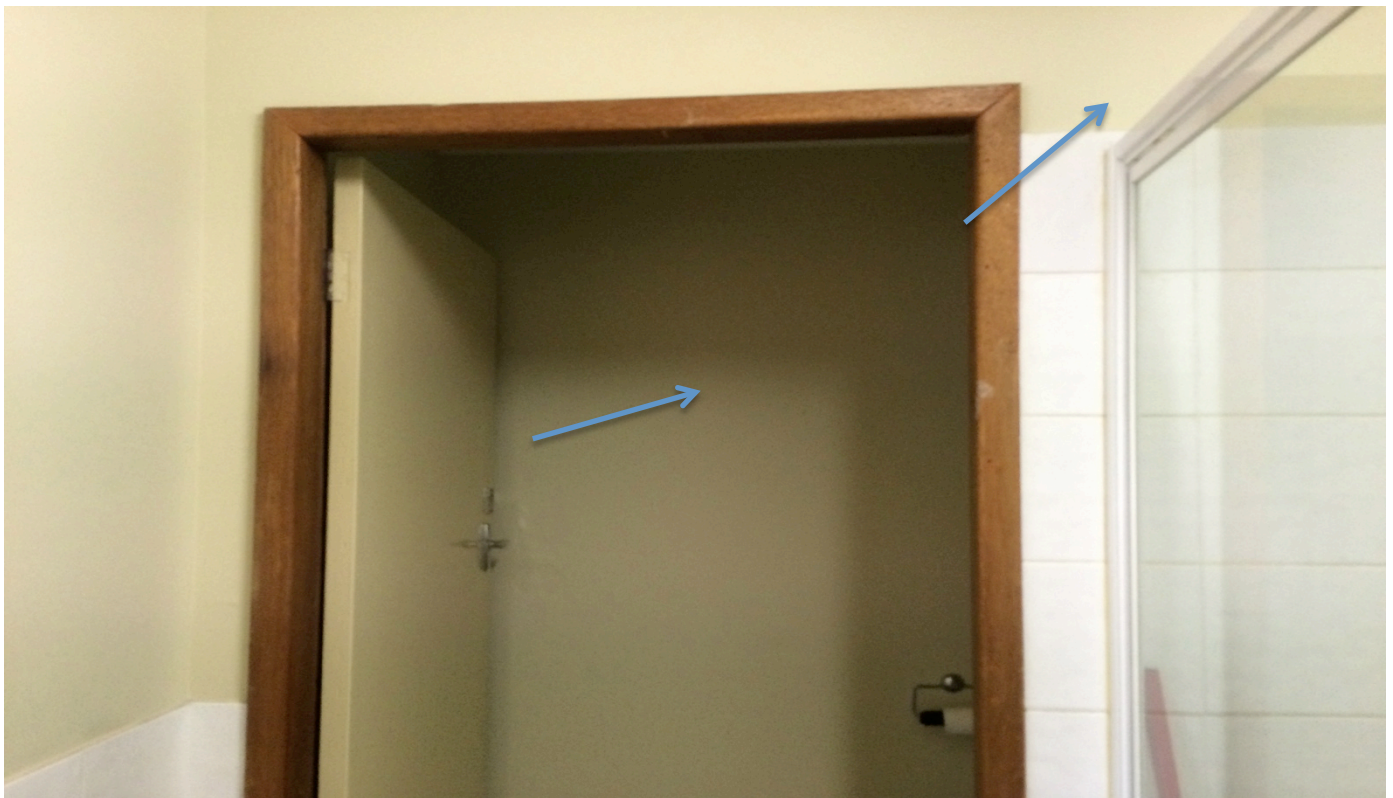
| Location | Material | Sample ID | Sample Status | Photo No. | Asbestos Classification | Condition | Accessibility | Re-inspect | Current Label | Control Measure | Record of Works Undertaken |
|---|---|---|---|---|---|---|---|---|---|---|---|
| Toilet – internal wall cladding<br><b>328</b> | Fibreboard | 25132-37-6 | Positive | 130 | Bonded | Stable | Medium | December 2019 | Not labeled | 4 | |
| Shower – internal wall cladding<br><b>329</b> | Fibreboard | Similar to 25132-37-6 | Assumed Positive | 130 | Bonded | Stable | Medium | December 2019 | Not labeled | 4 | |

| 25132-37-6 | Warrimoo Rural Fire Service Bushfire Station – Internal – Toilet – internal wall cladding | 7x5x2mm fibreboard fragment | Chrysotile asbestos detected<br>[Organic fibres detected] |

**Photo 130:** Fibreboard containing asbestos internal wall cladding of the Toilet and Shower in the Warrimoo Rural Fire Service Bushfire Brigade.
