ASBESTOS REGISTER

LAWSON FORMER GOLF COURSE - MACHINERY SHED

48-78 WILSON STREET, LAWSON

3.1.29 Asset E00017 – Former Lawson Golf Course – Machinery Shed

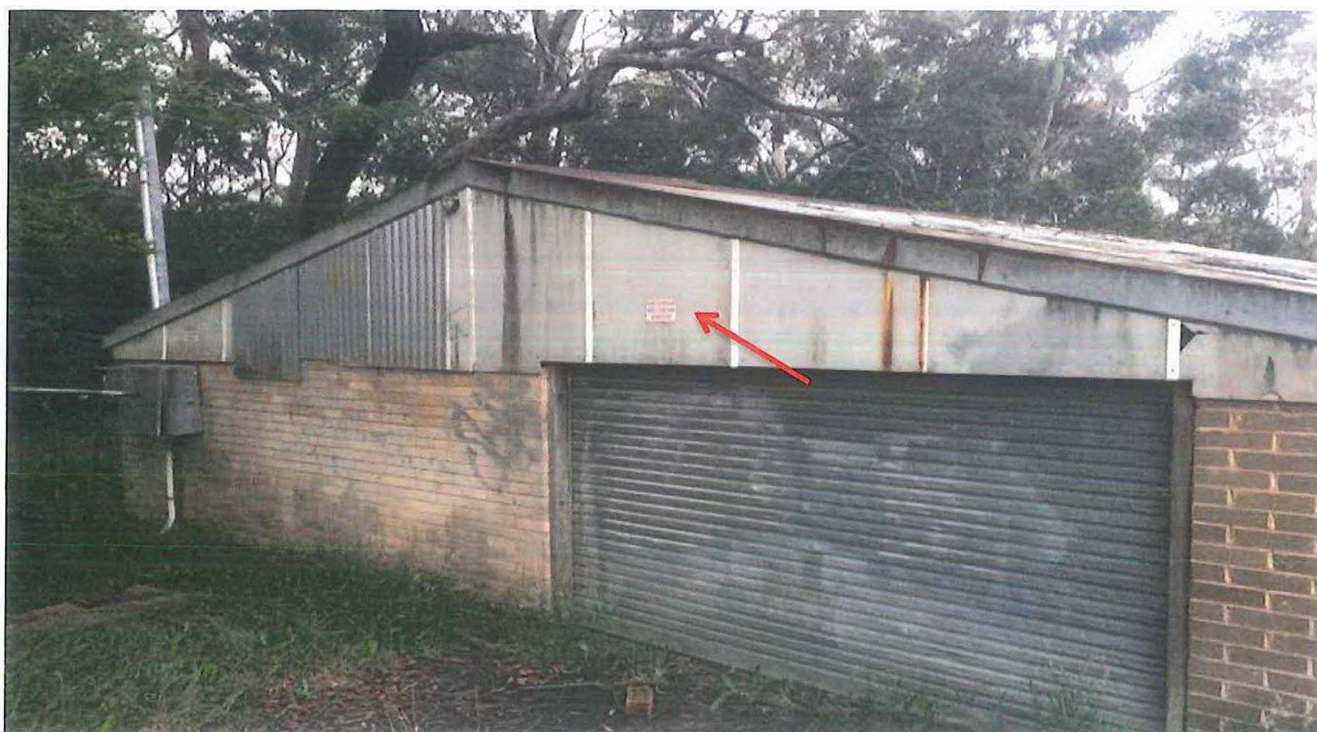
Location	Material	Sample ID	Sample Status	Photo No.	Asbestos Classification	Condition	Accessibility	Re-inspect	Current Label	Control Measure	Record of Works Undertaken
Asset E00017 – Former Lawson Golf Course – Machinery Shed											
External											
Western Perimeter – gable end 2066	Fibreboard	28781-29-1	Positive	100	Bonded	Stable	Low	November 2020	Incorrectly labeled	4	
Western Perimeter – Electrical Box (small) – electrical backing board 2067	Bituminous backing board	Similar to 28781-29-2	Assumed Positive	101	Bonded	Stable	Medium	November 2020	Not labeled	4	cc 17/122588 27/06/16
Western Perimeter – Electrical Box (large) – electrical backing board 2068	Bituminous backing board	28781-29-2	Positive	102	Bonded	Broken, unstable	Medium	November 2016	Incorrectly labeled	3	cc 17/122588 27/06/16
Eastern Perimeter – gable end 2069	Fibreboard	Similar to 28781-29-1	Assumed Positive	103	Bonded	Stable	Low	November 2020	Not labeled	4

Photo 100: Asset E00017 – **Former Lawson Golf Course – Machinery Shed** – Western Perimeter – fibreboard containing asbestos gable end.

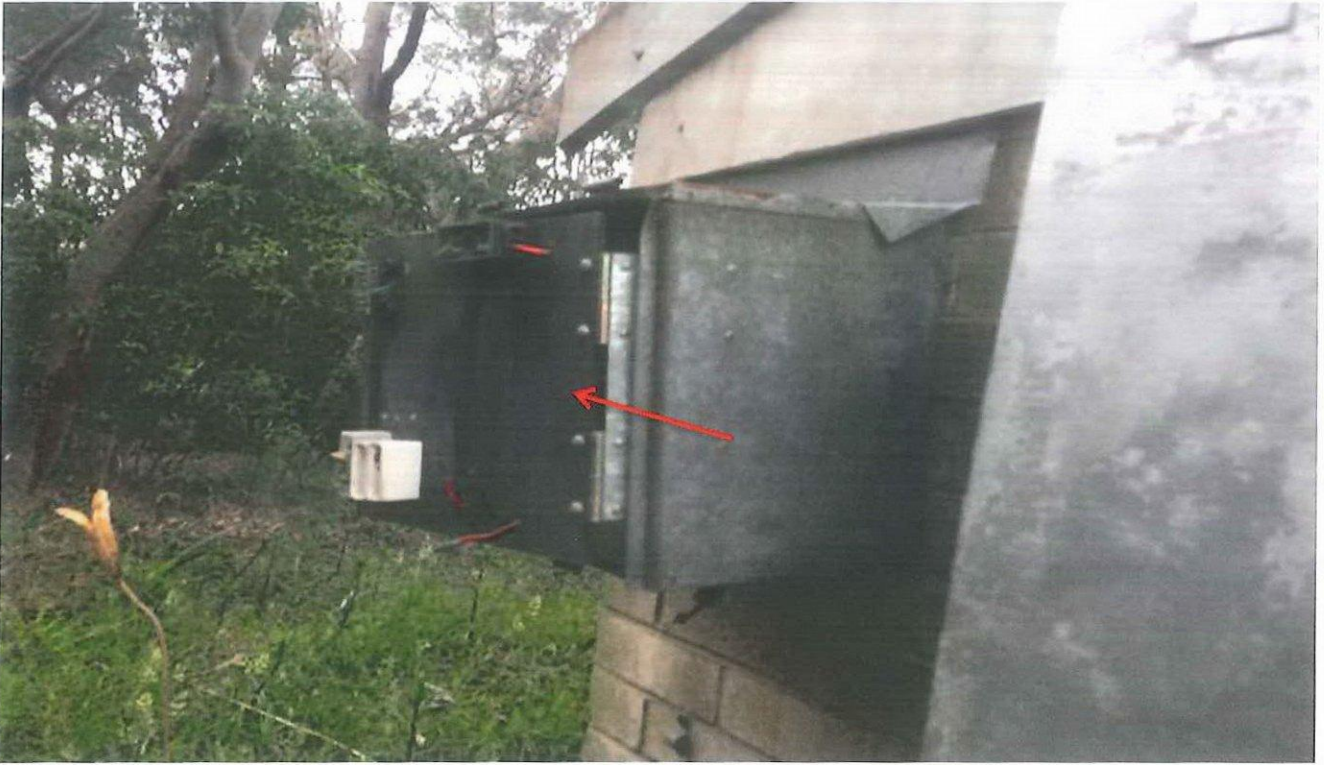
Photo 101: Asset E00017 – Former Lawson Golf Course – Machinery Shed – Western Perimeter – electrical backing board containing asbestos.

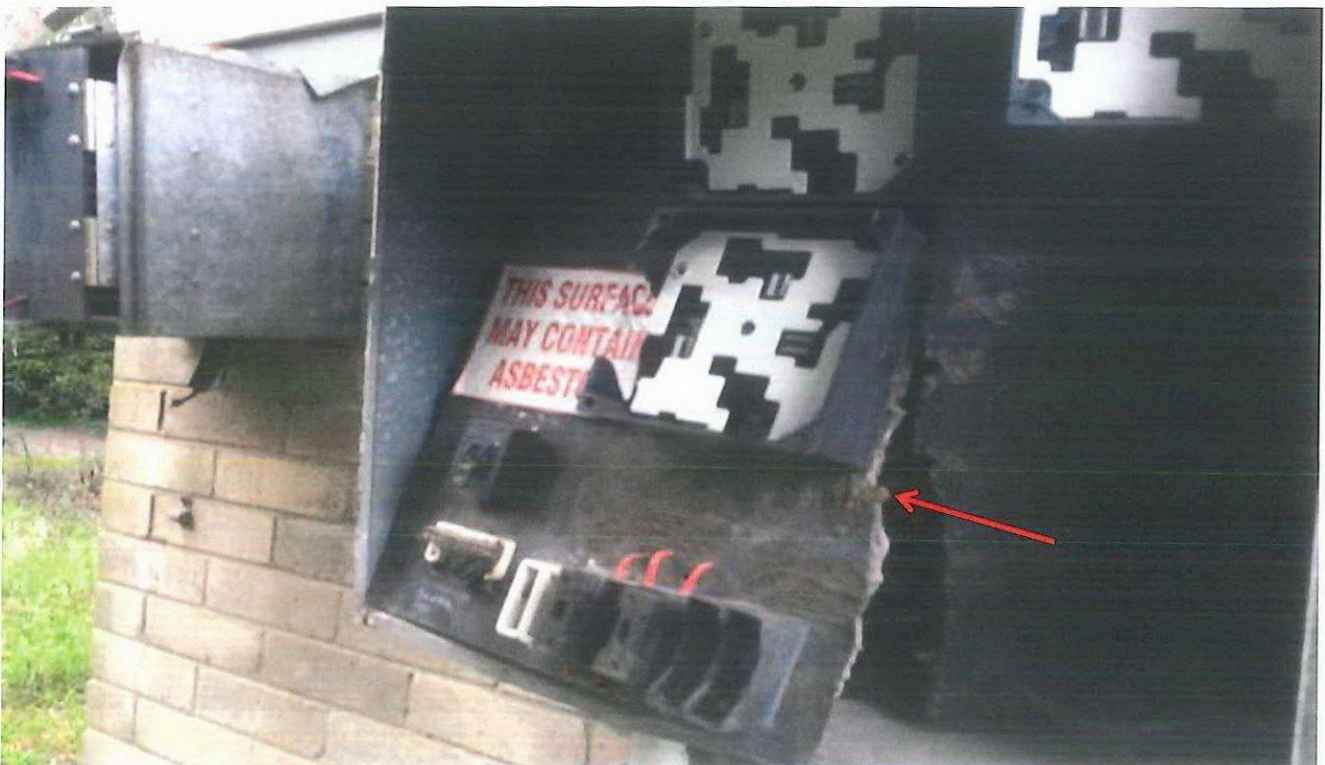
Photo 102: Asset E00017 – Former Lawson Golf Course – Machinery Shed – Western Perimeter – broken electrical backing board containing asbestos.

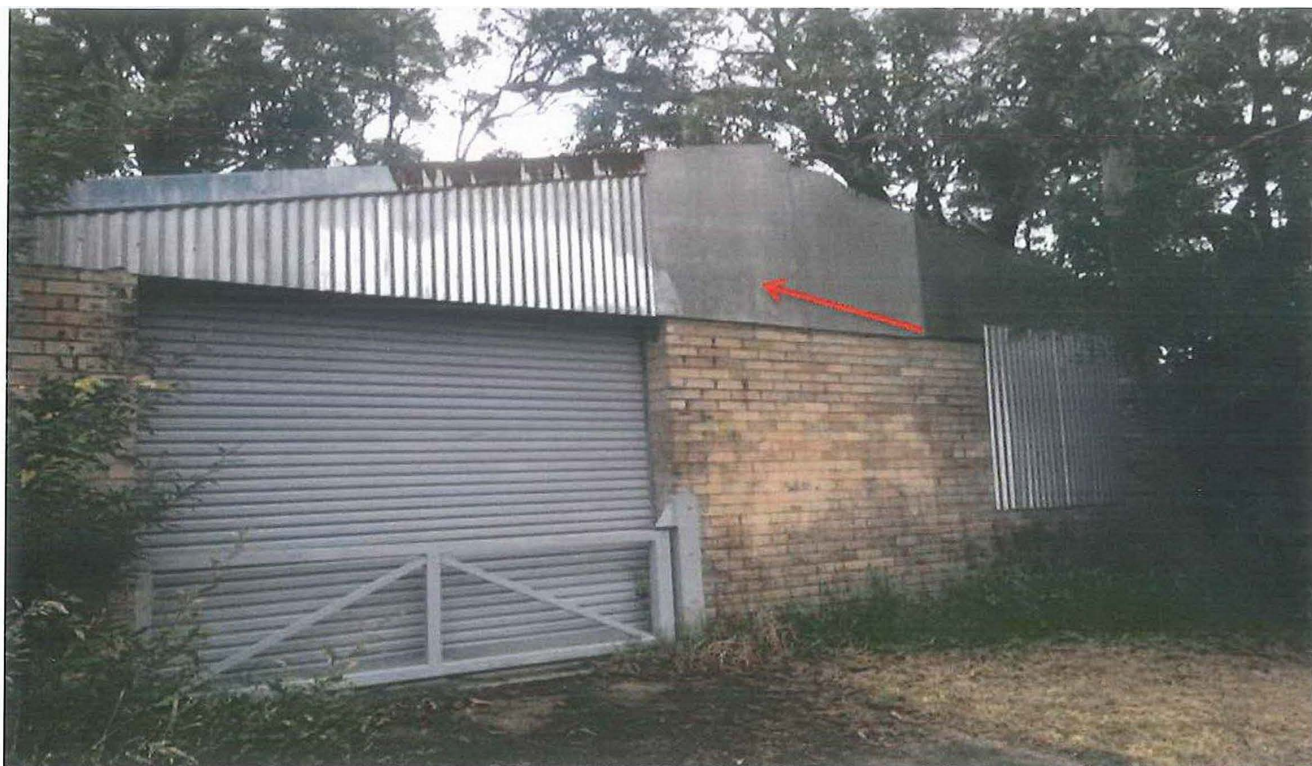
Photo 103: Asset E00017 – Former Lawson Golf Course – Machinery Shed – Eastern Perimeter – fibreglass containing asbestos sheeting is present behind the timber and tin gable end.
