ASBESTOS MANAGEMENT REGISTER

Cottage 2, Residential Property

2-20 Lawson Road

Jan 2020

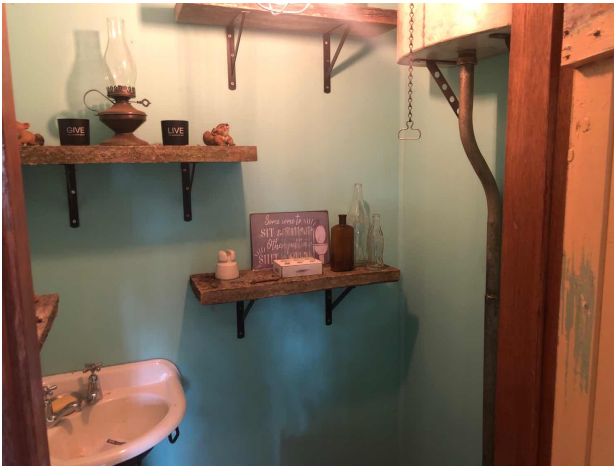
197612A4.1 Flat cement sheets External GF Toilet Wall panels behind plasterboard

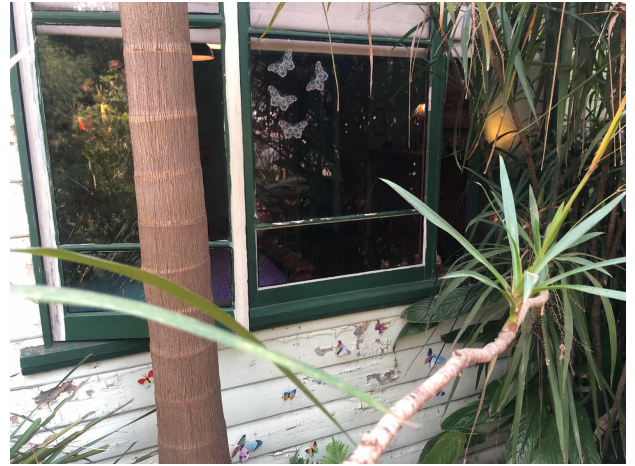
197612A7 Putty External GF All Elevations Window frames

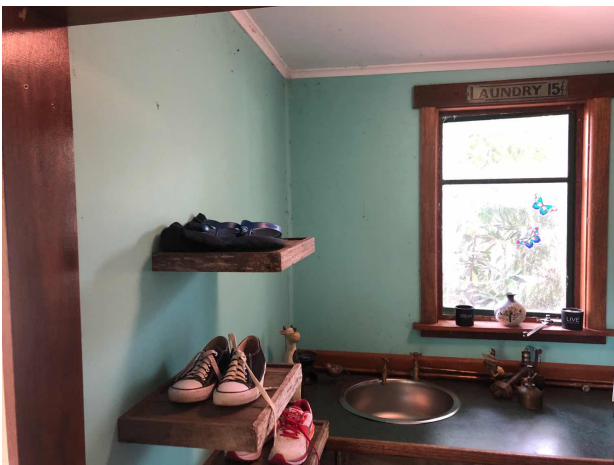
197612A4 Flat cement sheets External GF Laundry Wall panels behind plasterboard

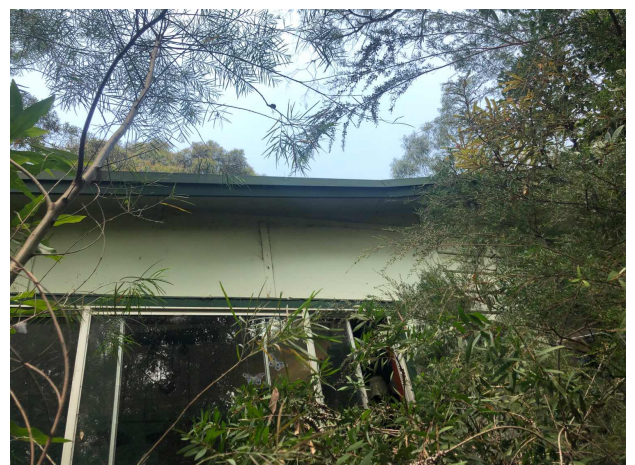
197612A5.3 Flat cement sheets External GF North Elevation Eaves

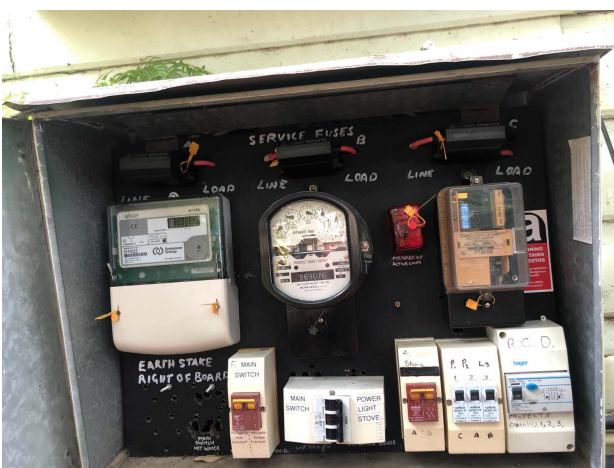
197612A6 Compressed bitumen External GF South Elevation Electrical mounting board

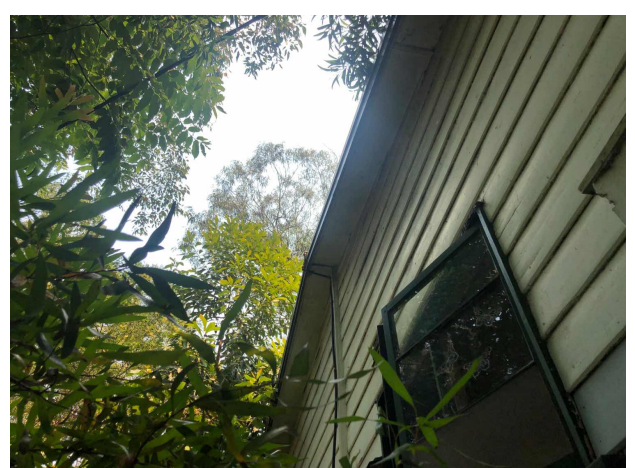
197612A5.5 Flat cement sheets External GF South Elevation Eaves

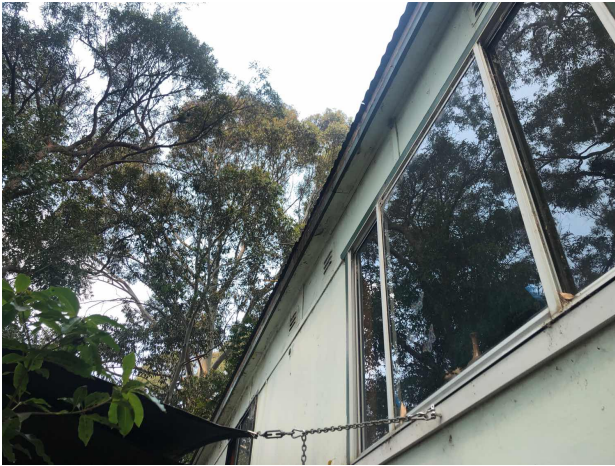
197612A5 Flat cement sheets External GF East Elevation Eaves

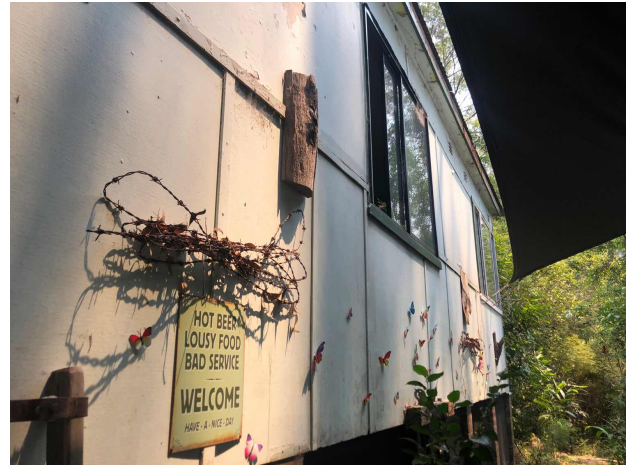
197612A5.1 Flat cement sheets External GF East Elevation Wall panels

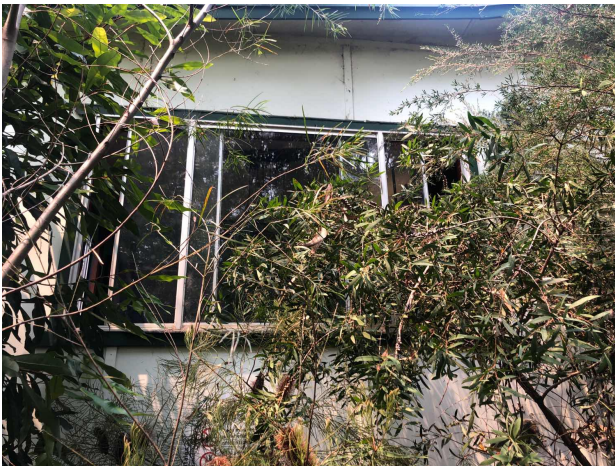
197612A5.2 Flat cement sheets External GF North Elevation Wall panels

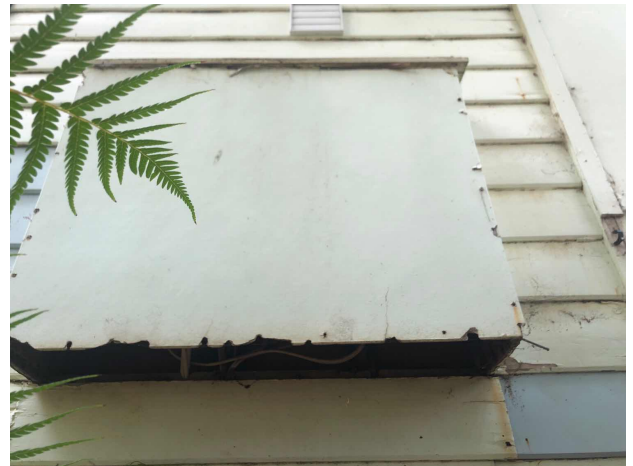
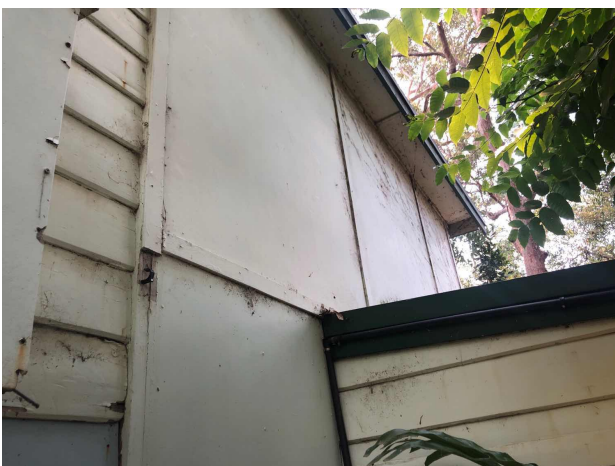
197612A5.4 Flat cement sheets External GF South Elevation Wall panels

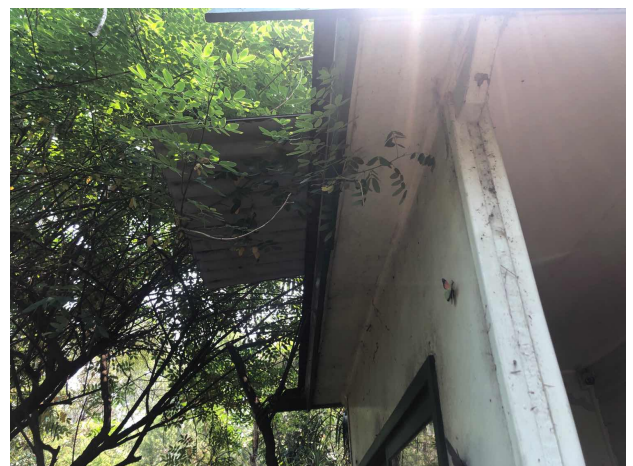
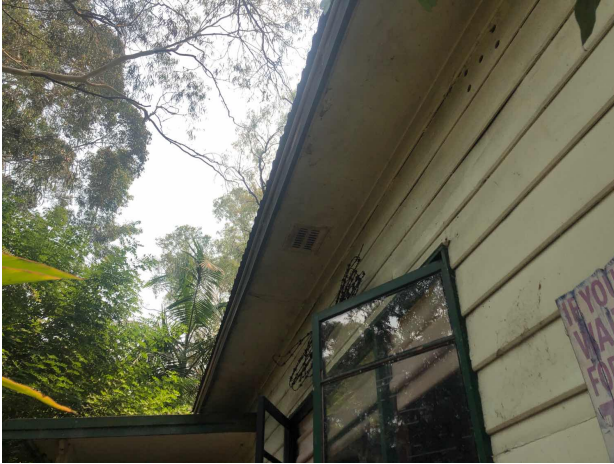
197612A5.7 Flat cement sheets External GF West Elevation Eaves

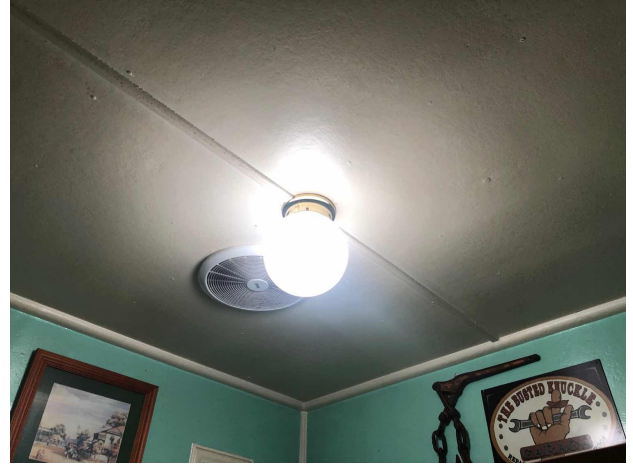
197612A2.2 Flat cement sheets Internal GF Bath Ceiling panels

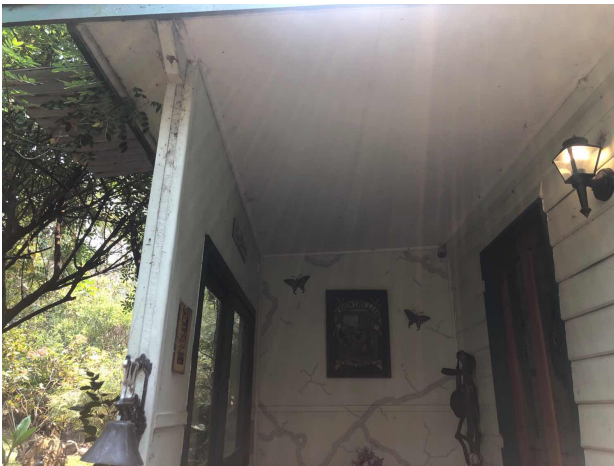
197612A5.6 Flat cement sheets External GF West Elevation Wall and ceiling panels to front porch

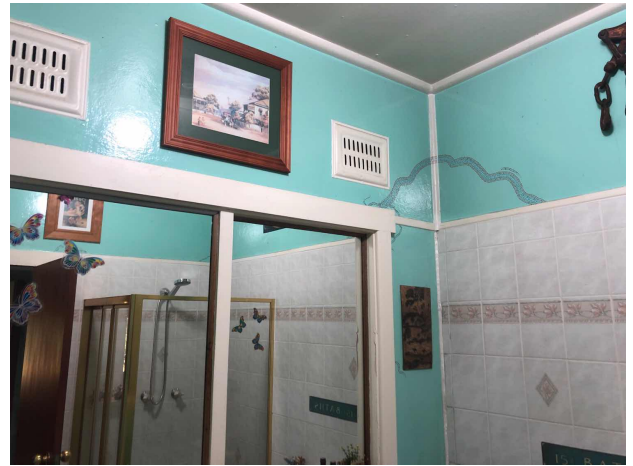
197612A1.1 Flat cement sheets Internal GF Bath Wall panels

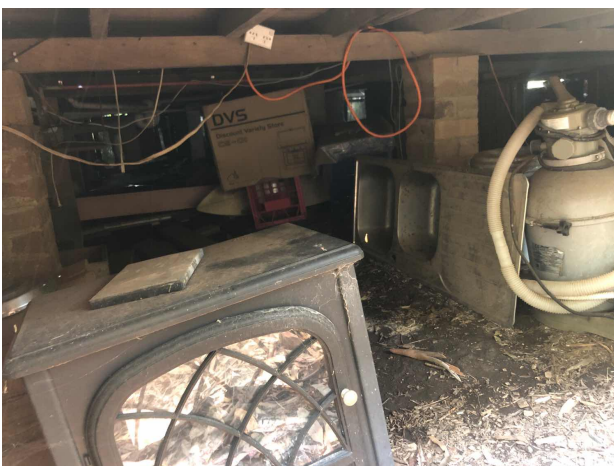
197612La1 Internal Sub-Floor Undercroft Undercroft

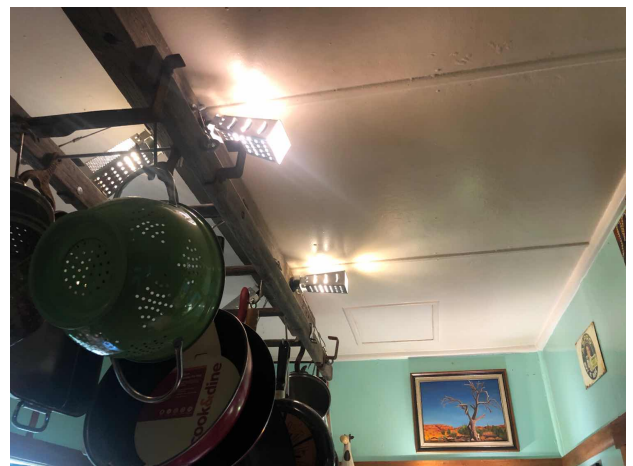
197612A2 Flat cement sheets Internal GF Kitchen Ceiling panels

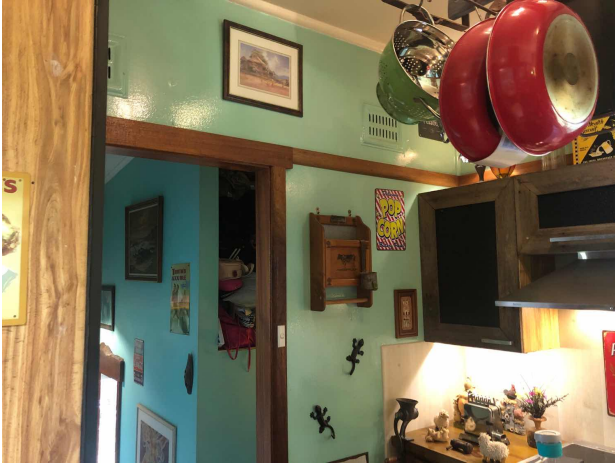
14	197612A1	Asbestos	CHR,AMO,CRO	Flat cement sheets	Internal, GF, Kitchen, Wall panels	10 m ²	No	Low	A4	Annual Reinspection	-
15	197612A2.2	Asbestos	CHR,CRO,ORG	Flat cement sheets	Internal, GF, Bath, Ceiling panels	4 m ²	No	Low	A4	Annual Reinspection	-
16	197612A1.1	Asbestos	CHR,AMO,CRO	Flat cement sheets	Internal, GF, Bath, Wall panels	10 m ²	No	Low	A4	Annual Reinspection	Assume cement sheeting also behind wall tiles
17	197612A2	Asbestos	CHR,CRO,ORG	Flat cement sheets	Internal, GF, Kitchen, Ceiling panels	8 m ²	No	Low	A4	Annual Reinspection	-
18	197612A2.1	Asbestos	CHR,CRO,ORG	Flat cement sheets	Internal, GF, Roof Space, Panels forming ceiling to kitchen and bathroom below	8 m ²	No	Very Low	A4	Annual Reinspection	-

197612A1 Flat cement sheets Internal GF Kitchen Wall panels

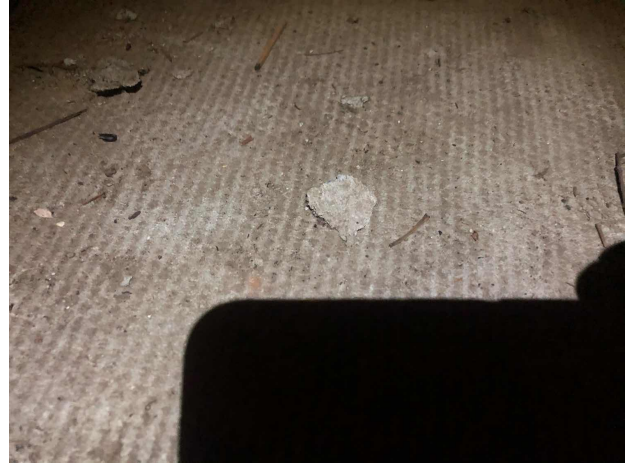
#	Reference #	Hazard	Results	Material Description	Location	Quantity	Friable	Overall Risk Rating ¹	Action Item	RECOMMENDED TIME FRAMES	COMMENTS
19	197612A3	Asbestos	CHR,CRO,ORG	Cement debris	Internal, GF, Roof Space, Adjacent manhole	0.02 m ²	No	Very Low	A3	Annual Reinspection	-

197612A3 Cement debris Internal GF Roof Space Adjacent manhole

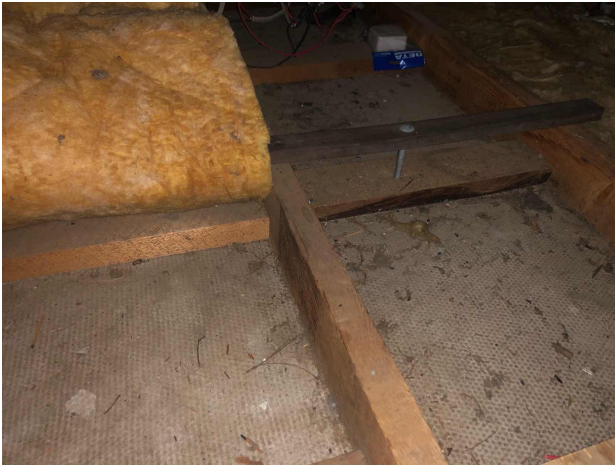
197612A2.1 Flat cement sheets Internal GF Roof Space Panels forming ceiling to kitchen and bathroom below
