Asbestos Register

Regional EnviroScience Pty Ltd was requested by Mr. Rick Harris of Blue Mountain City Council to undertake a Hazardous Building Materials Survey and to prepare a Hazardous Materials Register and Management Plan of the Community Hall at the property known as Lawson Mechanics Institute, located at 284 Great Western Highway, Lawson, NSW, 2783. The purpose of the audit was to locate and identify asbestos based building materials and product within the building in accordance with the *NSW Work Health and Safety Act and Regulation 2017* and the *Code of Practice; How to Manage and Control Asbestos in the Workplace* [Safe Work Australia: 2016] and the *Code of Practice; How to Safely Remove Asbestos* [Safe Work Australia: 2016].

On the 21st March 2018, an Asbestos Audit was conducted at the Lawson Mechanics Institute and asbestos containing materials were found to be present at the premises. Please refer Appendix I for results of products that were considered and consequently analysed but did not contain asbestos.

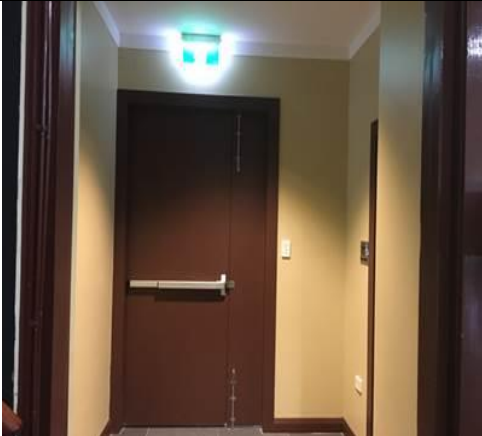
| ASBESTOS MATERIALS REGISTER | | ASSET: Lawson Mechanics Institute, 284 Great Western Highway, Lawson, NSW, 2783 | | | |
|---|---|--|--|---|---|
| 21 st March 2018 | | Western Entrance. Ceramic Tile Floor, Timber Skirting, Eastern Wall Rendered Brick, Plasterboard Walls & Ceiling, Timber Door & Architraves. | No Sample Taken No Asbestos Containing Materials Sighted 78 | A5 | N/A |

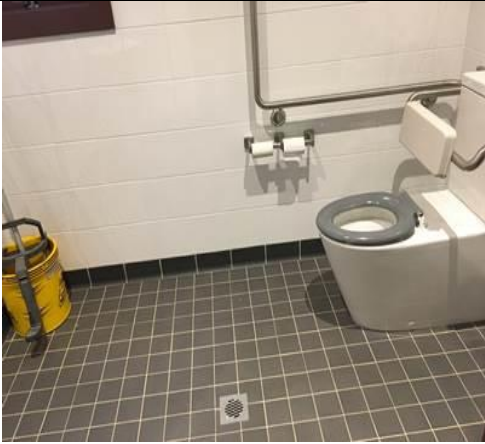
| ASBESTOS MATERIALS REGISTER | | ASSET: Lawson Mechanics Institute, 284 Great Western Highway, Lawson, NSW, 2783 | | | |
|---|---|---|--|---|---|
| 21 st March 2018 | | Wheelchair Accessible Toilet. Ceramic Tile Floor & 2m High on Walls, Timber Skirting, Architraves, Window Frames & Door, Ceramic Toilet & Sink & Plasterboard Ceiling | No Sample Taken No Asbestos Containing Materials Sighted 79 | A5 | N/A |

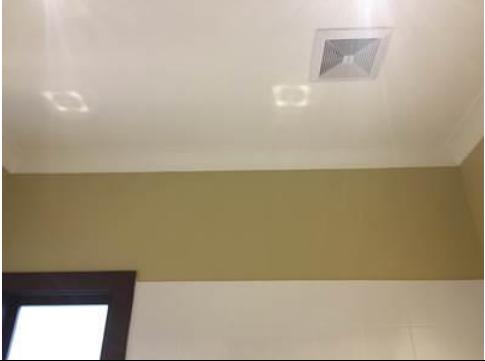
| ASBESTOS MATERIALS REGISTER | | ASSET: Lawson Mechanics Institute, 284 Great Western Highway, Lawson, NSW, 2783 | | | |
|---|---|---|--|---|---|
| 21 st March 2018 | | Wheelchair Accessible Toilet. Wall Linings Fibre Cement Sheet | Sample #B18109S01 No Asbestos Detected 80 | A5 | N/A |

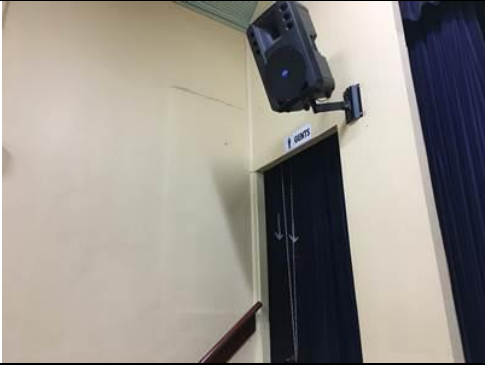
| ASBESTOS MATERIALS REGISTER | | ASSET: Lawson Mechanics Institute, 284 Great Western Highway, Lawson, NSW, 2783 | | | |
|---|---|---|--|---|---|
| 21 st March 2018 | | Main Hall. Eastern Wall Plasterboard Infill Above Stage Stairs. 82 | No Sample Taken No Asbestos Containing Materials Sighted | A5 | N/A |

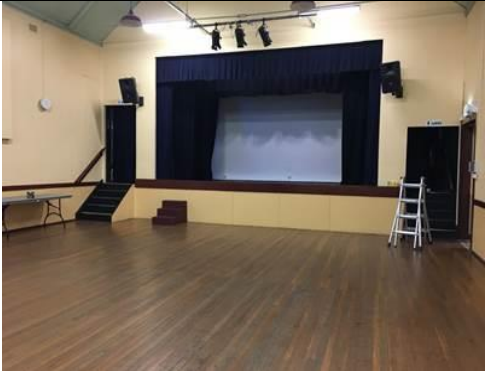
| ASBESTOS MATERIALS REGISTER | | ASSET: Lawson Mechanics Institute, 284 Great Western Highway, Lawson, NSW, 2783 | | | |
|---|---|---|--|---|---|
| 21 st March 2018 | | Main Hall. Southern Wall Decorative Timber Panelled Wall, Timber Panels to Below Stage Walls, Timber Stairs and Railings. | No Sample Taken No Asbestos Containing Materials Sighted 83 | A5 | N/A |

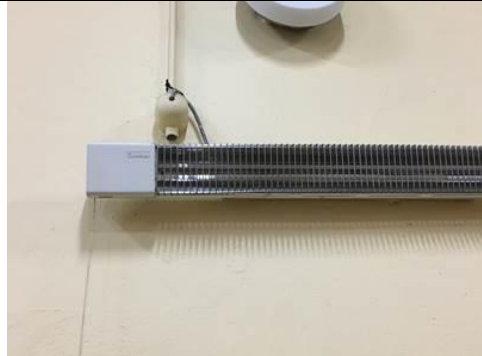
| ASBESTOS MATERIALS REGISTER | | ASSET: Lawson Mechanics Institute, 284 Great Western Highway, Lawson, NSW, 2783 | | | |
|---|---|---|---|---|---|
| 21 st March 2018 | | Main Hall. Six Bakelite Fittings on Eastern & Western Walls. 85 | No Sample Taken Assume Contains Asbestos | A4 | Good Condition Accessible to Tradespeople Refer to Asbestos Management Plan |

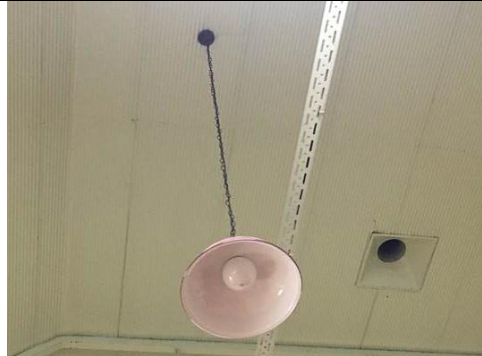
| ASBESTOS MATERIALS REGISTER | | ASSET: Lawson Mechanics Institute, 284 Great Western Highway, Lawson, NSW, 2783 | | | |
|---|---|---|---|---|---|
| 21 st March 2018 | | Main Hall. Six Bakelite Light Fittings to Ceiling. 86 | No Sample Taken Assume Contains Asbestos | A4 | Good Condition Accessible to Tradespeople Refer to Asbestos Management Plan |

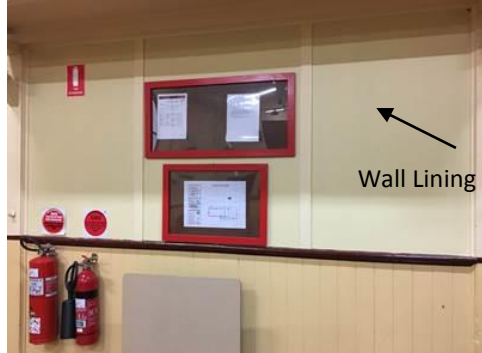
| ASBESTOS MATERIALS REGISTER | | ASSET: Lawson Mechanics Institute, 284 Great Western Highway, Lawson, NSW, 2783 | | | |
|---|---|---|---|---|---|
| 21 st March 2018 | | Audio Visual Store Room. Exterior Upper Wall Fibre Cement Sheet 87 | Sample #B18109S02 No Asbestos Detected | A5 | N/A |

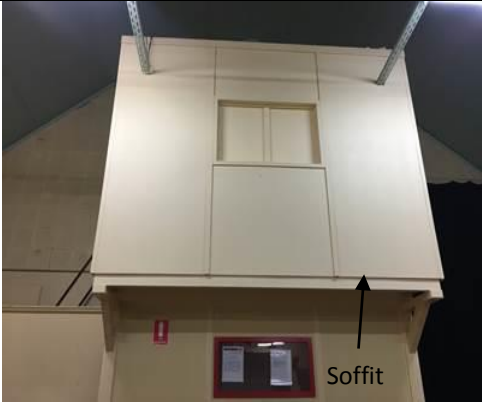
| ASBESTOS MATERIALS REGISTER | | ASSET: Lawson Mechanics Institute, 284 Great Western Highway, Lawson, NSW, 2783 | | | |
|---|---|--|--|---|---|
| 21 st March 2018 | | Audio Visual Room. Compressed Timber to Upper Level of Audio Visual Room - Exterior Soffit Fibre Cement Sheet. West and East | Assumed Positive 88 | A4 | Good Condition Accessible to Tradespeople Refer to Asbestos Management Plan |

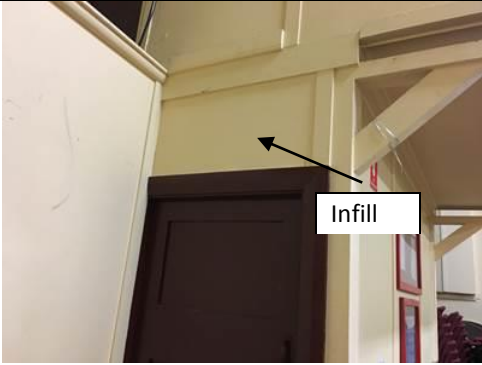
| ASBESTOS MATERIALS REGISTER | | ASSET: Lawson Mechanics Institute, 284 Great Western Highway, Lawson, NSW, 2783 | | | |
|---|---|--|--|---|---|
| 21 st March 2018 | | Audio Visual Room. Infill Panel Above East and West Doors. Fibre Cement Sheet. | No Asbestos Detected 89 | A5 | Clearance Certificate JMB 4/1/2020 HPE# 20/1887 |

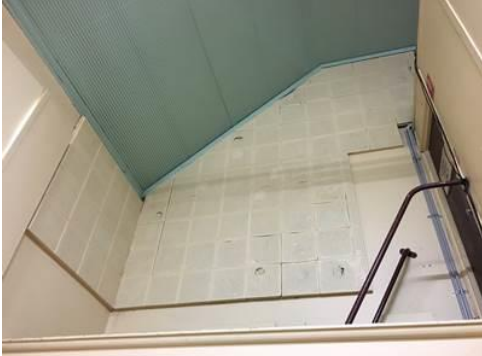
| ASBESTOS MATERIALS REGISTER | | ASSET: Lawson Mechanics Institute, 284 Great Western Highway, Lawson, NSW, 2783 | | | |
|---|---|--|--|---|---|
| 21 st March 2018 | | Main Hall. Acoustic Panelling to North Wall. Approximately 30m ² | Sample #B18109S04 No Asbestos Detected 90 | A5 | N/A |

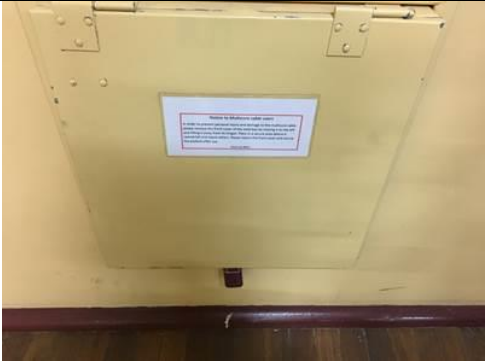
| ASBESTOS MATERIALS REGISTER | | ASSET: Lawson Mechanics Institute, 284 Great Western Highway, Lawson, NSW, 2783 | | | |
|---|---|--|---|---|--|
| 21 st March 2018 | | Main Hall. North Wall Audio Visual Box. | No Sample Taken No Asbestos Containing Material Sighted 91 | A5 | N/A |

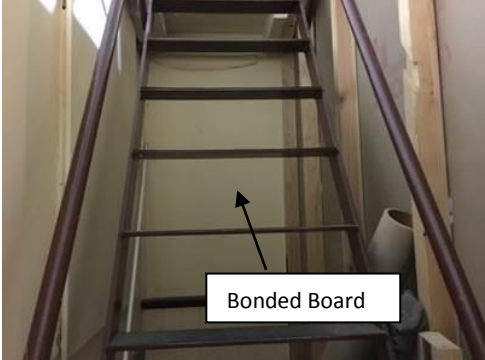
| ASBESTOS MATERIALS REGISTER | | ASSET: Lawson Mechanics Institute, 284 Great Western Highway, Lawson, NSW, 2783 | | | |
|---|---|--|---|---|--|
| 21 st March 2018 | | Main Hall. Stairwell to Upper Level of Audio Visual Room. North Wall Cement with Plasterboard Infills, South Wall Plasterboard, Bonded Board East Wall, Steel Staircase, Timber Cover Strips & Flooring. | No Asbestos Detected 92 | A5 | Clearance Certificate JMB 4/1/2020 HPE# 20/1887 |

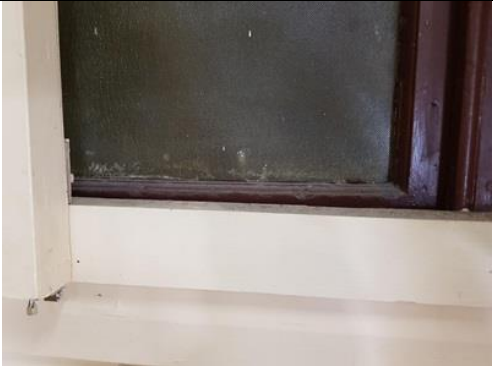
| ASBESTOS MATERIALS REGISTER | | ASSET: Lawson Mechanics Institute, 284 Great Western Highway, Lawson, NSW, 2783 | | | |
|---|--|---|--|---|---|
| 21 st March 2018 | | Main Hall. Window Mastic on all Hall Windows | Sample #B18109S05 No Asbestos Detected 94 | A5 | N/A |

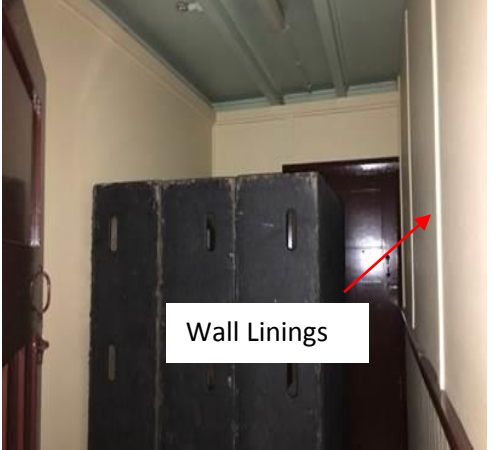
| ASBESTOS MATERIALS REGISTER | | ASSET: Lawson Mechanics Institute, 284 Great Western Highway, Lawson, NSW, 2783 | | | |
|---|--|---|--|---|---|
| 21 st March 2018 | Wall Linings | AV Room Store– Lower Level. Timber Floor, Timber Skirting & Architraves, Timber Wall Panelling to 1.3m, Northern Plasterboard Wall, Compressed Timber Ceiling – Wall Linings Fibre Cement Sheet Approximately 10m ² | Sample #B18109S17 No Asbestos Detected 95 | A5 | N/A |

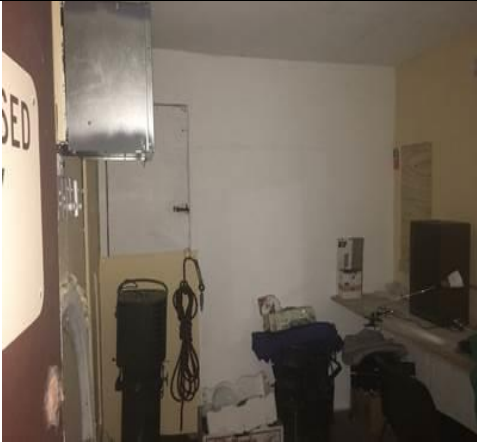
| ASBESTOS MATERIALS REGISTER | | ASSET: Lawson Mechanics Institute, 284 Great Western Highway, Lawson, NSW, 2783 | | | |
|---|---|---|--|---|---|
| 5 th April 2018 | | AV Room – Upper Level. Northern Wall Rendered Cement, West, East & South Walls Aluminium Sheeting, Timber & Masonite Infills, Compressed Timber Desk & Window Frames, Aluminium Ceiling & Floor. | No Sample Taken. No Asbestos Containing Materials Sighted. 97 | A5 | N/A |

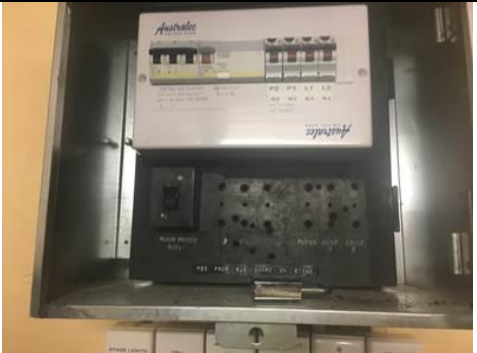
| ASBESTOS MATERIALS REGISTER | | ASSET: Lawson Mechanics Institute, 284 Great Western Highway, Lawson, NSW, 2783 | | | |
|---|---|---|--|---|---|
| 5 th April 2018 | | AV Room – Upper Level. North Wall Electrical Bakelite Backing Board. Approximately 0.5m ² | No Sample Taken. Assume Contains Asbestos. 98 | A4 | Good Condition Accessible to Tradespeople Refer to Asbestos Management Plan |

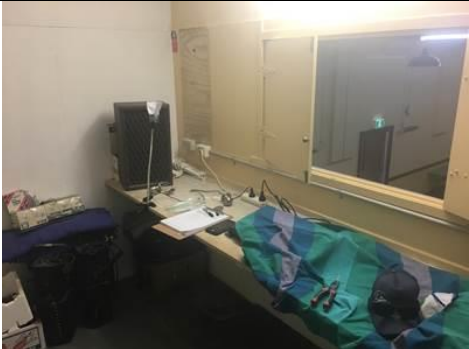
| ASBESTOS MATERIALS REGISTER | | ASSET: Lawson Mechanics Institute, 284 Great Western Highway, Lawson, NSW, 2783 | | | |
|---|---|---|--|---|---|
| 5 th April 2018 | | AV Room – Upper Level. Wall Insulation in Southern Wall. | Sample #B18109S27 No Asbestos Detected. 100 | A5 | N/A |

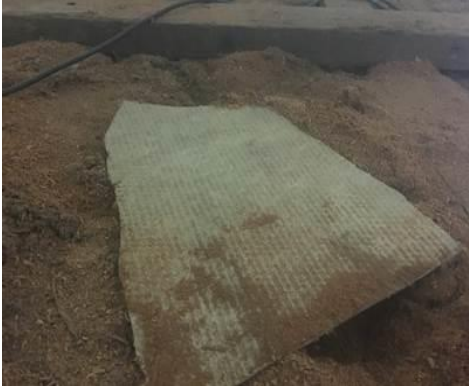
| ASBESTOS MATERIALS REGISTER | | ASSET: Lawson Mechanics Institute, 284 Great Western Highway, Lawson, NSW, 2783 | | | |
|---|---|---|--|---|---|
| 5 th April 2018 | | AV Room – Roof Exposed Timber Supports, Chipboard Insulation Fibre Cement Sheet Approximately 0.5m ² | No Asbestos Detected 101 | A5 | Cleared by ART 5/042018 Ceiling Removed 4/1/2020 Clearance Certificate JMB 4/1/2020 HPE# 20/1887 |

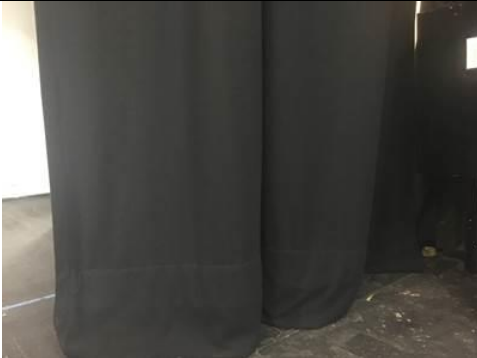
| ASBESTOS MATERIALS REGISTER | | ASSET: Lawson Mechanics Institute, 284 Great Western Highway, Lawson, NSW, 2783 | | | |
|---|---|---|--|---|---|
| 5 th April 2018 | | Stage Area. Black Stage Curtains. | Sample #B18109S23 No Asbestos Detected. 103 | A5 | N/A |

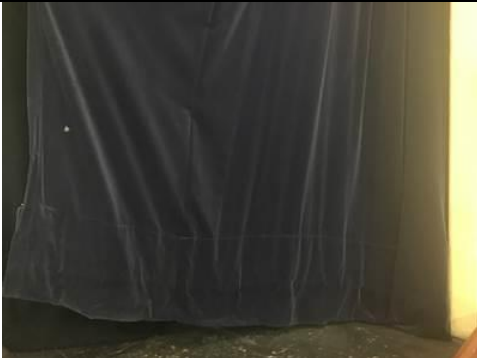
| ASBESTOS MATERIALS REGISTER | | ASSET: Lawson Mechanics Institute, 284 Great Western Highway, Lawson, NSW, 2783 | | | |
|---|---|---|--|---|---|
| 5 th April 2018 | | Stage Area. Blue Stage Curtains. | Sample #B18109S24 No Asbestos Detected. 104 | A5 | N/A |

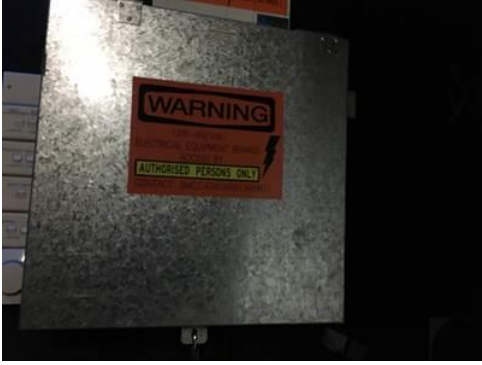
| ASBESTOS MATERIALS REGISTER | | ASSET: Lawson Mechanics Institute, 284 Great Western Highway, Lawson, NSW, 2783 | | | |
|---|--|---|---|---|---|
| 21 st March 2018 | | Stage Area Eastern Wall Electrical Backing Board. Locked, No Access Approximately 0.5m ² | No Asbestos Detected 106 | A5 | N/A |

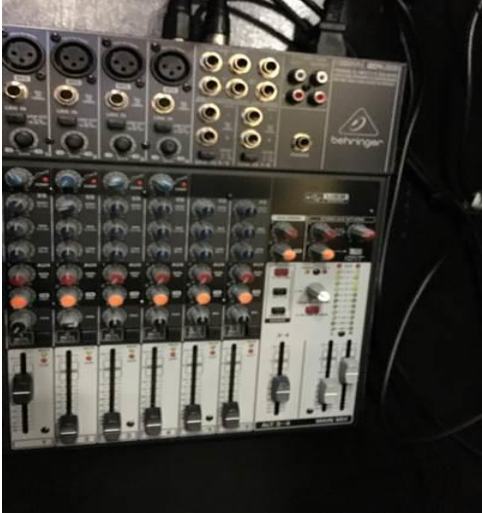
| ASBESTOS MATERIALS REGISTER | | ASSET: Lawson Mechanics Institute, 284 Great Western Highway, Lawson, NSW, 2783 | | | |
|---|--|---|---|---|---|
| 21 st March 2018 | | Stage. Western Wall Electrical Panel Backing Board | No Sample Taken. No Asbestos Material Sighted. 107 | A5 | N/A |

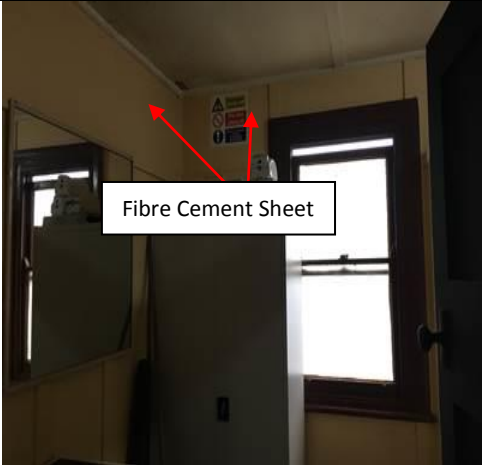
| ASBESTOS MATERIALS REGISTER | | ASSET: Lawson Mechanics Institute, 284 Great Western Highway, Lawson, NSW, 2783 | | | |
|---|--|---|--|---|--|
| 21 st March 2018 | <p>Fibre Cement Sheet</p> | Male Toilets. Timber & Concrete Floor, Timber Skirting, Architraves & Window Frames. Western Wall Cement, Timber Cover Strips & Masonite Walls to North & East to 2m. Fibre Cement Sheet Above Masonite. | No Asbestos Detected 108 | A5 | Clearance Certificate JMB 4/1/2020 HPE# 20/1887 |

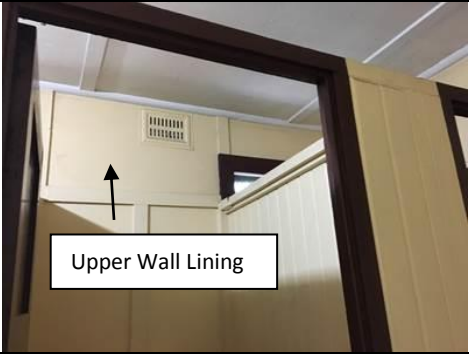
| ASBESTOS MATERIALS REGISTER | | ASSET: Lawson Mechanics Institute, 284 Great Western Highway, Lawson, NSW, 2783 | | | |
|---|--|---|--|---|--|
| 21 st March 2018 | <p>Upper Wall Lining</p> | Male Toilets. Upper Wall Lining Fibre Cement Sheet Approximately 10m ² | No Asbestos Detected 109 | A5 | Clearance Certificate JMB 4/1/2020 HPE# 20/1887 |

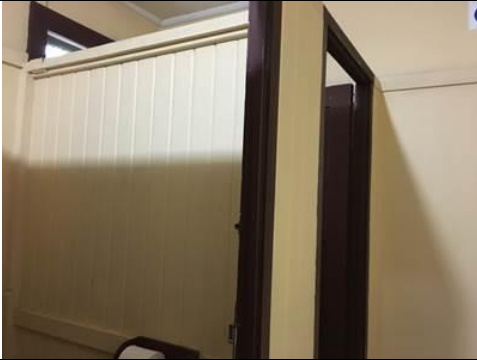
| ASBESTOS MATERIALS REGISTER | | ASSET: Lawson Mechanics Institute, 284 Great Western Highway, Lawson, NSW, 2783 | | | |
|---|---|--|--|---|---|
| 21 st March 2018 | | Male Toilets. Timber Toilet Partitions and Doors. 1017 | No Sample Taken No Asbestos Containing Material Sighted | A5 | N/A |

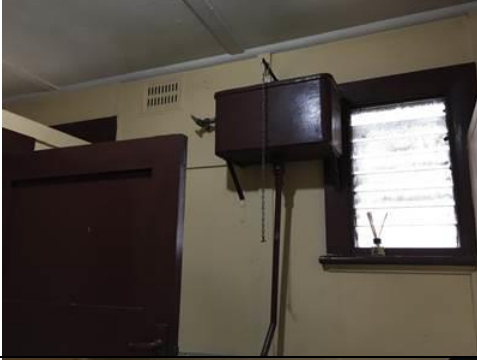
| ASBESTOS MATERIALS REGISTER | | ASSET: Lawson Mechanics Institute, 284 Great Western Highway, Lawson, NSW, 2783 | | | |
|---|---|--|--|---|---|
| 21 st March 2018 | | Male Toilets. Cement Urinal with Stainless Steel Catchment & Steel Cistern 1018 | No Sample Taken No Asbestos Containing Material Sighted | A5 | N/A |

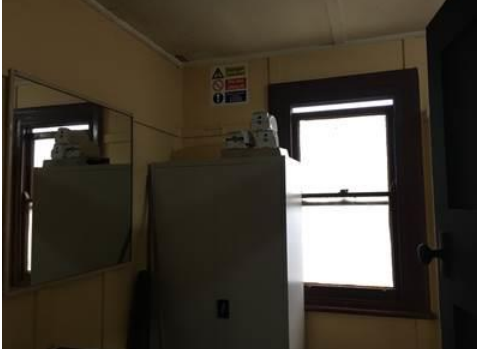
| ASBESTOS MATERIALS REGISTER | | ASSET: Lawson Mechanics Institute, 284 Great Western Highway, Lawson, NSW, 2783 | | | |
|---|---|--|--|---|---|
| 21 st March 2018 | | Male Toilets. Window Mastic. 1019 | Similar to Sample #B18109S05 No Asbestos Detected | A5 | N/A |

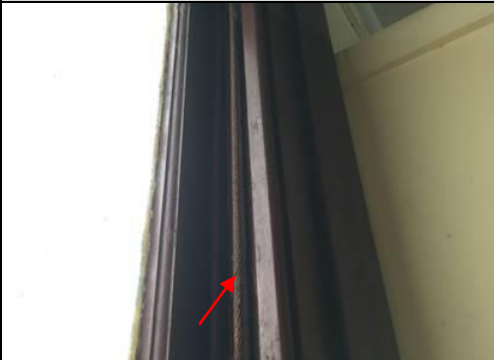
| ASBESTOS MATERIALS REGISTER | | ASSET: Lawson Mechanics Institute, 284 Great Western Highway, Lawson, NSW, 2783 | | | |
|---|---|---|---|---|---|
| 21 st March 2018 | | Male Toilets. Window Sash. 1020 | Sample #B18109S08 No Asbestos Detected | A5 | N/A |

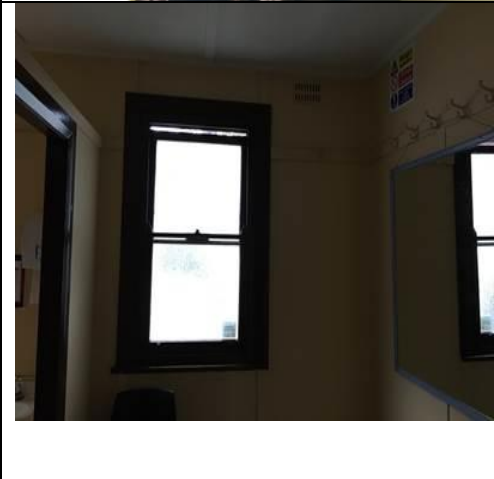
| ASBESTOS MATERIALS REGISTER | | ASSET: Lawson Mechanics Institute, 284 Great Western Highway, Lawson, NSW, 2783 | | | |
|---|---|---|---|---|---|
| 21 st March 2018 | | Female Toilets. Timber and Concrete Floor, Timber Skirting, Architraves, cover Strips & Window Frames, Eastern Wall Two-thirds Concrete – Window Mastic and Window Sash 1021 | Mastic Similar to Sample #B18109S05 No Asbestos Detected Window Sash Similar to Sample #B18109S08 No Asbestos Detected | A5 | N/A |

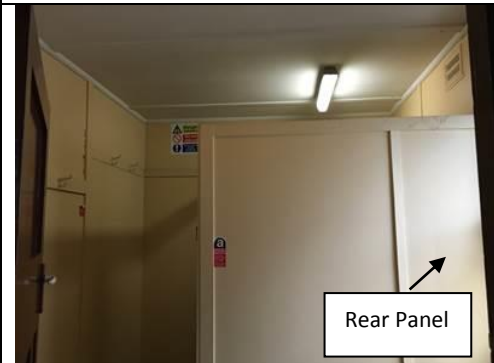
| ASBESTOS MATERIALS REGISTER | | ASSET: Lawson Mechanics Institute, 284 Great Western Highway, Lawson, NSW, 2783 | | | |
|---|---|---|---|---|---|
| 21 st March 2018 | | Female Toilets. Rear Partition Panel to 1 st Cubicle Fibre Cement Sheet Approximately 1m ² 1022 | No Asbestos Detected | A5 | Clearance Certificate JMB 4/1/2020 HPE# 20/1887 |

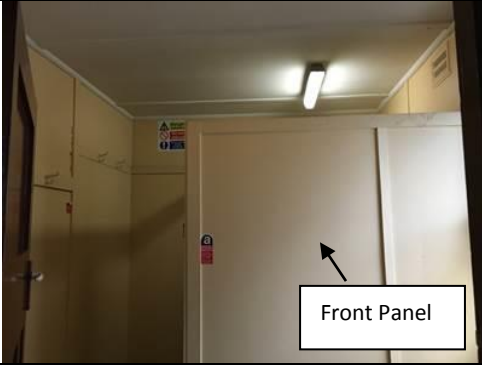
| ASBESTOS MATERIALS REGISTER | | ASSET: Lawson Mechanics Institute, 284 Great Western Highway, Lawson, NSW, 2783 | | | |
|---|---|---|---|---|---|
| 21 st March 2018 | | Female Toilets. Front Partition Panel to 1 st Cubicle Fibre Cement Sheet Approximately 2m ² 801 | Sample #B18109S10 No Asbestos Detected | A5 | N/A |

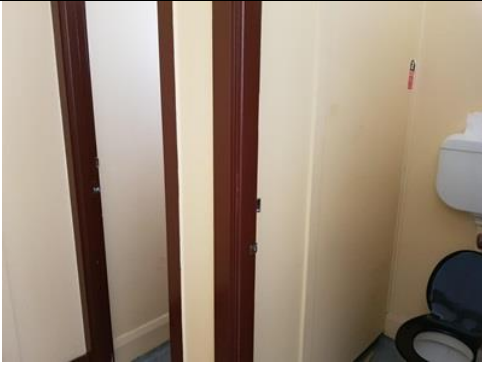
| ASBESTOS MATERIALS REGISTER | | ASSET: Lawson Mechanics Institute, 284 Great Western Highway, Lawson, NSW, 2783 | | | |
|---|---|---|---|---|---|
| 21 st March 2018 | | Female Toilets. All Remaining Partitions, Including Entry Partition Fibre Cement Sheet Approximately 20m ² 802 | | A5 | Clearance Certificate JMB 4/1/2020 HPE# 20/1887 |

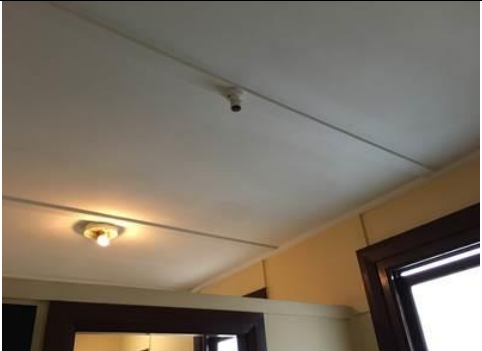
| ASBESTOS MATERIALS REGISTER | | ASSET: Lawson Mechanics Institute, 284 Great Western Highway, Lawson, NSW, 2783 | | | |
|---|---|---|---|---|---|
| 21 st March 2018 | | Female Toilets. Ceiling Lining Fibre Cement Sheet Approximately 16m ² 803 | | A5 | Clearance Certificate JMB 4/1/2020 HPE# 20/1887 |

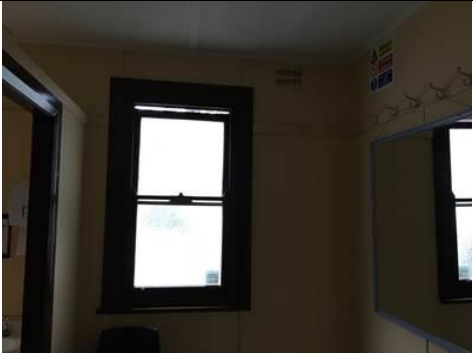
| ASBESTOS MATERIALS REGISTER | | ASSET: Lawson Mechanics Institute, 284 Great Western Highway, Lawson, NSW, 2783 | | | |
|---|---|--|--|---|--|
| 21 st March 2018 | | Female Toilets. Wall Linings Fibre Cement Sheet 804 | | A5 | Clearance Certificate JMB 4/1/2020 HPE# 20/1887 |

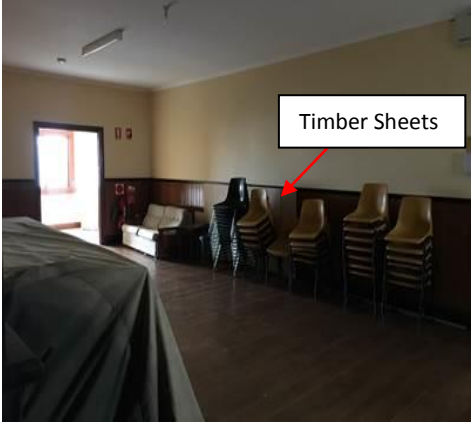
| ASBESTOS MATERIALS REGISTER | | ASSET: Lawson Mechanics Institute, 284 Great Western Highway, Lawson, NSW, 2783 | | | |
|---|---|--|--|---|--|
| 21 st March 2018 | | Supper Room. Timber Flooring, Timber Architraves, Skirtings & Doors, Timber Panelling to 1.5m, Northern Cement Rendered Wall, Plasterboard Walls & Ceilings, Compressed Timber Sheets Stacked Against Southern Wall. | No Sample Taken. No Asbestos Containing Material Sighted. 805 | A5 | N/A |

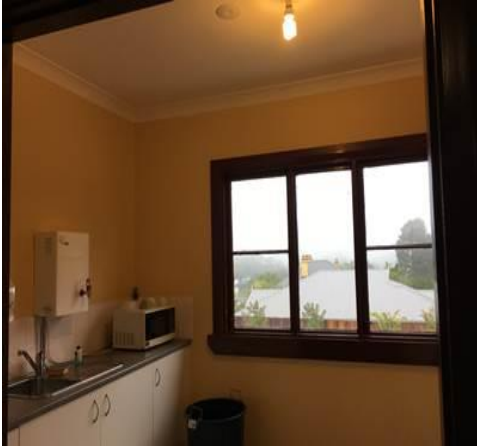
| ASBESTOS MATERIALS REGISTER | | ASSET: Lawson Mechanics Institute, 284 Great Western Highway, Lawson, NSW, 2783 | | | |
|---|---|---|--|---|---|
| 21 st March 2018 | | Kitchen. Plasterboard Walls & Ceiling, Laminex Kitchen with Laminate Benchtop, Ceramic Splashback, Timber Skirting, Architraves & Window Frames – Window Mastic | Similar to Sample #B18109S05 No Asbestos Detected 807 | A5 | N/A |

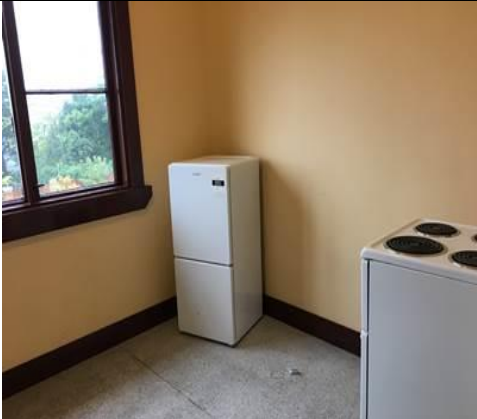
| ASBESTOS MATERIALS REGISTER | | ASSET: Lawson Mechanics Institute, 284 Great Western Highway, Lawson, NSW, 2783 | | | |
|---|---|---|--|---|---|
| 21 st March 2018 | | Kitchen. Vinyl Flooring Approximately 10m ² | Sample #B18109S11 No Asbestos Detected 808 | A5 | N/A |

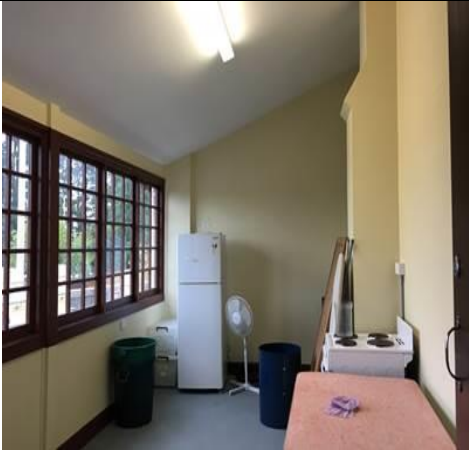
| ASBESTOS MATERIALS REGISTER | | ASSET: Lawson Mechanics Institute, 284 Great Western Highway, Lawson, NSW, 2783 | | | |
|---|---|--|--|---|---|
| 21 st March 2018 | | Store Room - New Section. Concrete Floor, Timber Skirting, Architraves & Windows, Cement Western Wall, Plasterboard Walls & Ceiling, Laminex Kitchenette, Ceramic Tile Splashback & Timber Door | No Sample Taken. No Asbestos Containing Material Sighted. 809 | A5 | N/A |

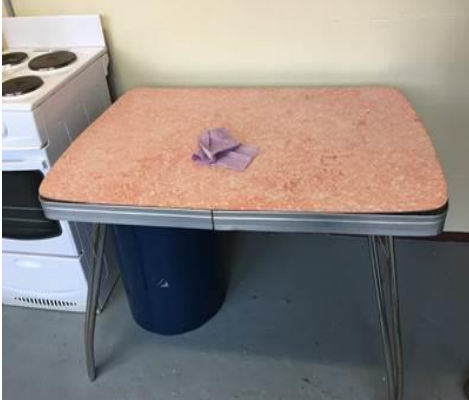
| ASBESTOS MATERIALS REGISTER | | ASSET: Lawson Mechanics Institute, 284 Great Western Highway, Lawson, NSW, 2783 | | | |
|---|---|--|--|---|---|
| 21 st March 2018 | | Store Room – New Section. Tilux Table Top. Approximately 1.5m ² | No Sample Taken. Potentially Contains Asbestos Materials. 810 | A4 | Good Condition Accessible to Tradespeople Refer to Asbestos Management Plan |

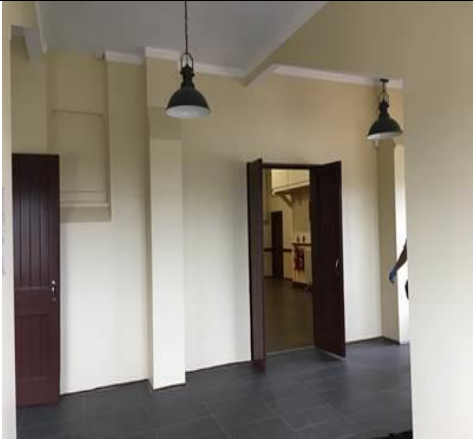
| ASBESTOS MATERIALS REGISTER | | ASSET: Lawson Mechanics Institute, 284 Great Western Highway, Lawson, NSW, 2783 | | | |
|---|---|---|---|---|---|
| 21 st March 2018 | | Eastern Entrance. Tile Floor, Timber Skirting, Architraves & Window Frames, Timber Doors, Western Cement Wall, Northern & Eastern Plasterboard Walls, Plasterboard Ceiling | No Sample Taken. No Asbestos Containing Material Sighted 811 | A5 | N/A |

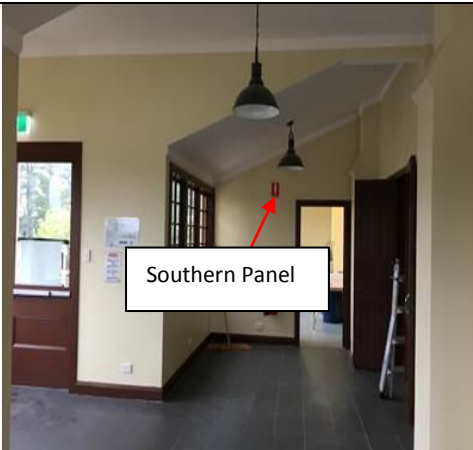
| ASBESTOS MATERIALS REGISTER | | ASSET: Lawson Mechanics Institute, 284 Great Western Highway, Lawson, NSW, 2783 | | | |
|---|---|---|---|---|---|
| 21 st March 2018 | | Eastern Entrance. Southern Wall Lining to Store Room Approximately 9m ² | Sample #B18109S12 No Asbestos Detected 812 | A5 | N/A |

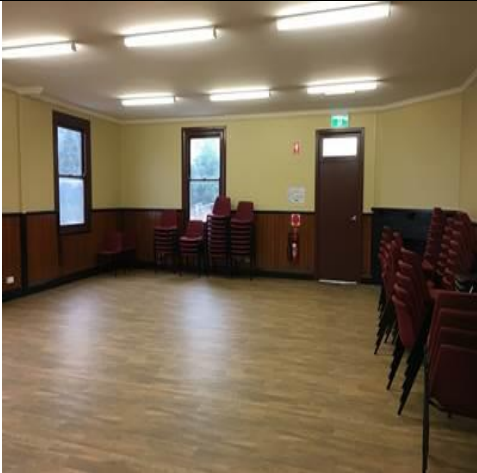
| ASBESTOS MATERIALS REGISTER | | ASSET: Lawson Mechanics Institute, 284 Great Western Highway, Lawson, NSW, 2783 | | | |
|---|---|---|--|---|---|
| 21 st March 2018 | | Billiard Room Plasterboard Walls & Ceiling, Timber Skirting, Architraves, Window Frames & Doors, Timber Panels to 1.3m, Rendered Concrete Wall Above Brick Fireplace, Linoleum on Compressed Timber Floor – Window Mastic | Similar to Sample #B18109S05 No Asbestos Detected 813 | A5 | N/A |

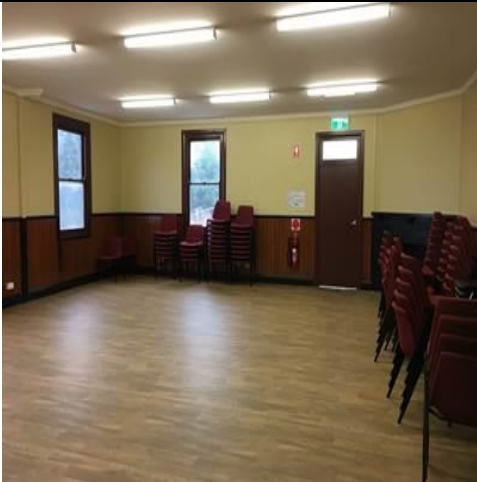
| ASBESTOS MATERIALS REGISTER | | ASSET: Lawson Mechanics Institute, 284 Great Western Highway, Lawson, NSW, 2783 | | | |
|---|---|---|--|---|---|
| 21 st March 2018 | | Billiard Room. Window Sashes | Similar to Sample #B18109S08 No Asbestos Detected 814 | A5 | N/A |

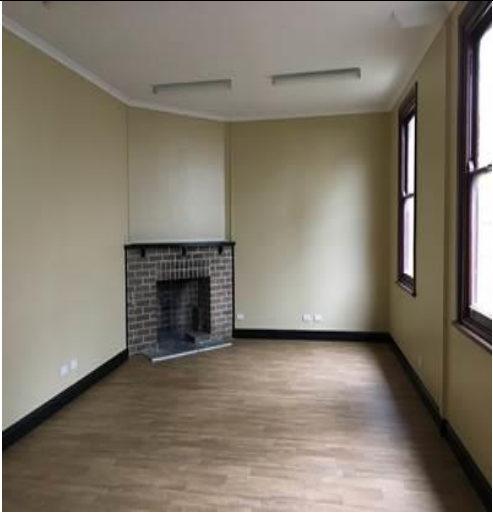
| ASBESTOS MATERIALS REGISTER | | ASSET: Lawson Mechanics Institute, 284 Great Western Highway, Lawson, NSW, 2783 | | | |
|---|---|--|--|---|---|
| 21 st March 2018 | | Library. Plasterboard Walls & Ceiling, Timber Skirting, Architraves, Window Frames & Doors, Timber Panels to 1.3m, Cement Wall Above Brick Fireplace, Linoleum on Compressed Timber Floor – Window Mastic | Similar to Sample #B18109S05 No Asbestos Detected 815 | A5 | N/A |

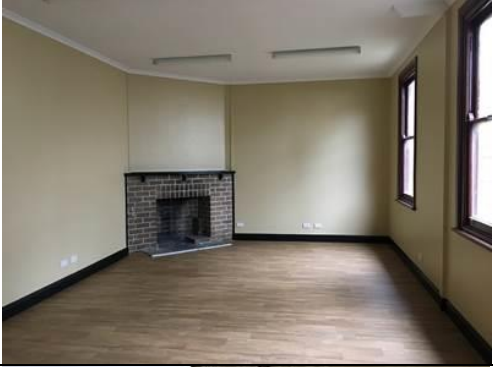
| ASBESTOS MATERIALS REGISTER | | ASSET: Lawson Mechanics Institute, 284 Great Western Highway, Lawson, NSW, 2783 | | | |
|---|---|--|--|---|---|
| 21 st March 2018 | | Library. Window Sashes | Similar to Sample #B18109S08 No Asbestos Detected 816 | A5 | N/A |

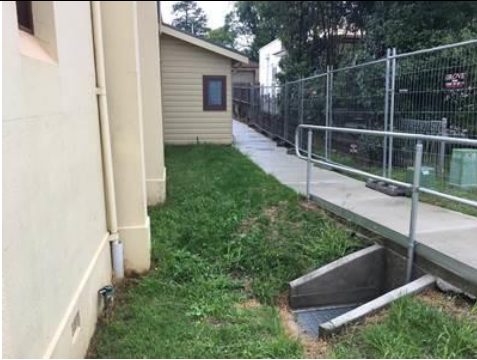
| ASBESTOS MATERIALS REGISTER | | ASSET: Lawson Mechanics Institute, 284 Great Western Highway, Lawson, NSW, 2783 | | | |
|---|---|---|--|---|---|
| 21 st March 2018 | | Western Aspect. Corrugated Iron Roof, Steel Guttering & Downpipes, Rendered Wall to Main Hall & Timber Window Frames | No Sample Taken. No Asbestos Containing Material Sighted. 818 | A5 | N/A |

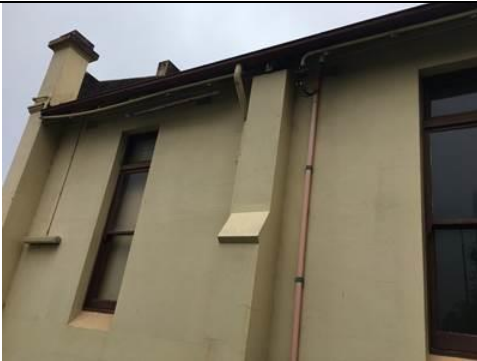
| ASBESTOS MATERIALS REGISTER | | ASSET: Lawson Mechanics Institute, 284 Great Western Highway, Lawson, NSW, 2783 | | | |
|---|---|---|--|---|---|
| 21 st March 2018 | | Western Aspect. External Window Mastic. | Sample #B18109S13 No Asbestos Detected 819 | A5 | N/A |

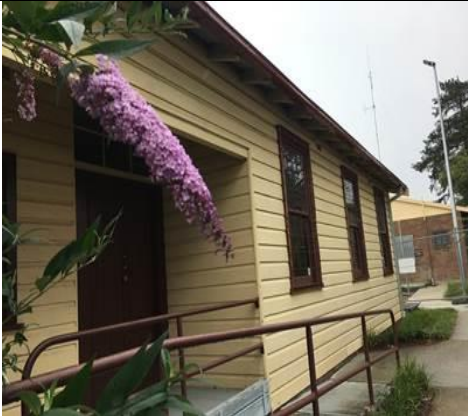
| ASBESTOS MATERIALS REGISTER | | ASSET: Lawson Mechanics Institute, 284 Great Western Highway, Lawson, NSW, 2783 | | | |
|---|---|---|---|---|---|
| 21 st March 2018 | | Western Aspect. Corrugated Iron Roof, Steel Guttering, PVC Downpipes, Timber Weatherboards, Fascia, Trims, & Window Frames, Exposed Timber Trusses, Brick Foundation | No Sample Taken. No Asbestos Containing Material Sighted 821 | A5 | N/A |

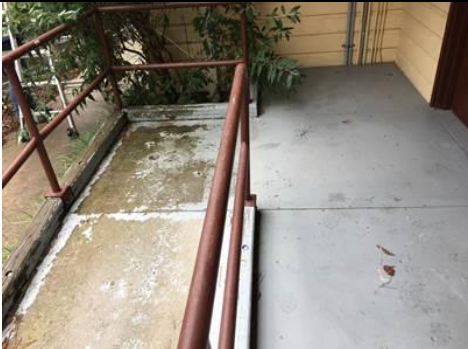
| ASBESTOS MATERIALS REGISTER | | ASSET: Lawson Mechanics Institute, 284 Great Western Highway, Lawson, NSW, 2783 | | | |
|---|---|---|---|---|---|
| 21 st March 2018 | | Western Aspect. Verandah & Ramp Flooring Fibre Cement Approximately 8m ² | Sample #B18109S14 No Asbestos Detected 822 | A5 | N/A |

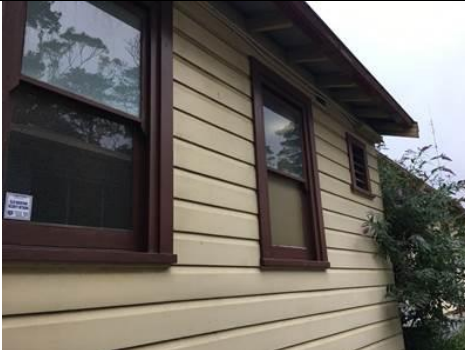
| ASBESTOS MATERIALS REGISTER | | ASSET: Lawson Mechanics Institute, 284 Great Western Highway, Lawson, NSW, 2783 | | | |
|---|---|--|--|---|---|
| 21 st March 2018 | | Western Aspect. Window Mastic. | Similar to Sample #B18109S13 No Asbestos Detected 826 | A5 | N/A |

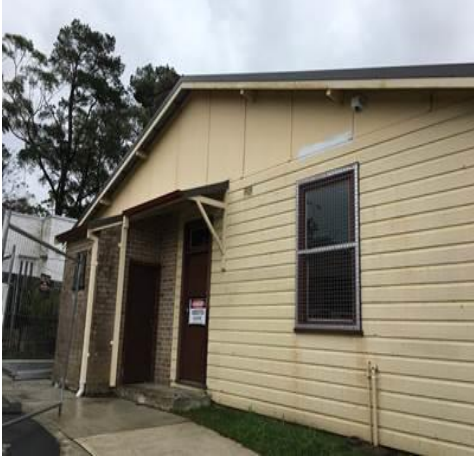
| ASBESTOS MATERIALS REGISTER | | ASSET: Lawson Mechanics Institute, 284 Great Western Highway, Lawson, NSW, 2783 | | | |
|---|---|--|--|---|---|
| 21 st March 2018 | | Southern Aspect. Corrugated Iron Roof, Timber Weatherboards, Brick Wall, Chimneys & Foundation, Timber Fascia, Steel Capping, Guttering & Downpipes, Timber Trusses, Doors & Window Frames. | No Sample Taken. No Asbestos Containing Material Sighted. 827 | A5 | N/A |

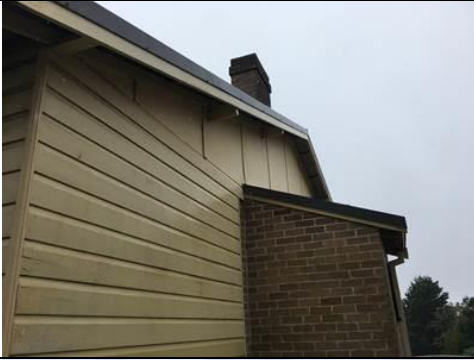
| ASBESTOS MATERIALS REGISTER | | ASSET: Lawson Mechanics Institute, 284 Great Western Highway, Lawson, NSW, 2783 | | | |
|---|---|--|--|---|---|
| 21 st March 2018 | | Southern Aspect. Gable Fibre Cement Sheet Approximately 12m ² | Sample #B18109S16 No Asbestos Detected 828 | A5 | N/A |

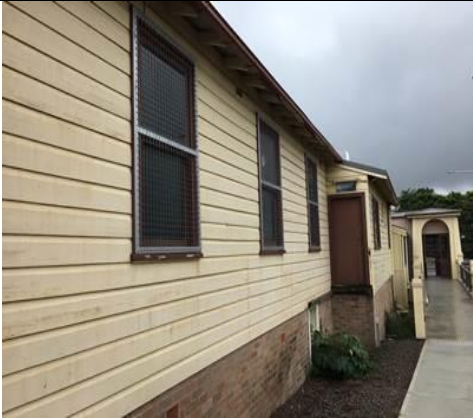
| ASBESTOS MATERIALS REGISTER | | ASSET: Lawson Mechanics Institute, 284 Great Western Highway, Lawson, NSW, 2783 | | | |
|---|---|---|--|---|---|
| 21 st March 2018 | | Eastern Aspect. Corrugated Iron Roof, Timber Weatherboards, Brick Foundation, Timber Fascia, Steel Capping, Guttering & Downpipes, Timber Trusses, Doors & Window Frames – Window Mastic | Similar to Sample #B18109S13 No Asbestos Detected 830 | A5 | N/A |

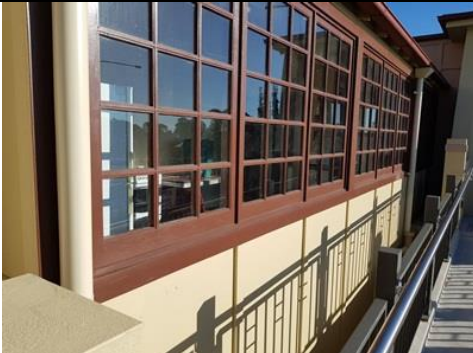
| ASBESTOS MATERIALS REGISTER | | ASSET: Lawson Mechanics Institute, 284 Great Western Highway, Lawson, NSW, 2783 | | | |
|---|---|---|--|---|---|
| 21 st March 2018 | | Eastern Aspect. External Wall Lining to New Section Fibre Cement Sheet. Approximately 20m ² | Sample #B18109S18 No Asbestos Detected 831 | A5 | N/A |

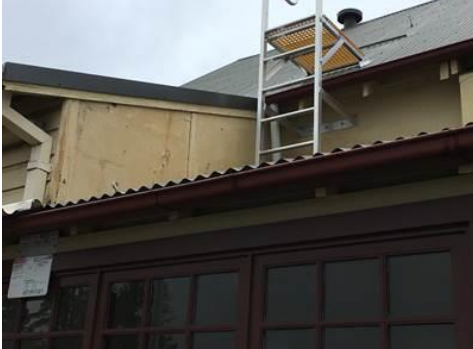
| ASBESTOS MATERIALS REGISTER | | ASSET: Lawson Mechanics Institute, 284 Great Western Highway, Lawson, NSW, 2783 | | | |
|---|---|---|--|---|---|
| 21 st March 2018 | | Eastern Aspect. North-East Facing Infill, Fibre Cement Sheet Approximately 4m ² | No Asbestos Detected 832 | A5 | |

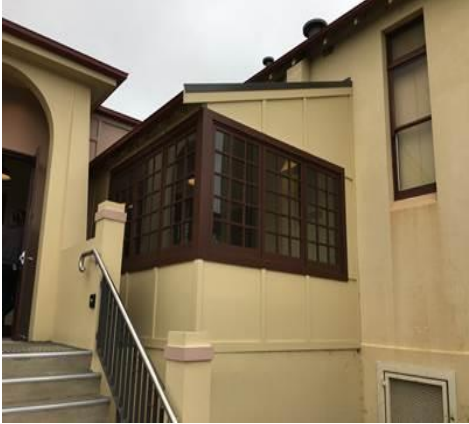
| ASBESTOS MATERIALS REGISTER | | ASSET: Lawson Mechanics Institute, 284 Great Western Highway, Lawson, NSW, 2783 | | | |
|---|---|--|---|---|---|
| 21 st March 2018 | | Northern Aspect New Section. Corrugated Iron Roof, Timber Trusses, Cover Strips & Window Frames, Cement Rendered Footings – Wall Panels Approximately 20m ² | Similar to Sample #B18109S18 No Asbestos Detected 1025 | A5 | N/A |

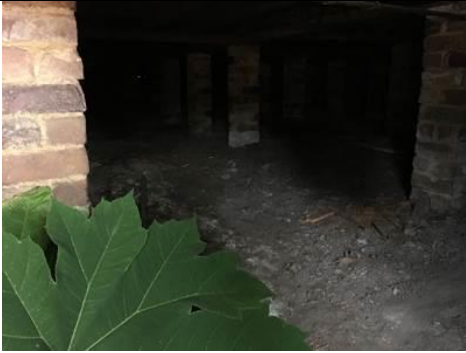
| ASBESTOS MATERIALS REGISTER | | ASSET: Lawson Mechanics Institute, 284 Great Western Highway, Lawson, NSW, 2783 | | | |
|---|---|--|--|---|--|
| 21 st March 2018 | | Subfloor Space. South-East Entrance. Timber Unfloor Timber Bearers & Joists, Brick Piers, Scattered Building & Plant Debris | N/A | | N/A |

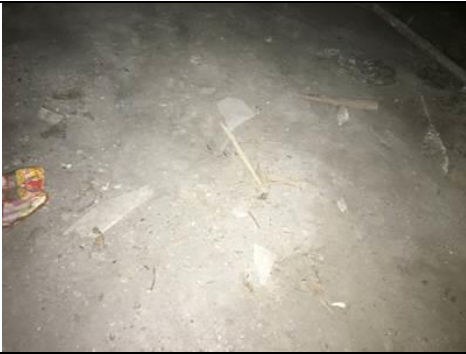
| ASBESTOS MATERIALS REGISTER | | ASSET: Lawson Mechanics Institute, 284 Great Western Highway, Lawson, NSW, 2783 | | | |
|---|---|--|--|---|--|
| 21 st March 2018 | | Subfloor Space. Scattered Fibre Cement Sheet Debris Located at Eastern Entrance. 1027 | No Asbestos Detected | A5 | Asbestos Removed Empire Contracting |

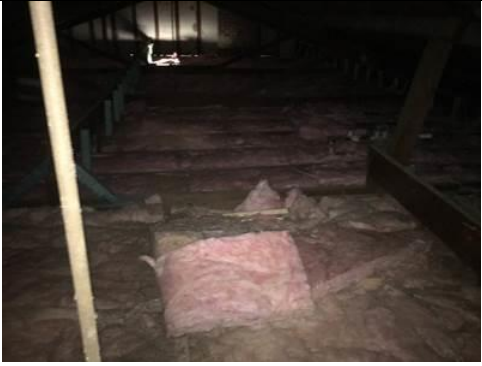
| ASBESTOS MATERIALS REGISTER | | ASSET: Lawson Mechanics Institute, 284 Great Western Highway, Lawson, NSW, 2783 | | | |
|---|---|--|---|---|---|
| 21 st March 2018 | | Roof Space. Corrugated Iron Roof, Timber Trusses, Northern Brick Wall, Southern Fibre Cement Sheet Gable & Pink Insulation Batts. | No Sample Taken. No Asbestos Containing Material Sighted 1032 | A5 | N/A |

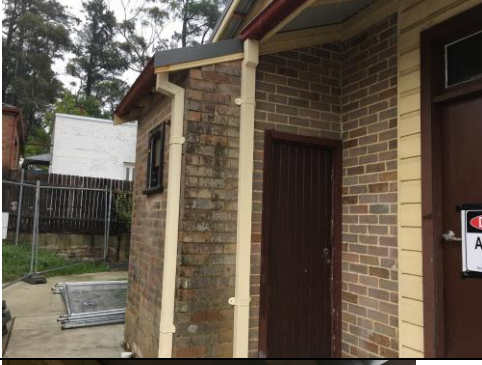
| ASBESTOS MATERIALS REGISTER | | ASSET: Lawson Mechanics Institute, 284 Great Western Highway, Lawson, NSW, 2783 | | | |
|---|---|--|---|---|---|
| 21 st March 2018 | | External Toilet. Corrugated Iron Roof, Brick Walls, Steel Downpipes, Timber Window & Door Frame, Timber Door & Cement Floor. | No Sample Taken. No Asbestos Containing Material Sighted. 1033 | A5 | N/A |

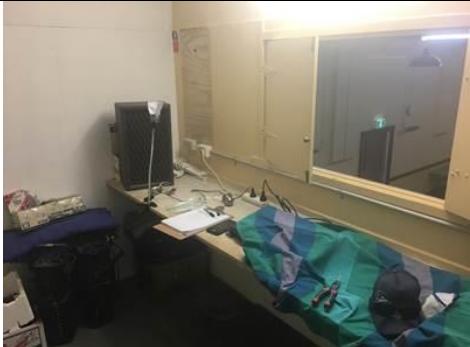
| SYNTHETIC MINERAL FIBRE REGISTER | | ASSET: Lawson Mechanics Institute, 284 Great Western Highway, Lawson, NSW, 2783 | | | |
|---|---|--|---|---|--|
| 5 th April 2018 | | AV Room – Upper Level. Wall Insulation in Southern Wall. | Visual Inspection | A4 | Bonded, Good Condition Refer to Management Plan |

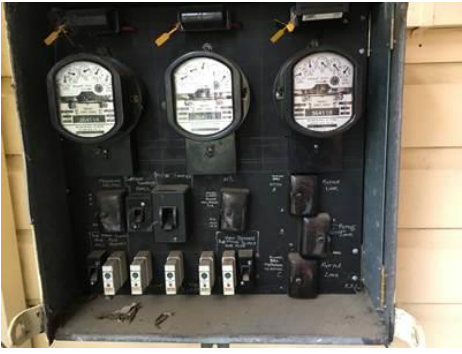
| PHENOLS REGISTER | | ASSET: Lawson Mechanics Institute, 284 Great Western Highway, Lawson, NSW, 2783 | | | |
|---|---|---|---|---|--|
| 21 st March 2018 | | External Electrical Switchboard Potential Bakelite Backing Board | Visual Inspection Assume Phenol Positive | A4 | Good Condition Accessible to Tradespeople Refer to Management Plan |

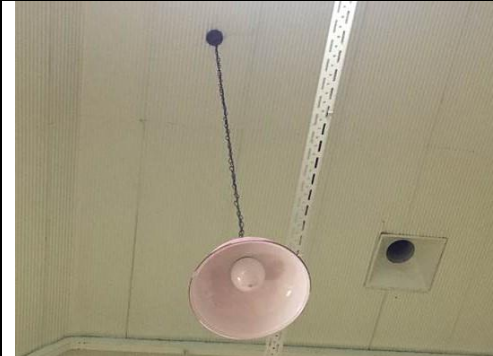
| PHENOLS REGISTER | | ASSET: Lawson Mechanics Institute, 284 Great Western Highway, Lawson, NSW, 2783 | | | |
|---|---|---|---|---|--|
| 21 st March 2018 | | Main Hall. Six (6) Potential Bakelite Light Fittings to Ceiling. | Visual Inspection Assume Phenol Positive | A4 | Good Condition Accessible to Tradespeople Refer to Management Plan |
