# **Asbestos Register & Management Plan**

**Hazardous Materials Team  
Glenbrook Preschool**

## Asbestos Register and Management Plan

The site is located: 15 Deane Street, Glenbrook

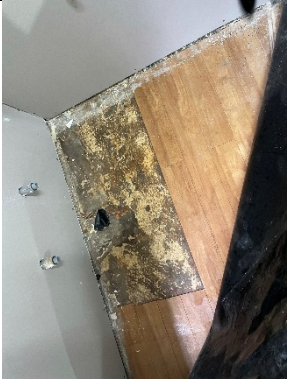
Reference Number Int / Ext Floor Specific Location	Photographs
3432 Orange linoleum throughout whole interior of building – underneath modern vinyl and tiles

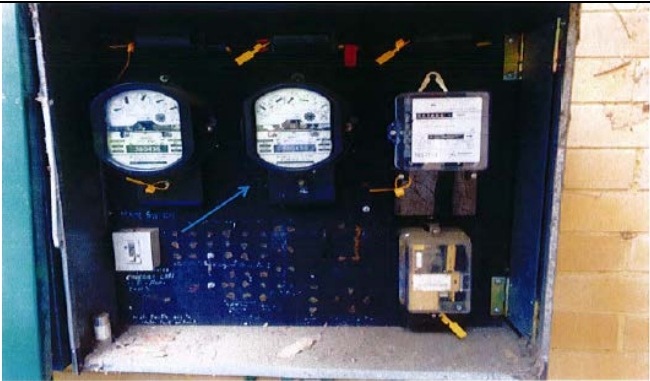
1465 Electrical Box (north)

Exterior														
1465	Airsafe 25132-62-3	Electrical Box (North)	Bituminous Backing Board	0.3m2	Positive	2	1	1	1	5	A4	Yes		Dec 2025

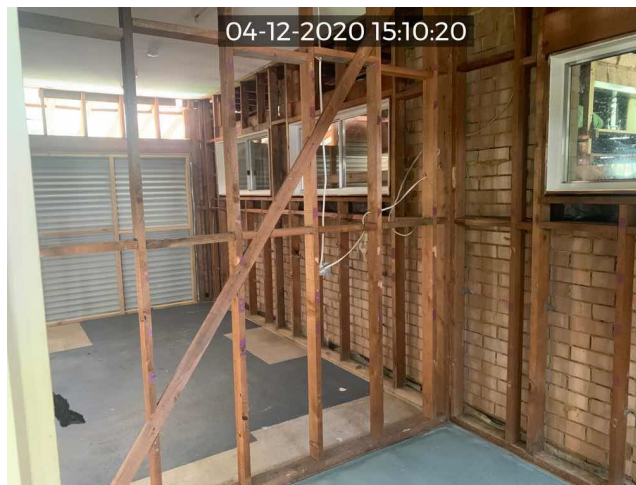
Stage 2 : Walls following removal work within storage rooms

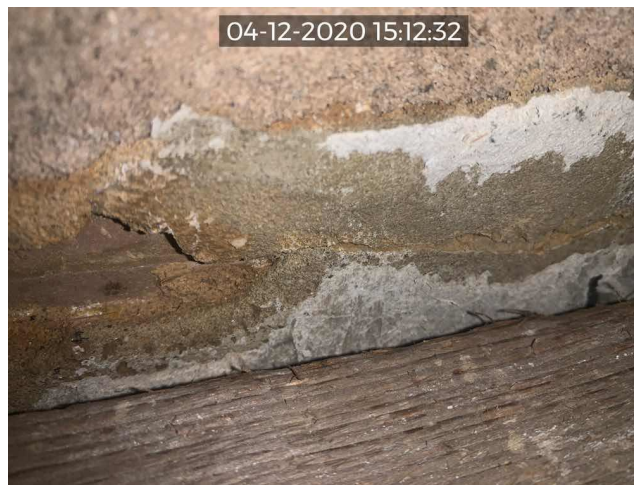
Stage 2 : Asbestos cement to back side of bathroom plinth

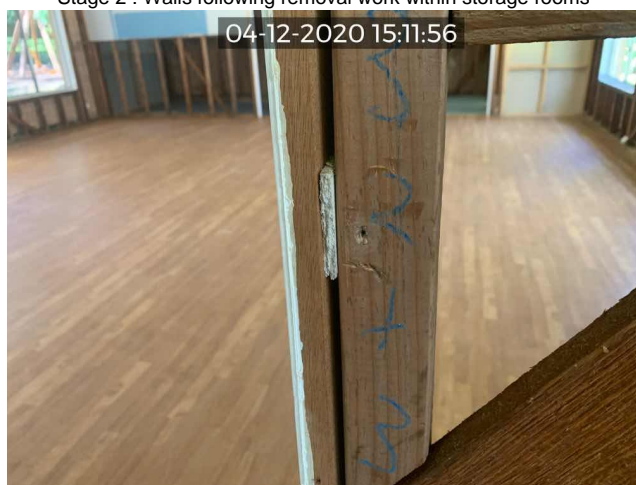
Stage 2 : Example of Packers to all doors

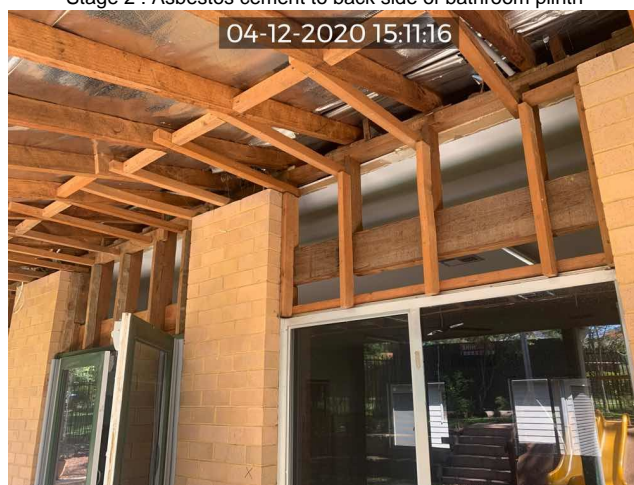
Stage 2 : Awning infill panels following removal work

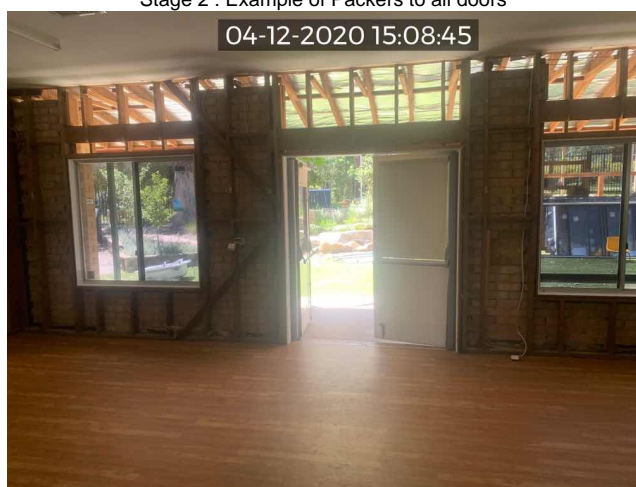
Stage 2 : Walls following removal within classroom

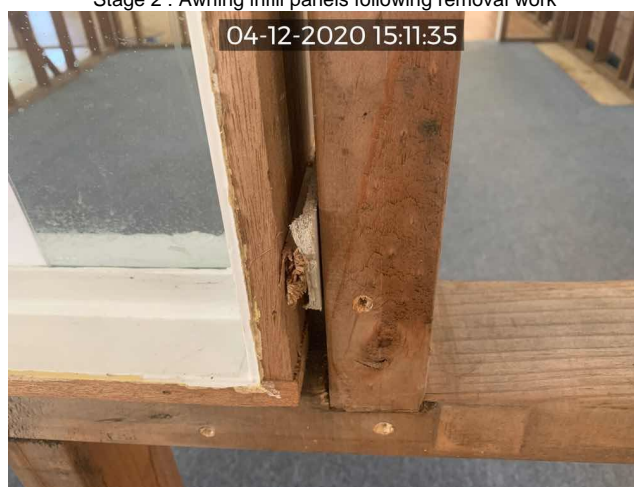
Stage 2 : Example of Packers between all windows

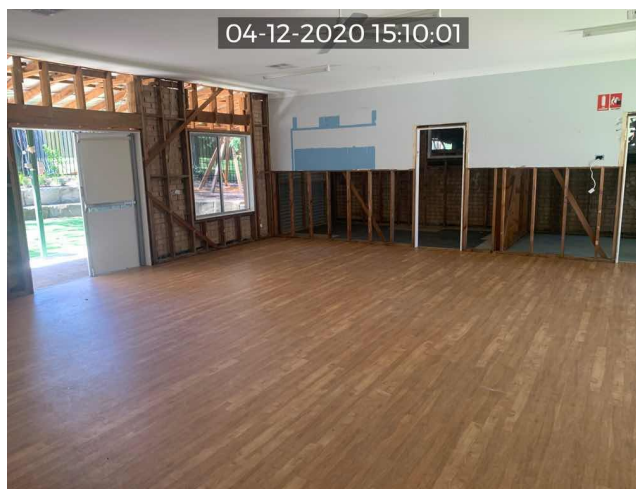
Stage 2 : Walls following removal work within classroom

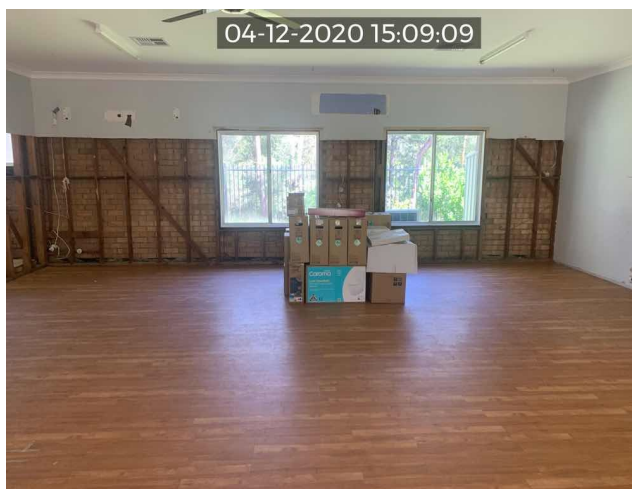
Stage 2 : Walls following removal work within classroom

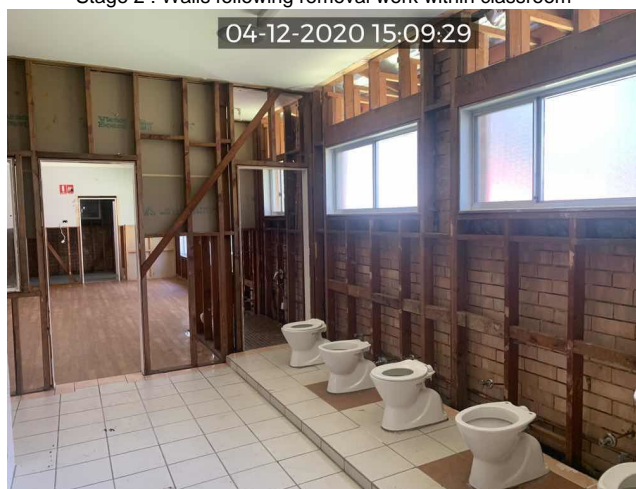
Stage 2 : Walls following removal work within toilet and shower

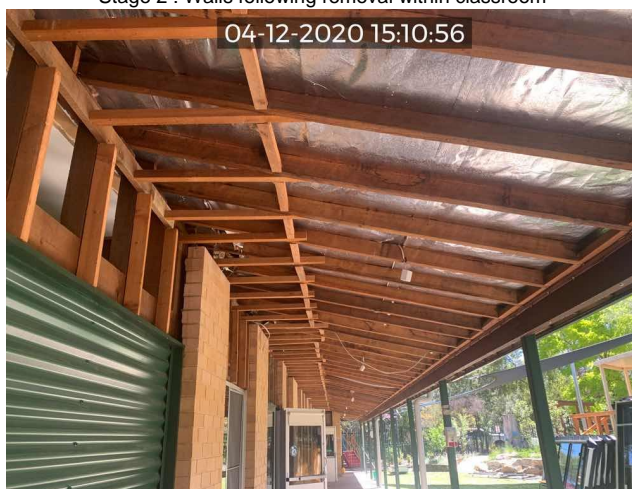
Stage 2 : Awning ceiling following removing work

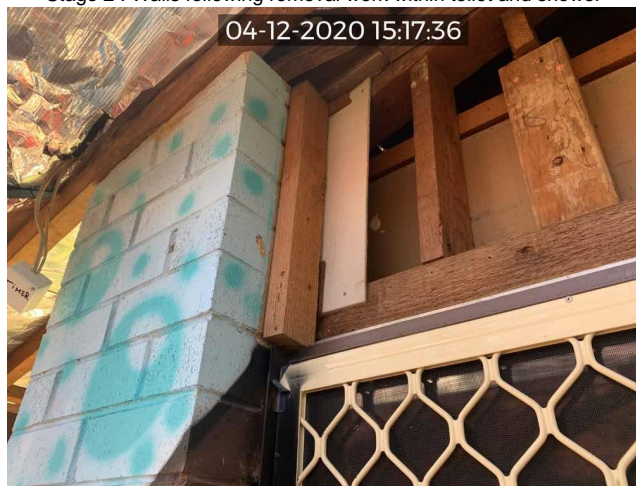
Stage 4 : Trapped asbestos cement still remains to the north-west corner eaves

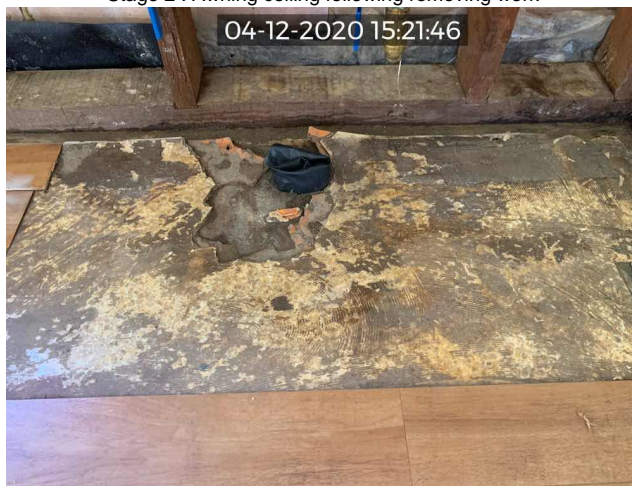
Stage 4 : Potential asbestos final below modern vinyl and tiles throughout

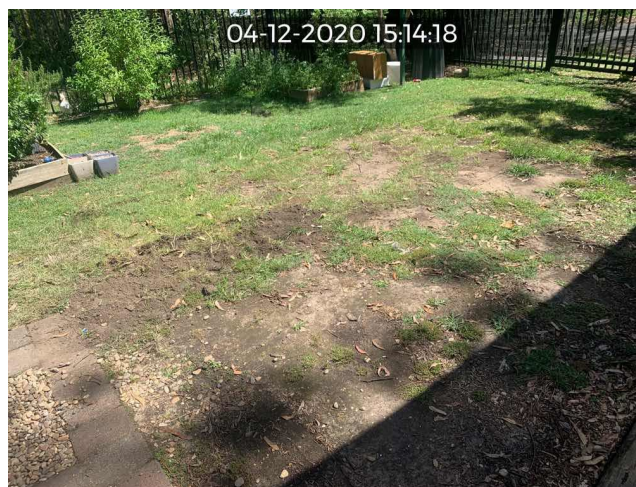
Stage 4 : Area where Skippin was positioned

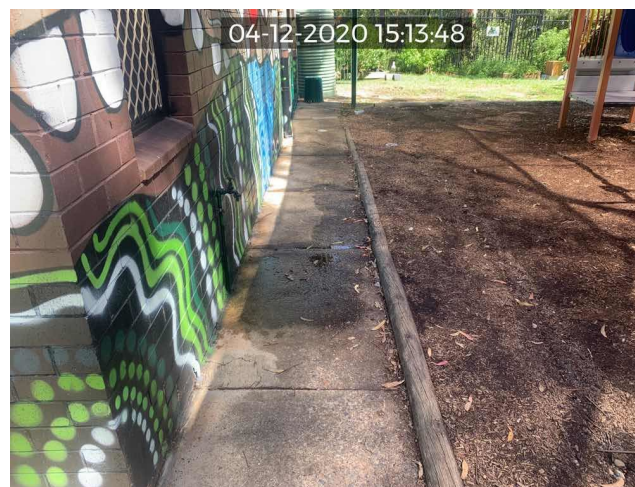
Stage 4 : Former West transit route
