## HAZARDOUS BUILDING MATERIALS SURVEY REPORT

Katoomba Solitary Restaurant  
90 Cliff Drive, Katoomba NSW 2780

Report Number 610.17816.00000.0240-R01-ASR

19 March 2018

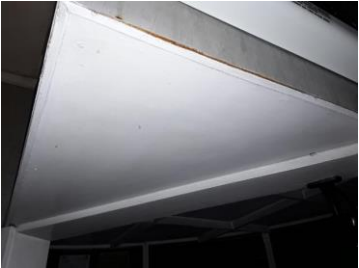
<b>Location:</b>	Katoomba Solitary Restaurant , Ground - Floor Kitchen - ceiling to doorway into restaurant area	<b>Material Application</b>	Ceiling, Fibrous Cement	<b>Extent:</b>	<1 m <sup>2</sup>	<b>Sample Number</b>	22
<b>Main Photo</b>		<b>Close Up Photo</b>		<b>Product Type</b>	Asbestos reinforced composites etc. (1)	<b>Material Score</b>

<b>Condition</b>	Good (0)	2	
				<b>Surface Treatment</b>	Sealed (0)	<b>Risk</b>	
				<b>Asbestos Type</b>	Chrysotile (1)	Very Low	
				<b>Recommendation:</b>	Manage

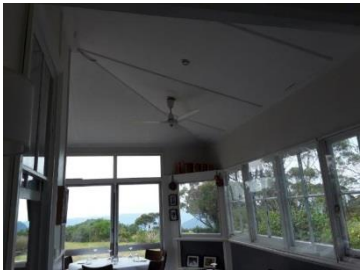
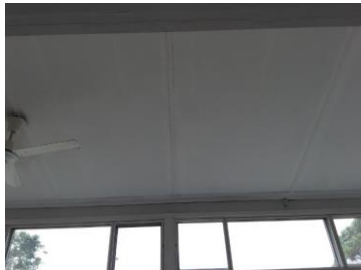
<b>Location:</b>	Katoomba Solitary Restaurant , Ground Floor - Restaurant area enclosed porch	<b>Material Application</b>	Ceiling, Fibrous Cement	<b>Extent:</b>	16 m <sup>2</sup>	<b>Sample Number</b>	24
<b>Main Photo</b>		<b>Close Up Photo</b>		<b>Product Type</b>	Asbestos reinforced composites etc. (1)	<b>Material Score</b>

<b>Condition</b>	Good (0)	2	
				<b>Surface Treatment</b>	Sealed (0)	<b>Risk</b>	
				<b>Asbestos Type</b>	Chrysotile (1)	Very Low	
				<b>Recommendation:</b>	Manage

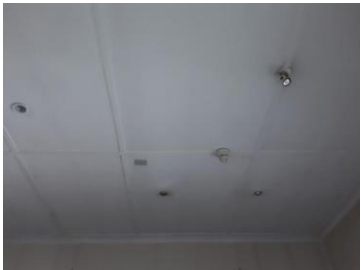
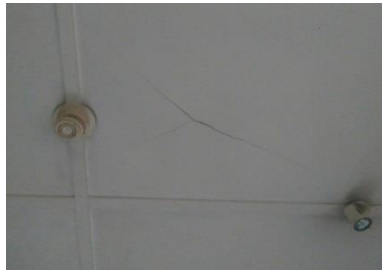
<b>Location:</b>	Katoomba Solitary Restaurant , Ground Floor - Reception	<b>Material Application</b>	Ceiling, Fibrous Cement	<b>Extent:</b>	16 m <sup>2</sup>	<b>Sample Number</b>	Similar to 12
<b>Main Photo</b>		<b>Close Up Photo</b>		<b>Product Type</b>	Asbestos reinforced composites etc. (1)	<b>Material Score</b>

<b>Condition</b>	Fair (1)	3	
				<b>Surface Treatment</b>	Sealed (0)	<b>Risk</b>	
				<b>Asbestos Type</b>	Chrysotile (1)	Very Low	
				<b>Recommendation:</b>	Manage

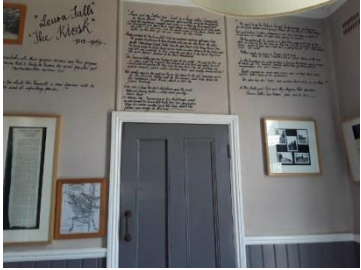
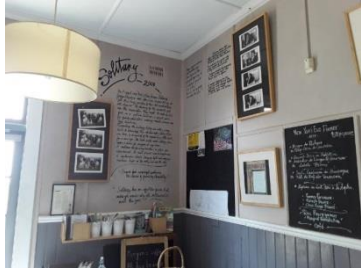
<b>Location:</b>	Katoomba Solitary Restaurant , Ground Floor - Restaurant entrance area -Upper walls	<b>Material Application</b>	Upper walls, Fibrous Cement	<b>Extent:</b>	18 m <sup>2</sup>	<b>Sample Number</b>	Similar to 11
<b>Main Photo</b>

<b>Product Type</b>	Asbestos reinforced composites etc. (1)	<b>Material Score</b>	2
				<b>Condition</b>	Good (0)	<b>Risk</b>	Very Low
				<b>Surface Treatment</b>	Sealed (0)		
				<b>Asbestos Type</b>	Chrysotile (1)		
				<b>Recommendation:</b>	Manage

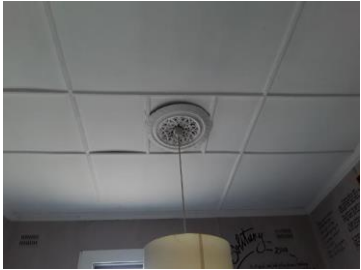
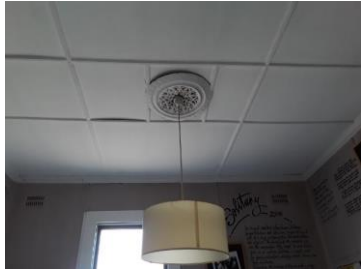
<b>Location:</b>	Katoomba Solitary Restaurant , Ground Floor - Restaurant entrance area -ceiling	<b>Material Application</b>	Ceiling, Fibrous Cement	<b>Extent:</b>	9 m <sup>2</sup>	<b>Sample Number</b>	Similar to 12
<b>Main Photo</b>

<b>Product Type</b>	Asbestos reinforced composites etc. (1)	<b>Material Score</b>	2
				<b>Condition</b>	Good (0)	<b>Risk</b>	Very Low
				<b>Surface Treatment</b>	Sealed (0)		
				<b>Asbestos Type</b>	Chrysotile (1)		
				<b>Recommendation:</b>	Manage

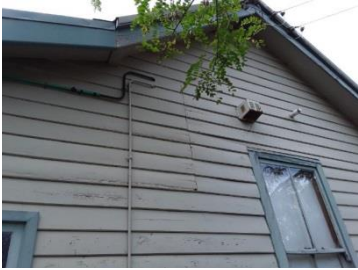
<b>Location:</b>	Katoomba Solitary Restaurant , External - Back half restaurant - North, east and west soffits - also run on the western soffit		<b>Material Application</b>	Soffit, Fibrous Cement	<b>Extent:</b>	12 m <sup>2</sup>	<b>Sample Number</b>	03
<b>Main Photo</b>	<b>Close Up Photo</b>		<b>Product Type</b>	Asbestos reinforced composites etc. (1)

<b>Condition</b>	Fair(1)				
			<b>Surface Treatment</b>	Sealed (0)				
			<b>Asbestos Type</b>	Chrysotile (1)				
			<b>Recommendation:</b>	Manage				
							<b>Material Score</b>	
							<b>3</b>	
							<b>Risk</b>	
							<b>Very Low</b>

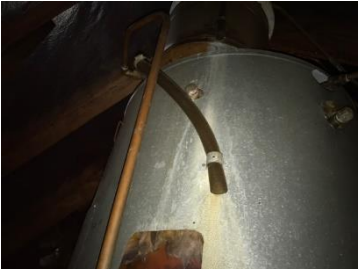
<b>Location:</b>	Restaurant, Ground Floor - Ceiling cavity - Hot water system		<b>Material Application</b>	Old style hot water system internal insulation material, Insulation	<b>Extent:</b>	Unknown	<b>Sample Number</b>	Assumed
<b>Main Photo</b>	<b>Close Up Photo</b>		<b>Product Type</b>	Thermal insulation, sprayed asbestos, loose asbestos etc. (3)

No Photo Available		<b>Condition</b>	Good (0)				
			<b>Surface Treatment</b>	Composite materials sealed by nature, Sealed (0)				
			<b>Asbestos Type</b>	Assumed Asbestos (3)				
			<b>Recommendation:</b>					
							<b>Material Score</b>	
							<b>6</b>	
							<b>Risk</b>	
							<b>Low</b>

- Airborne lead and asbestos fibre monitoring is recommended on a twelve monthly basis to ensure that all controls in place are sufficient.
- Friable asbestos in the form of assumed asbestos insulation to the hot water system and old ceramic fuse in the switchboard was identified during the survey. The assumed materials are currently encapsulated. Upon next service the items should have further testing to determine if they contain asbestos, and replaced with non-asbestos items. Removal must be by a contractor licensed to undertake such works.

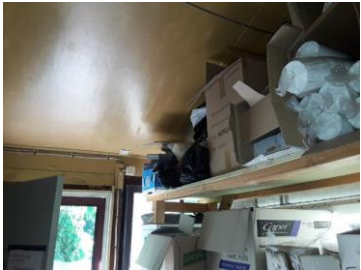
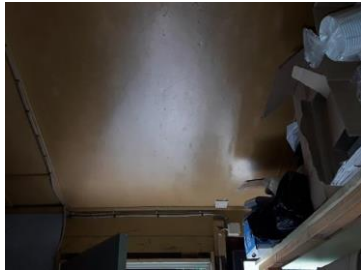
<b>Location:</b>	Restaurant, Ground Floor - Room with Cool room- northern section ceiling-directly above entrance door	<b>Material Application</b>	ceiling, Fibrous Cement	<b>Extent:</b>	4 m <sup>2</sup>	<b>Sample Number</b>	07
<b>Main Photo</b>		<b>Close Up Photo</b>		<b>Product Type</b>	Asbestos reinforced composites etc. (1)	<b>Material Score</b>

<b>Condition</b>	Good (0)	2	
				<b>Surface Treatment</b>	Sealed (0)	Risk	
				<b>Asbestos Type</b>	Chrysotile (1)	Very Low	
				<b>Recommendation:</b>	Manage

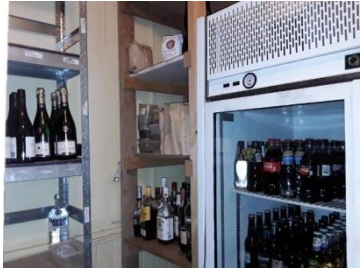
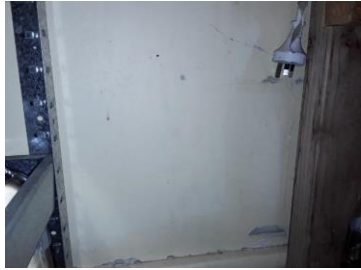
<b>Location:</b>	Restaurant, Ground Floor - Cool room drinks room - upper walls	<b>Material Application</b>	Upper walls north and east, Fibrous Cement	<b>Extent:</b>	18 m <sup>2</sup>	<b>Sample Number</b>	11
<b>Main Photo</b>		<b>Close Up Photo</b>		<b>Product Type</b>	Asbestos reinforced composites etc. (1)	<b>Material Score</b>

<b>Condition</b>	Good (0)	4	
				<b>Surface Treatment</b>	Sealed (0)	Risk	
				<b>Asbestos Type</b>	Chrysotile (1)	Very Low	
				<b>Recommendation:</b>	Manage

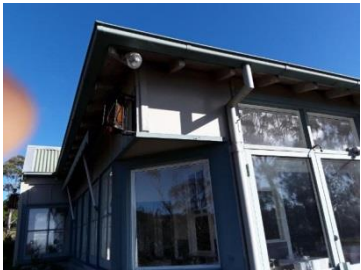
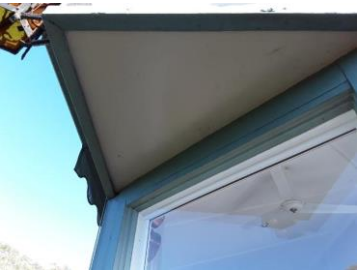
<b>Location:</b>	Restaurant, External - S/W Corner upper ceiling sheeting	<b>Material Application</b>	Infill, Fibrous Cement	<b>Extent:</b>	1 m <sup>2</sup>	<b>Sample Number</b>	Similar to 02
<b>Main Photo</b>		<b>Close Up Photo</b>		<b>Product Type</b>	Asbestos reinforced composites etc. (1)	<b>Material Score</b>

<b>Condition</b>	Good (0)	2	
				<b>Surface Treatment</b>	Sealed (0)	<b>Risk</b>	
				<b>Asbestos Type</b>	Chrysotile (1)	Very Low	
				<b>Recommendation:</b>	Manage

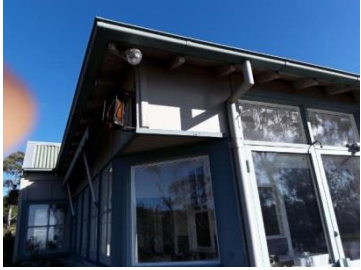
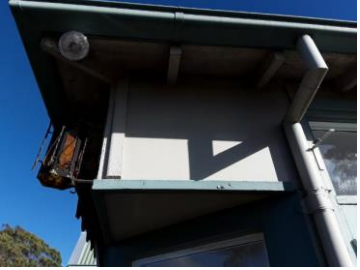
<b>Location:</b>	Restaurant, External - S/W Corner upper sheeting	<b>Material Application</b>	Infill, Fibrous Cement	<b>Extent:</b>	1 m <sup>2</sup>	<b>Sample Number</b>	02
<b>Main Photo</b>		<b>Close Up Photo</b>		<b>Product Type</b>	Asbestos reinforced composites etc. (1)	<b>Material Score</b>

<b>Condition</b>	Good (0)	2	
				<b>Surface Treatment</b>	Sealed (0)	<b>Risk</b>	
				<b>Asbestos Type</b>	Chrysotile (1)	Very Low	
				<b>Recommendation:</b>	Manage

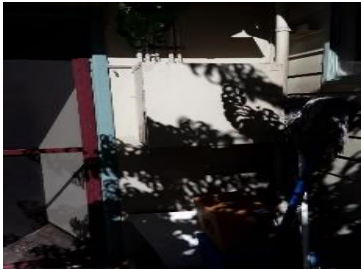
<b>Location:</b>	Restaurant, External - North side - wall sheet west side of back entrance - around electrical box	<b>Material Application</b>	Wall sheeting, Fibrous Cement	<b>Extent:</b>	3 m <sup>2</sup>	<b>Sample Number</b>	04
<b>Main Photo</b>		<b>Close Up Photo</b>		<b>Product Type</b>	Asbestos reinforced composites etc. (1)	<b>Material Score</b>

<b>Condition</b>	Good (0)	2	
				<b>Surface Treatment</b>	Sealed (0)	<b>Risk</b>	
				<b>Asbestos Type</b>	Chrysotile (1)	Very Low	
				<b>Recommendation:</b>	Manage
