Asbestos Register Condition Report

Asbestos Register Condition Inspection

Asset Name:	Faulconbridge Community Hall	Date:	6-3-2019	RAR No:	RAR-25
Asset Address:	9a Home Street Faulconbridge	Inspection Carried Out By:	Brian Ashton	HPE No:	19/84834
Are Staff/PCBU aware that there is ACM onsite?		Yes			
Is there a copy of the Asbestos Register for this location onsite?		Yes			
Is there a copy of the Asbestos Management Plan for this location onsite?		Yes

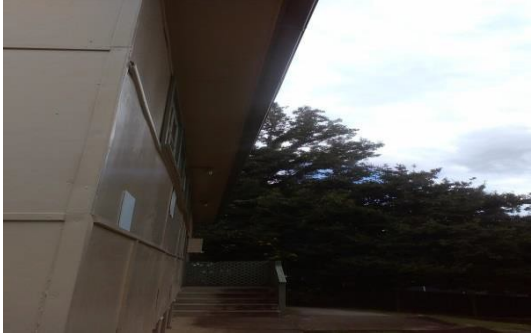
Reference Number Int / Ext Floor Specific Location	Photographs
<p style="text-align: center;">50 External Eave Linings</p> <p style="text-align: center;">51 External Wall Cladding</p>

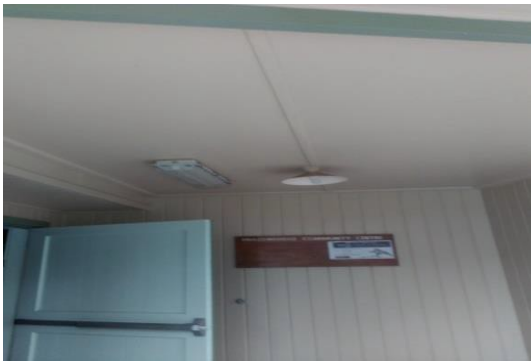
<p style="text-align: center;">52 External Main Entrance Ceiling Lining</p>

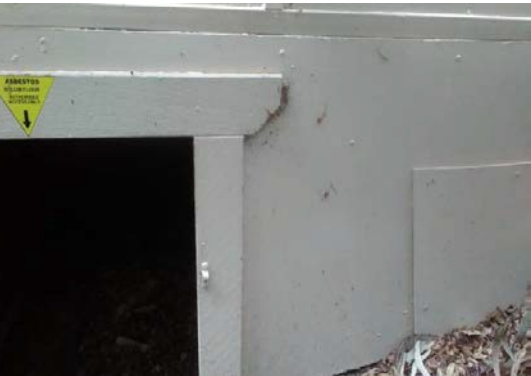
74	Similar to 21880-22	External Sub-Floor Entrance Wall Cladding	Fibrous Cement Sheeting	1m2	Assumed Positive	1 Non-Accessible	1 Good	1 Non-Friable	1 Sealed	4 Very Low	A4	Yes		12 months
68	21880-26	External Female Toilet Wall Cladding	Fibreboard		Negative						A5			
69	21880-27	External Female Toilet Cisterns	Cement		Negative						A5			
70	21880-28	Internal Entrance Panel on Wall Adjacent (Hatch)	Fibreboard		Negative						A5			
55	21880-29	Internal Stage Area northern stairs ceiling lining	Fibrous Cement Sheeting	4m2	Positive	1 Non-Accessible	1 Good	1 Non-Friable	1 Sealed	4 Very Low	A4	No		12 months
56	21880-30	Internal Stage Area northern stairs internal wall cladding	Fibrous Cement Sheeting	8m2	Positive	1 Non-Accessible	1 Good	1 Non-Friable	1 Sealed	4 Very Low	A4	No		12 months
57	Similar to 21880-29	Internal Stage Area northern stairs Storeroom ceiling lining	Fibrous Cement Sheeting	4m2	Assumed Positive	1 Non-Accessible	1 Good	1 Non-Friable	1 Sealed	4 Very Low	A4	No		12 months

<p style="text-align: center;">74 External Sub-Floor Entrance Wall Cladding</p>

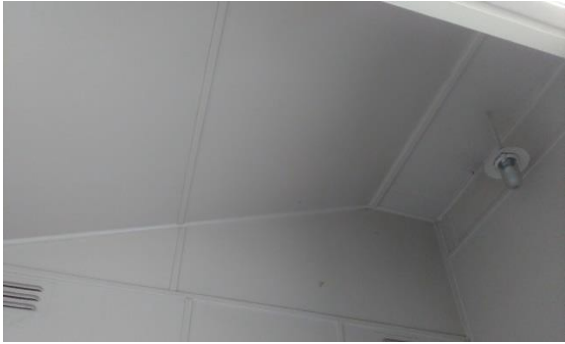
<p>55 Internal Stage Area Northern Stairs Ceiling Lining</p> <p>56 Internal Stage Area Northern Stairs Wall Cladding</p>

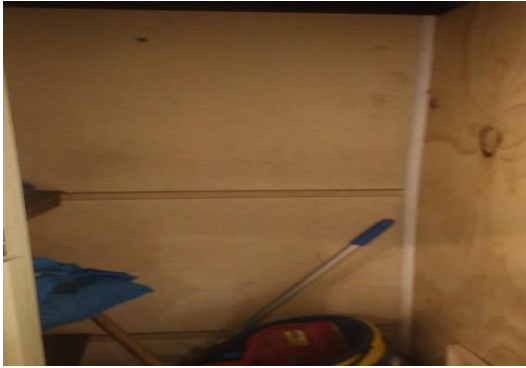
<p>62 Internal Stage Area Southern Stairs Storeroom Internal/External Wall Cladding</p>

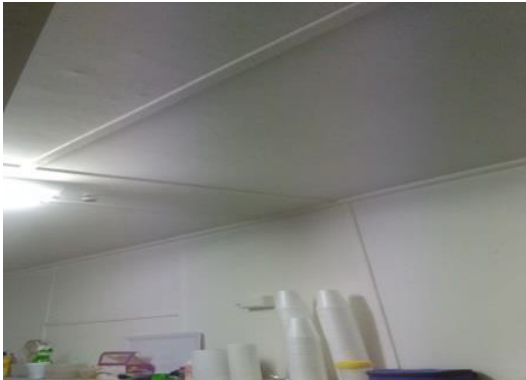
<p>64 and 65 Internal Kitchen Wall Cladding and Ceiling Lining</p>
