Asbestos Register

Management Plan

170-174 Leura Mall, Leura

Asbestos Register and Management Plan

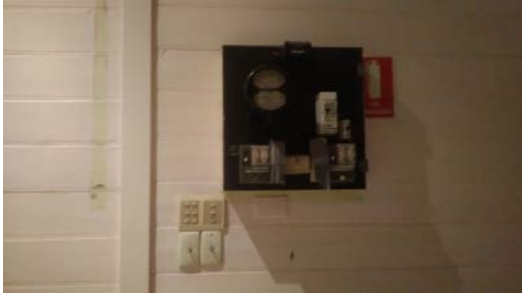
Reference Number Int / Ext Floor Specific Location	Photographs
269 Shop 1 Internal Front Room Electrical Backing Board

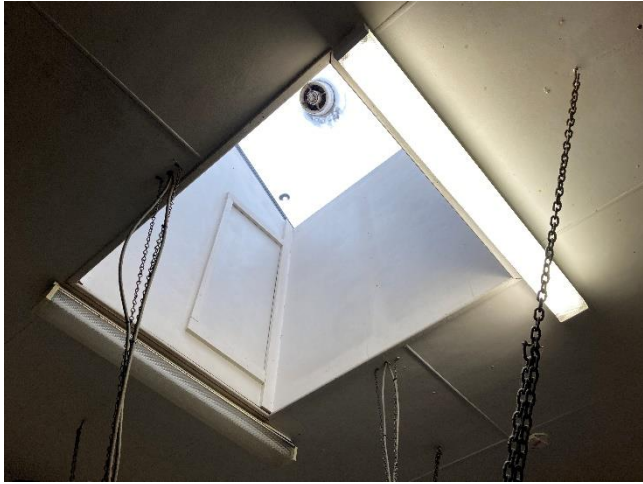
Photograph 1: Work area prior to removal works.

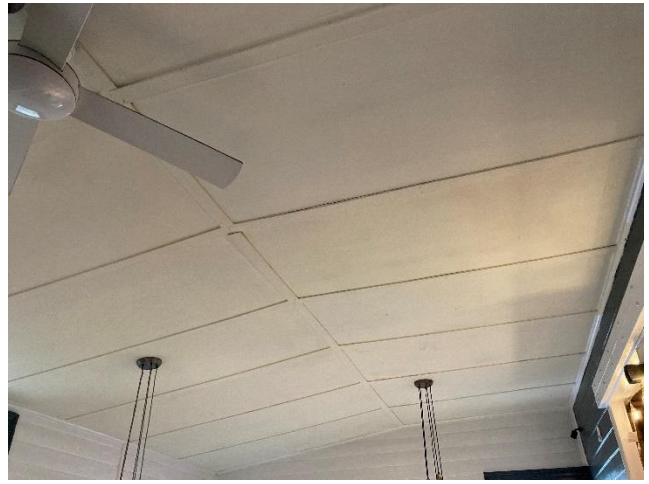
Photograph 2: Work area prior to removal works.

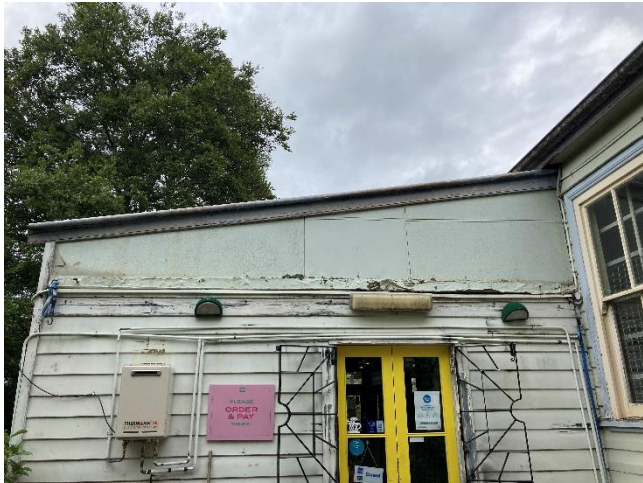
Photograph 3: Work area prior to removal works.

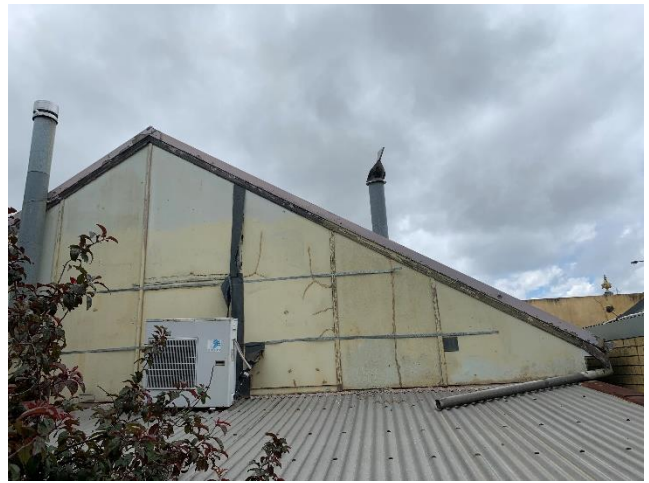
Photograph 4: Work area prior to removal works.

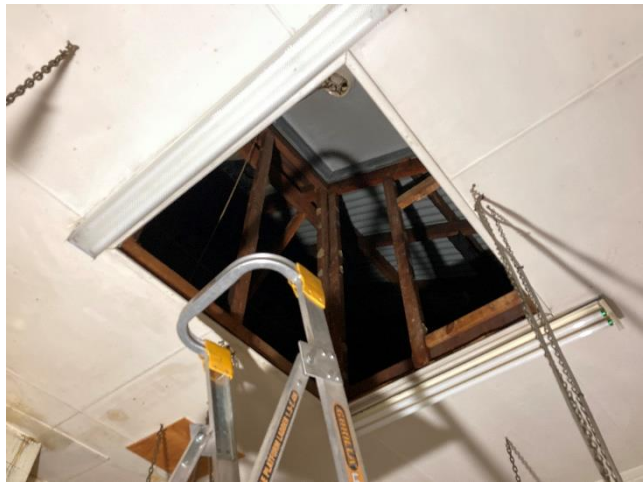
Photograph 5: Work area following removal works.

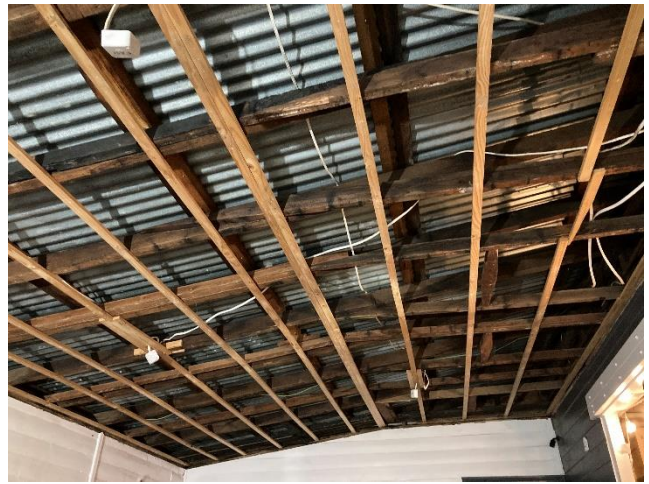
Photograph 6: Work area following removal works.

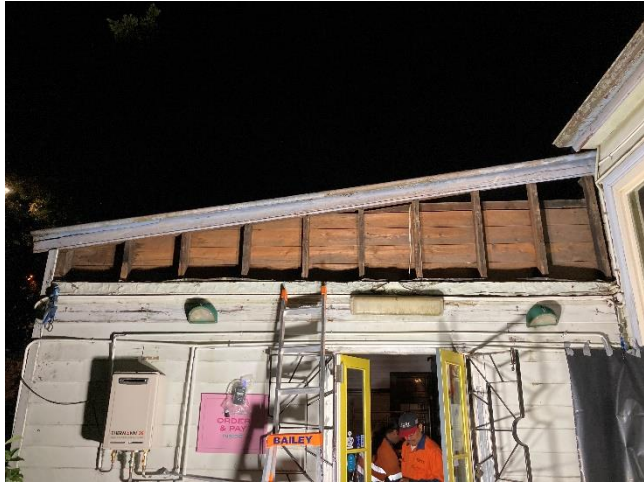
Photograph 7: Work area following removal works.

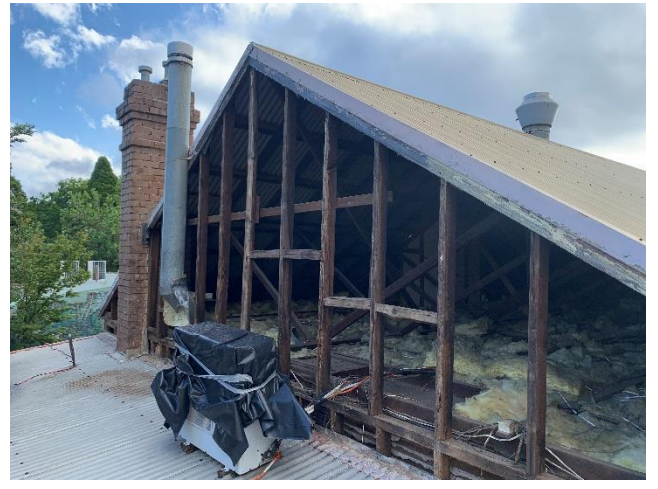
Photograph 8: Work area following removal works.
