**BLUE MOUNTAINS CITY
COUNCIL**

ASBESTOS REGISTER

**MOUNT IRVINE – RURAL FIRE
SERVICE STATION**

**Extract Asbestos Register AS25132
December 2014**

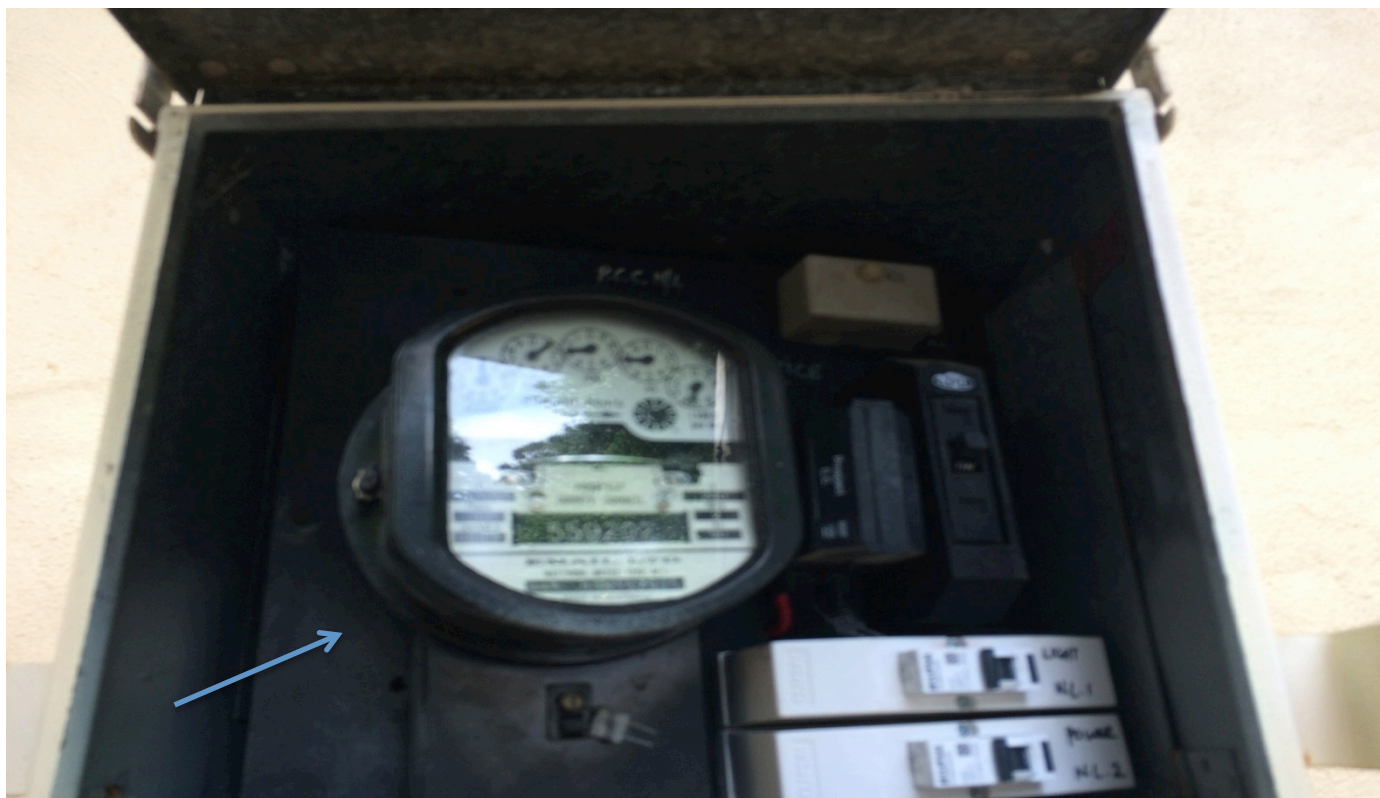
Location	Material	Sample ID	Sample Status	Photo No.	Asbestos Classification	Condition	Accessibility	Re-inspect	Current Label	Control Measure	Record of Works Undertaken
Mount Irvine Rural Fire Service Bushfire Station											
External											
Eave linings 3093	Fibreboard	25132-34-1	Negative	-	-	-	-	-	-	-	-
Northern Perimeter – Electrical Box – electrical backing board 3094	Bituminous backing board	25132-34-2	Positive	125	Bonded	Stable	Low	December 2019	Not labeled	4	cc 18/101869 04/05/18
Internal											
3095	No materials suspected of containing asbestos identified in accessible area's at the time of inspection

25132-34-1	Mount Irvine Rural Fire Service Bushfire Station – External – eave linings	7x7x2mm fibreboard fragment	No asbestos detected [Organic fibres detected]
25132-34-2	Mount Irvine Rural Fire Service Bushfire Station – External – Northern Perimeter – Electrical Box – electrical backing board	3x2x2mm bituminous backing board fragment	Chrysotile asbestos detected
25132-35-1	Mount Tomah Rural Fire Service Bushfire Station – External – Main Building – eave linings	9x8x1mm fibreboard fragment	No asbestos detected [Organic fibres detected]
25132-35-2	Mount Tomah Rural Fire Service Bushfire Station – External – Rear Addition – eave linings	16x8x2mm fibreboard fragment	No asbestos detected [Organic fibres detected]
25132-35-3	Mount Tomah Rural Fire Service Bushfire Station – Internal – Eastern Garage – ceiling lining	20x14x4mm fibreboard fragment	No asbestos detected [Organic fibres detected]
25132-35-4	Mount Tomah Rural Fire Service Bushfire Station – Internal – Mezzanine Office – external wall cladding	10x5x2mm fibreboard fragment	No asbestos detected [Organic fibres detected]

Photo 125: Electrical backing board containing asbestos on the northern perimeter of the **Mount Irvine Rural Fire Station.**
