Asbestos Register

Resurvey Report

| Asset Name: | Lawson - Storage and Workshop Building (behind the Library) | Date: | 13-3-19 | RAR No: | RAR-39 |
| Asset Address: | 1 Loftus Street Lawson | Inspection Carried Out By: | Brian Ashton | HPE No: | 19/84109 |

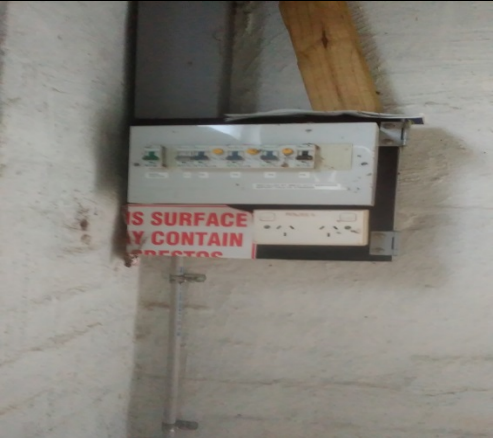
| Reference Number | Sample Number | Location | | | Analysis | Risk assessment | | | | | | Additional information | | |
|---|---|--|---|---|---|---|---|---|---|---|---|---|---|---|
| 2234 | 28781-30-2 | Internal Electrical Box Backing Board | Bituminous | 0.2m2 | Positive Cleared | 1 Low | 1 Good | 1 Non-friable | 1 Sealed | 4 Very Low | No Further Action | Yes | This Switchboard has been removed 18/04/19 - 19/100340 | 12 Months |

| Reference Number Int / Ext Floor Specific Location | Photographs |
|--|--|
| 2234 Eastern Shed South-eastern corner Electrical backing board | |

| 28781-30-2 | Lawson Depot – Storage and Workshop Building – Internal – Eastern Shed – south-eastern corner – electrical backing board | 3x2x2mm electrical backing board fragment | Chrysotile asbestos detected |
