ASBESTOS REGISTER

WINMALEE RURAL FIRE STATION
BUSHFIRE STATION

502A HAWKESBURY ROAD

Extract from Asbestos Register AS25132

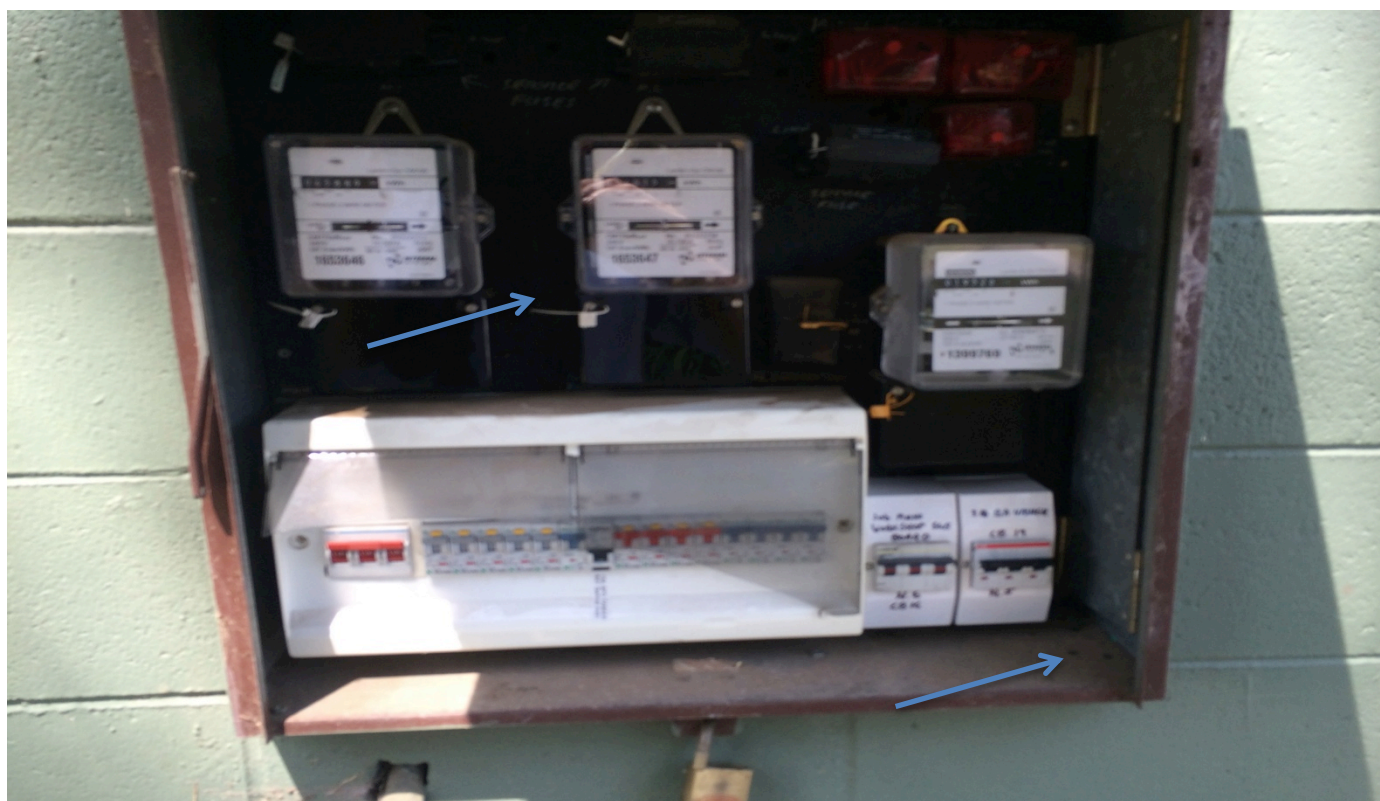
Location	Material	Sample ID	Sample Status	Photo No.	Asbestos Classification	Condition	Accessibility	Re-inspect	Current Label	Control Measure	Record of Works Undertaken
Winmalee Rural Fire Service Bushfire Station											
External											
Amenities – eave linings 3060	Fibreboard	25132-39-1	Negative	-	-	-	-	-	-	-	-
Amenities – gable ends 3061	Fibreboard	25132-39-2	Negative	-	-	-	-	-	-	-	-
Amenities – Main Entrance – awning lining 3062	Fibreboard	25132-39-3	Negative	-	-	-	-	-	-	-	-
Tanker Bay – eave linings 3063	Fibreboard	Similar to 25132-39-1	Assumed Negative	-	-	-	-	-	-	-	-
Tanker Bay – northern-eastern Perimeter – electrical box – electrical backing board and debris within box 323 324	Bituminous backing board	25132-39-4	Positive	131	Backing board: bonded. Debris: friable	Unstable	Low	December 2015	Not labeled	2	10/05/2018 Pacific HazMat CC #S04264 -18/104837

Photo 131: Electrical backing board and debris containing asbestos on the north-eastern perimeter of the Winmalee Rural Fire Service Bushfire Brigade.

Debris removed 28/06/2016 R. Kane-White
