Glenbrook Pool, Wascoe Park

# **Asbestos/Lead Register & Management Plan**

REPORT TYPE	Hazardous Materials Management Register
THE CLIENT	Blue Mountains City Council
AREA COVERED BY THE SCOPE	Aquatic Centre
LEAD SURVEYOR	Luke Trevena
ASSISTANT SURVEYOR	-
INSPECTION DATE	13/09/2022

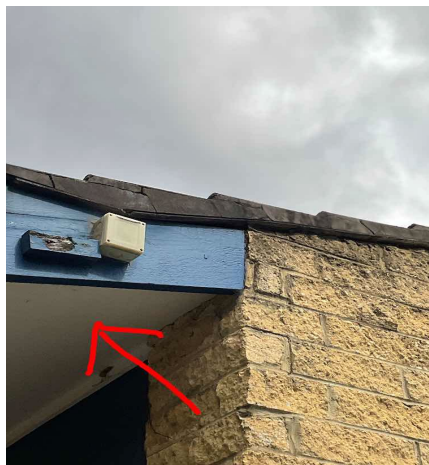
External, GF, Exterior, South East, Eave lining above infill over roller door - Fibre Cement, Assumed Positive, Same to B17372-S02 - Assumed Chrysotile

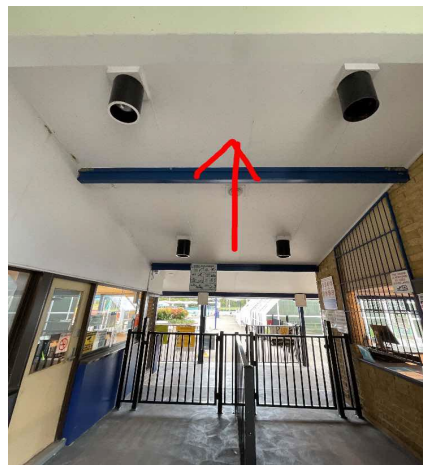
External, GF, Exterior, South East, Entrance ceiling lining - Fibre Cement, Assumed Positive, Same to B17372-S02 - Assumed Chrysotile

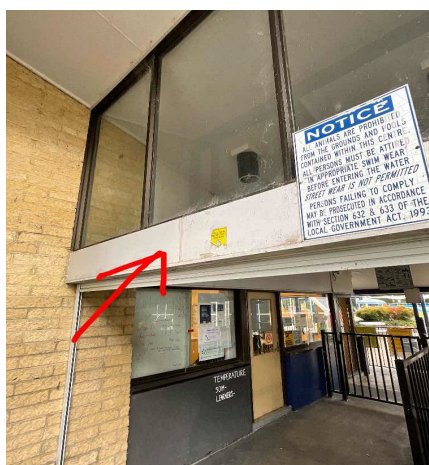
External, GF, Exterior, Infill Panel over entry - Fibre Cement, Assumed Positive, Similar to B17372-S16 - Assumed Chrysotile

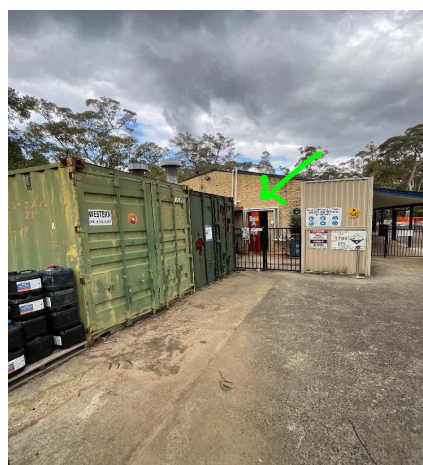
External, GF, Exterior, North East Wall Vertical Expansion Joint of Building - Vertical Expansion Point, No Asbestos identified, B17372-S05

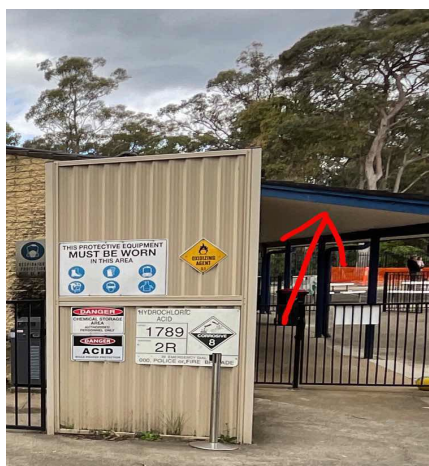
External, GF, Exterior, North West, North West elevation Eaves - Fibre

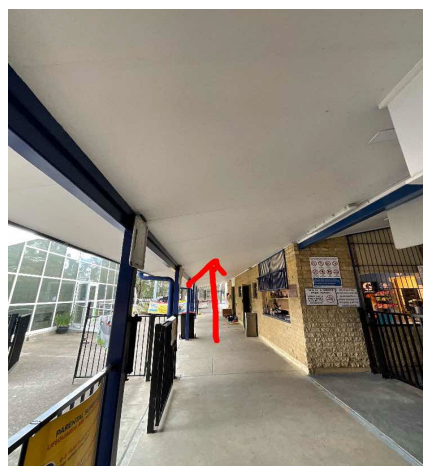
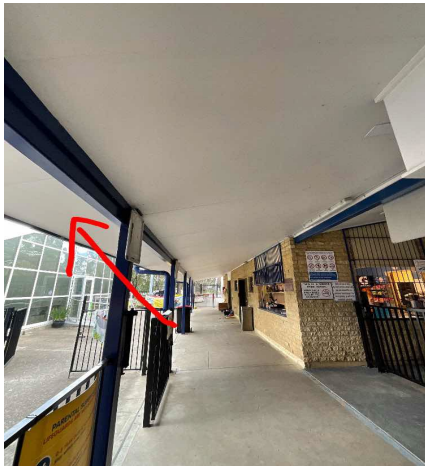
External, GF, Exterior, North West, North West elevation Eaves - Fibre

Cement, Chrysotile, B17372-S06

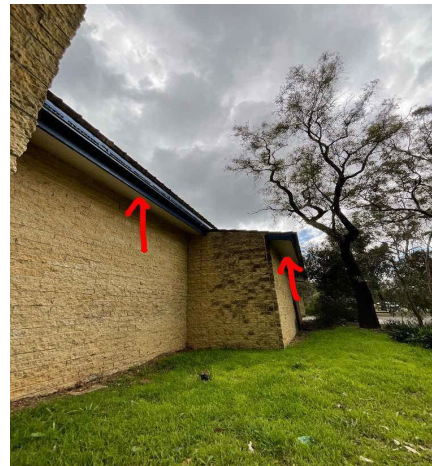
External, GF, Exterior, South East, South East elevation, Eaves - Fibre Cement, Chrysotile, B17372-S02

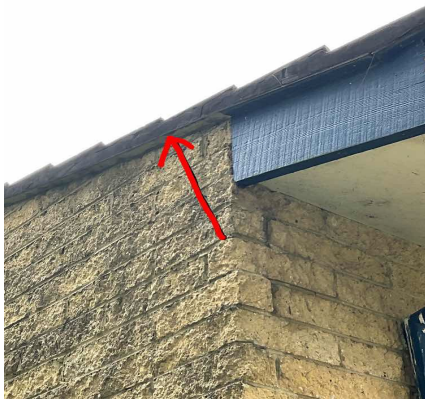
External, GF, Exterior, Throughout roof perimeter, Below Roof Tiles on Edge Soffit - Fibre Cement, Chrysotile, B17372-S03

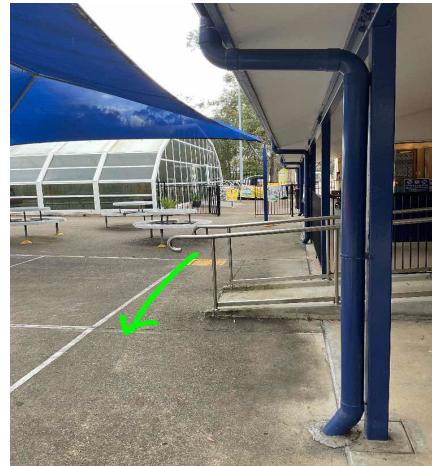
External, GF, Exterior, Walkways Bituminous Expansion Joints - Bituminous Expansion Joints, No Asbestos identified, B17372-S04

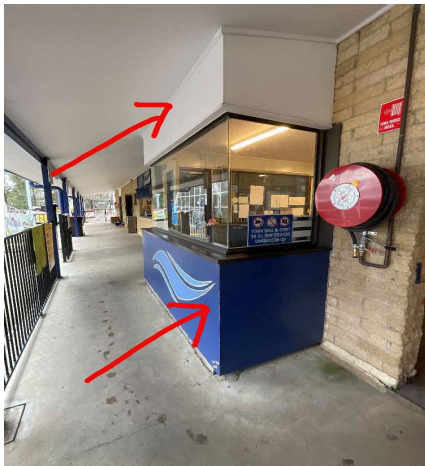
Photo #	REF #	HAZARD	RESULT	SPECIFIC LOCATION	MATERIAL	QUANTITIY	FRIABILITY	OVERALL RISK	ACTION CODE	TIMEFRAME	COMMENTS
13	B17372-S09	Asbestos	Chrysotile	Office exterior Entry Infill	Fibre Cement	25 m <sup>2</sup>	Non-Friable	Low	A4	5 Yearly Reinspection	Accessible to tradespeople.

External, GF, Exterior Office, Office exterior Entry Infill - Fibre Cement, Chrysotile, B17372-S09

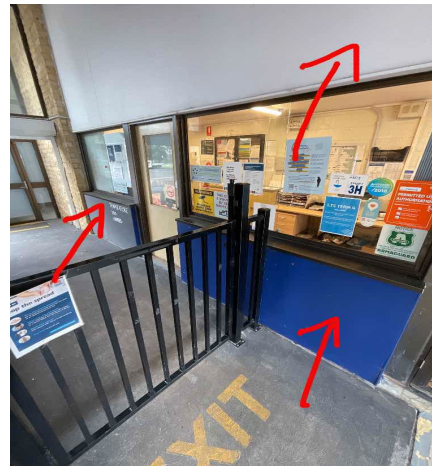
External, GF, Exterior Office, Office exterior Entry Infill - Fibre Cement, Chrysotile, B17372-S09

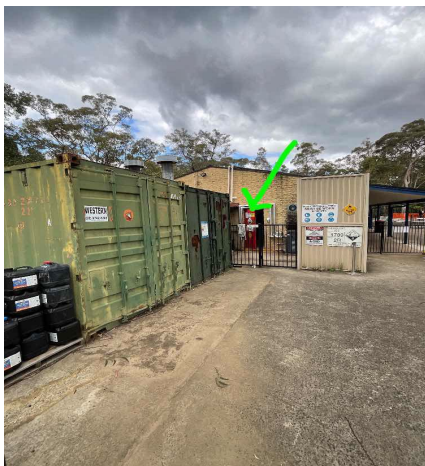
External, GF, Plantroom, Door - Red - Topcoat, <0.05 w/w, 17372S02

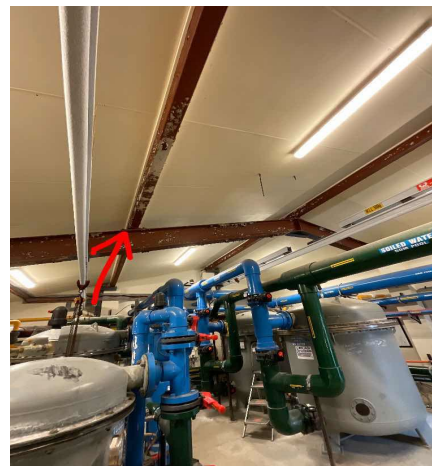
External, GF, Plantroom, Support beams to roof - Brown - Topcoat, Lead Detected (0.12%w/w), 431675/LP01

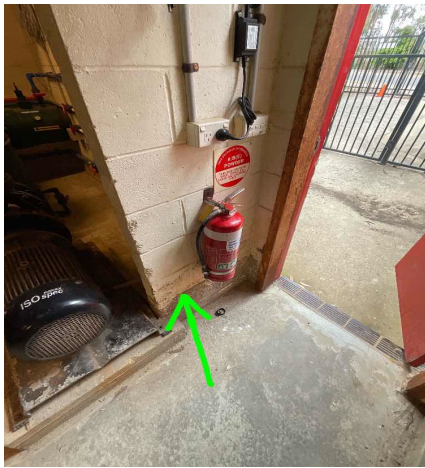
External, GF, Plantroom, Walls to plant room - Cream - Topcoat, Lead Not Detected (0.001%w/w), 431675/LP02

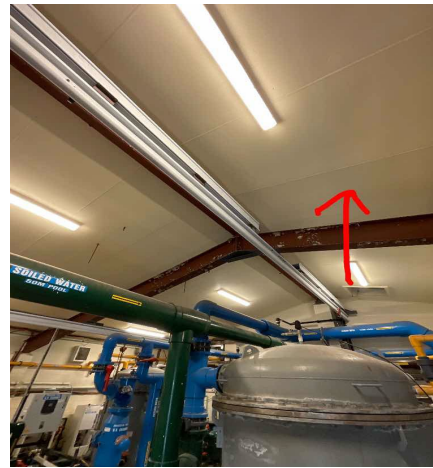
External, GF, Pump Room, Ceiling - Fibre Cement, Assumed Positive, Similar to B17372S10 - Assumed Chrysotile

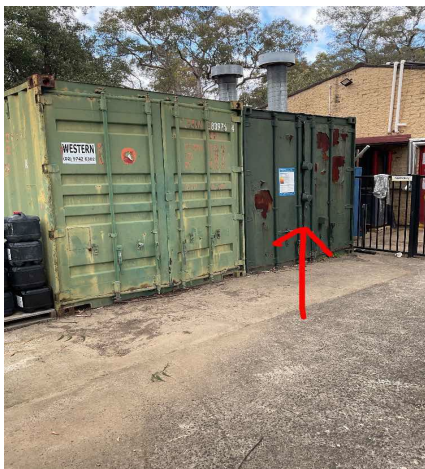
Photo #	REF #	HAZARD	RESULT	SPECIFIC LOCATION	MATERIAL	QUANTITIY	FRIABILITY	OVERALL RISK	ACTION CODE	TIMEFRAME	COMMENTS
19	17372S03	Lead	Lead Detected (%0.54 w/w)	All surfaces	Green (Dark) - Topcoat	25 m <sup>2</sup>	N/A	Low	A3	5 Yearly Reinspection	Accessible to staff
20	17372S04	Lead	Lead Detected (%0.74 w/w)	All surfaces	Green (Light) - Topcoat	25 m <sup>2</sup>	N/A	Low	A3	5 Yearly Reinspection	Accessible to staff

External, GF, Shipping Container, All surfaces - Green (Dark) - Topcoat, Lead Detected (%0.54 w/w), 17372S03

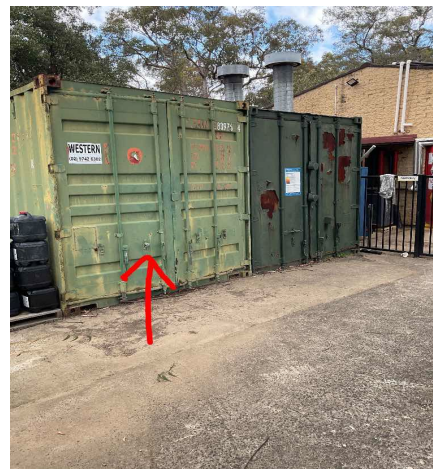
External, GF, Shipping Container, All surfaces - Green (Light) - Topcoat, Lead Detected (%0.74 w/w), 17372S04

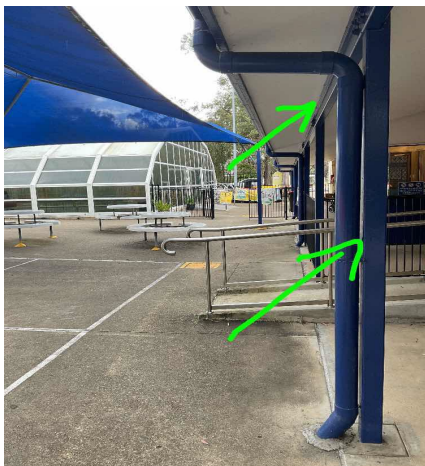
Photo #	REF #	HAZARD	RESULT	SPECIFIC LOCATION	MATERIAL	QUANTITY	FRIABILITY	OVERALL RISK	ACTION CODE	TIMEFRAME	COMMENTS
21	17372S05	Lead	<0.05% w/w	Vertical and Horizontal Support Beams	Blue - Topcoat	30 m <sup>2</sup>	Not Applicable	Low	A5	N/A	Paint is not classified as lead-based as less than 0.1% w/w.

External, GF, Verandah, North West, Vertical and Horizontal Support Beams - Blue - Topcoat, <0.05% w/w, 17372S05

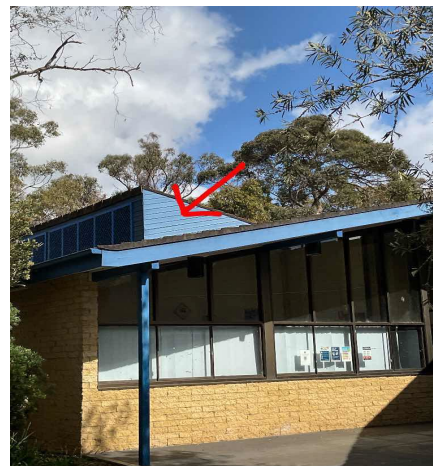
Photo #	REF #	HAZARD	RESULT	SPECIFIC LOCATION	MATERIAL	QUANTITY	FRIABILITY	OVERALL RISK	ACTION CODE	TIMEFRAME	COMMENTS
22	17372S01	Lead	Lead Detected (%0.1 w/w)	Fascia	Blue - Topcoat	20 m <sup>2</sup>	Not Applicable	Very Low	A5	N/A	-

External, Roof, Gable, South East, Fascia - Blue - Topcoat, Lead Detected (%0.1 w/w), 17372S01

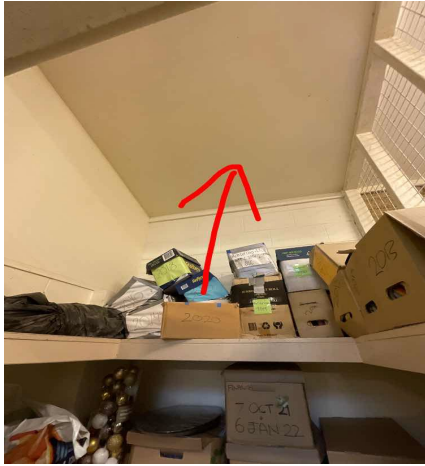
Internal, GF, Cleaners Storeroom adjacent female amenities, Ceiling - Fibre Cement, Assumed Positive, Similar to B17372S10 - Assumed Chrysotile

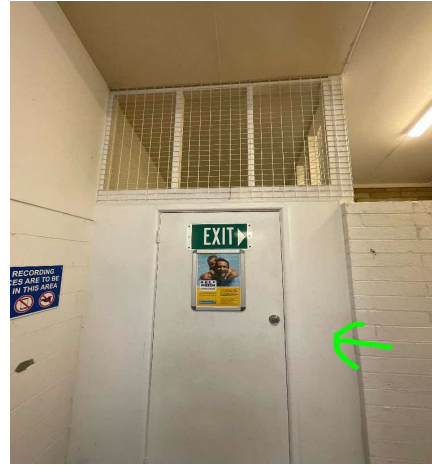
Internal, GF, Cleaners Storeroom adjacent female amenities, Infill Panel - Fibre Cement, No Asbestos identified, B17372-S11

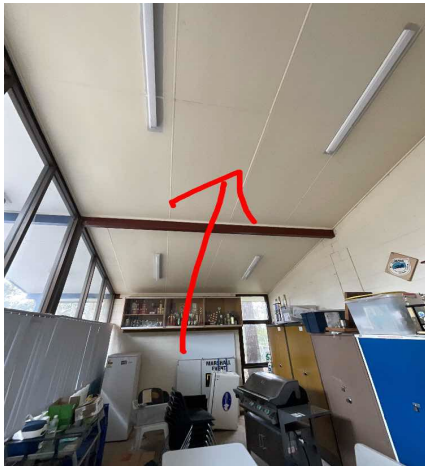
Internal, GF, Clubroom, Fibre Cement Ceiling - Fibre Cement, Assumed Positive, Similar to B17372- S10 - Assumed Chrysotile

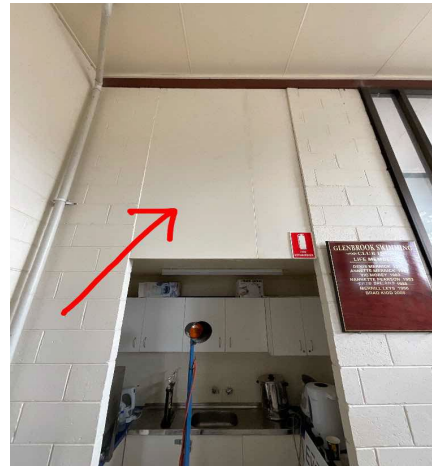
Internal, GF, Clubroom, Infill in Kitchenette - Fibre Cement, Chrysotile, B17372-S16

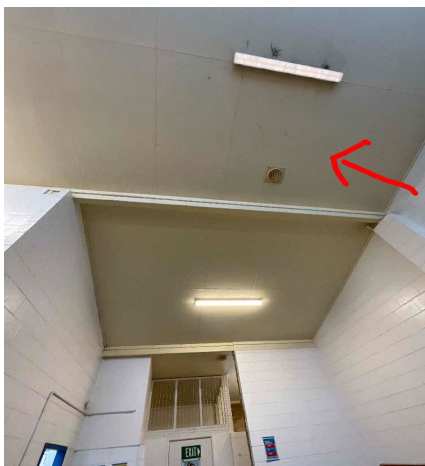
Internal, GF, Female Amenities, Ceiling - Fibre Cement, Assumed Positive, Similar to B17372-S10 - Assumed Chrysotile

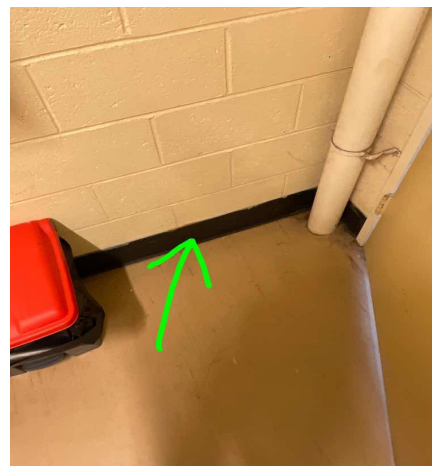
Internal, GF, First Aid Room, Bituminous Skirting - Bituminous Skirting, Assumed Negative, Similar to B17372S14 - Assumed Negative

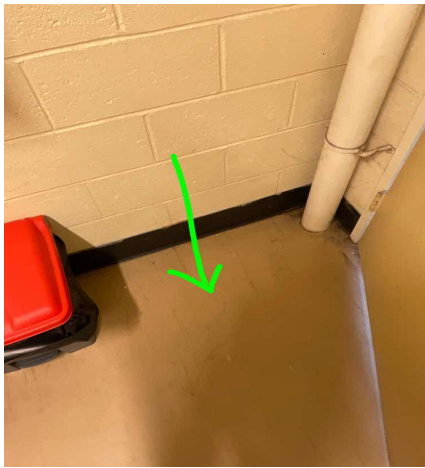
Internal, GF, First Aid Room, Vinyl Floor Covering - Vinyl Sheet, Assumed Negative, Similar to B17372-S14 - Assumed Negative

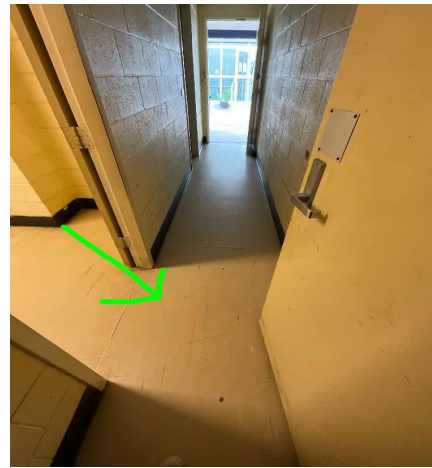
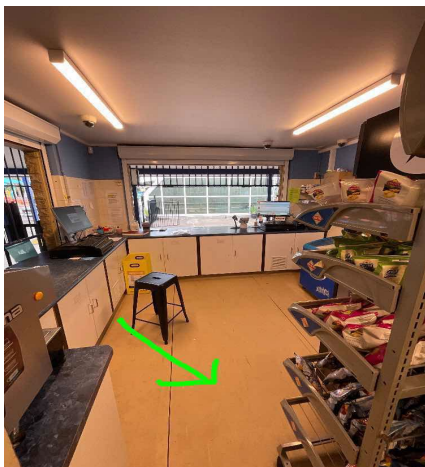
Photo #	REF #	HAZARD	RESULT	SPECIFIC LOCATION	MATERIAL	QUANTITIY	FRIABILITY	OVERALL RISK	ACTION CODE	TIMEFRAME	COMMENTS
30	B17372-S14	Asbestos	No Asbestos identified	Floor Covering - Vinyl Tile	Vinyl Tile	20 m <sup>2</sup>	Non-Friable	-	A5	5 Yearly Reinspection	-

Internal, GF, Hallway to Kiosk and Kitchen, Floor Covering - Vinyl Tile - Vinyl Tile, No Asbestos identified, B17372-S14

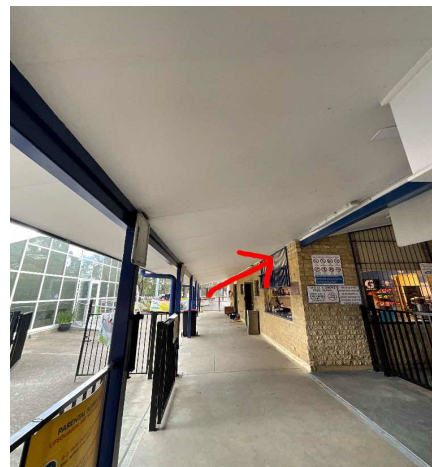
Photo #	REF #	HAZARD	RESULT	SPECIFIC LOCATION	MATERIAL	QUANTITIY	FRIABILITY	OVERALL RISK	ACTION CODE	TIMEFRAME	COMMENTS
31	Similar to B17372-S08 - Assumed Chrysotile	Asbestos	Assumed Positive	Infill Panel Roller Door	Fibre Cement	2 m²	Non-Friable	Very Low	A4	5 Yearly Reinspection	Accessible to tradespeople.

Internal, GF, Kiosk, Infill Panel Roller Door - Fibre Cement, Assumed Positive, Similar to B17372-S08 - Assumed Chrysotile

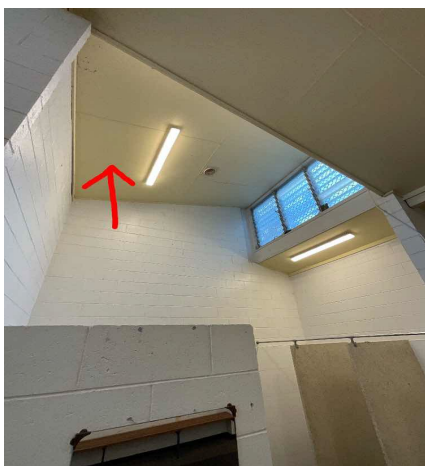
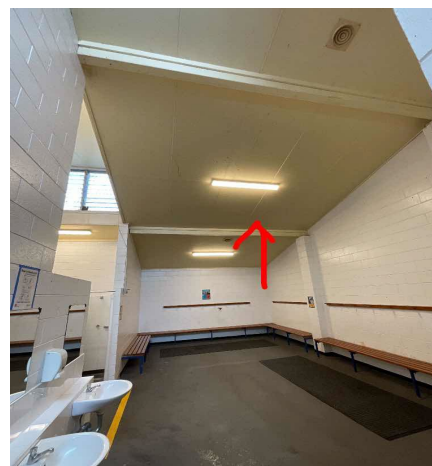
Internal, GF, Male Amenities, Ceiling - Fibre Cement, Assumed Positive, Similar to B17372-S10 - Assumed Chrysotile

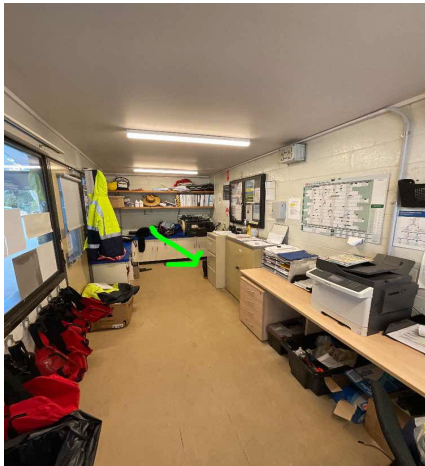
Internal, GF, Office, Bituminous Skirting - Bituminous Skirting, Assumed Negative, B17372-S12

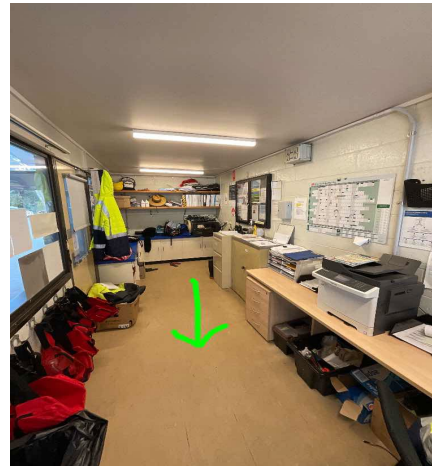
Internal, GF, Office, Floor Covering Vinyl Tile - Vinyl floor tiles, No Asbestos identified, B17372-S13

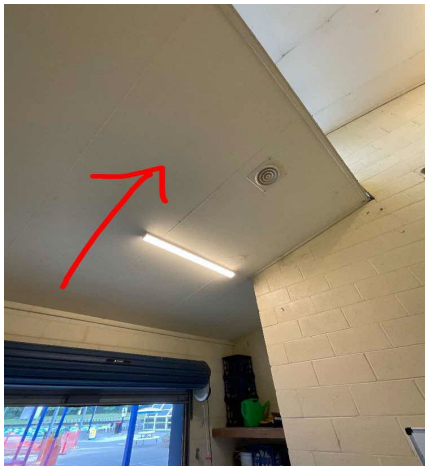
Photo #	REF #	HAZARD	RESULT	SPECIFIC LOCATION	MATERIAL	QUANTITIY	FRIABILITY	OVERALL RISK	ACTION CODE	TIMEFRAME	COMMENTS
36	B17372-S10	Asbestos	Chrysotile	Ceiling	Fibre Cement	20 m <sup>2</sup>	Non-Friable	-	A4	5 Years	-

Internal, GF, Store Room 3, Ceiling - Fibre Cement, Chrysotile, B17372-S10

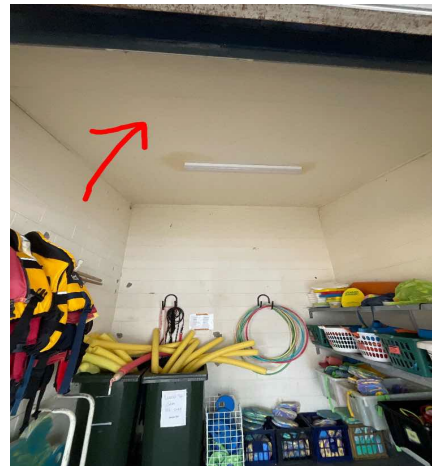
Internal, GF, Storeroom 1, Ceiling - Fibre Cement, Assumed Positive, Similar to B17372-S10 - Assumed Chrysotile

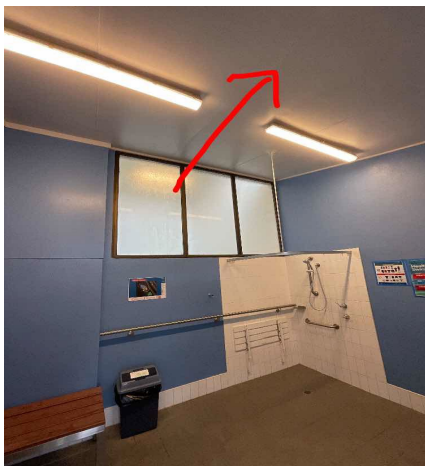
Internal, GF, Wheelchair Accessible Toilet, Ceiling - Fibre Cement, Assumed Positive, Similar to B17372 - S10 - Assumed Chrysotile

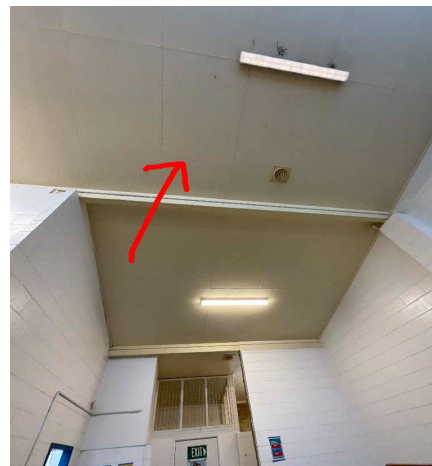
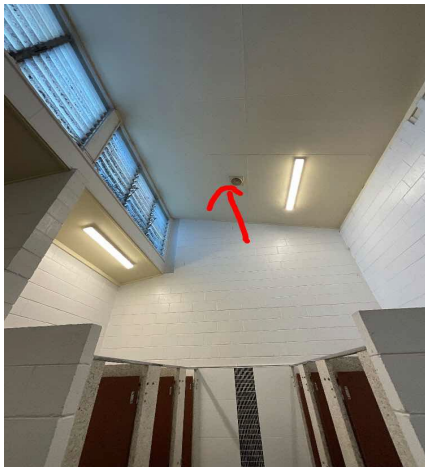
Internal, GF, Womens Toilet, Ceiling - Fibre Cement, Assumed Positive, Similar to B17372-S10 - Assumed Chrysotile
