Asbestos Register

Asbestos/Lead Register & Management Plan

Blue Mountains City Council conducted Hazardous Materials Management Register for the workplace located at 31 Waratah Street Katoomba NSW 2780.

REPORT TYPE	Hazardous Materials Management Register
THE CLIENT	Blue Mountains City Council
AREA COVERED BY THE SCOPE	Internal & external areas of building
LEAD SURVEYOR	Luke Trevena
ASSISTANT SURVERYOR	-
INSPECTION DATE	23/11/2022

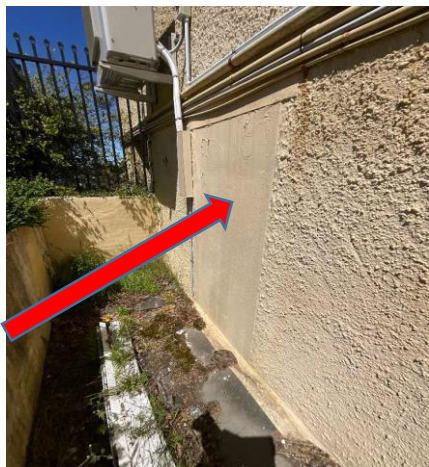
Photo #	REF #	HAZARD	RESULT	SPECIFIC LOCATION	MATERIAL	QUANTITIY	FRIABILITY	OVERALL RISK	ACTION CODE	TIMEFRAME	COMMENTS
1	Similar to previously sampled B17455S10	Asbestos	Chrysotile asbestos detected	Door infill	Fibre cement sheet	2 m ²	Non-Friable	Very Low	A4	5 yearly reinspection	-

External, GF, Exterior, East, Door infill - Fibre cement sheet, Chrysotile asbestos detected, Similar to previously sampled B17455S10

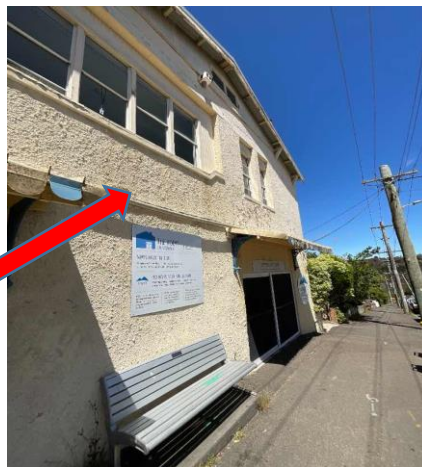
External, GF, Exterior, External yellow paint to all surfaces - Yellow - Topcoat, Lead based paint system (0.2%w/w), Previous sampled 17455-S02

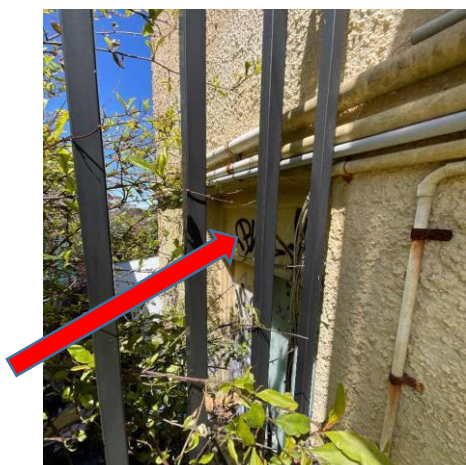
Photo #	REF #	HAZARD	RESULT	SPECIFIC LOCATION	MATERIAL	QUANTITIY	FRIABILITY	OVERALL RISK	ACTION CODE	TIMEFRAME	COMMENTS
3	Previously sampled B17455S10	Asbestos	Chrysotile asbestos detected	Infill panel	Fibre cement sheet	1 m ²	Non-Friable	Very Low	A4	5 yearly reinspection	-
4	442261/AS02	Asbestos	No Asbestos detected	Internal wall of lower ground floor	Fibre cement sheet	25 m ²	Not Applicable	Very Low	A5	5 yearly reinspection	-
5 & 6	-	Asbestos	No asbestos assumed	South and east elevation	Fibre cement sheet	50 m ²	Not Applicable	-	A5	-	Modern fibre cement sheet installed in December 2022. Previous asbestos containing material removed. Refer JMB clearance report 22/272452 issued 24/11/22
7 & 8	Similar to 442261/AS01	Asbestos	Presumed asbestos containing	South and East elevation wall cavities	Fibre cement	5 m ²	Non-Friable	Very Low	A4	5 yearly reinspection	Asbestos in the form of fibre cement packers and panels present in wall cavities and as form work. Ensure intrusive survey before demolition or renovation works.

External, GF, Exterior, Infill panel - Fibre cement sheet, Chrysotile asbestos detected, Previously sampled B17455S10

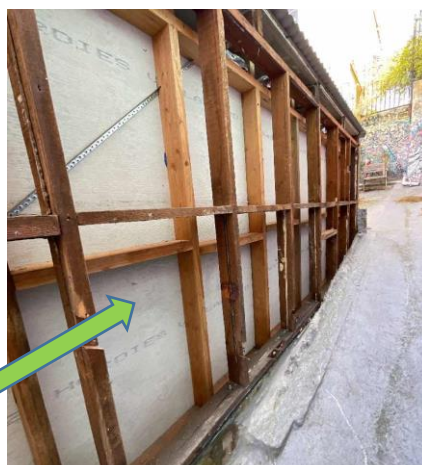
External, GF, Exterior, South West, Internal wall of lower ground floor - Fibre cement sheet, No Asbestos detected, 442261/AS02

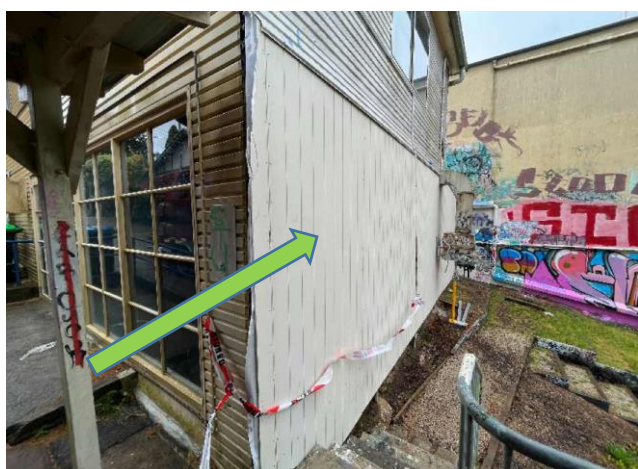
External, GF, Exterior, South and east elevation - Fibre cement sheet, No asbestos assumed, -

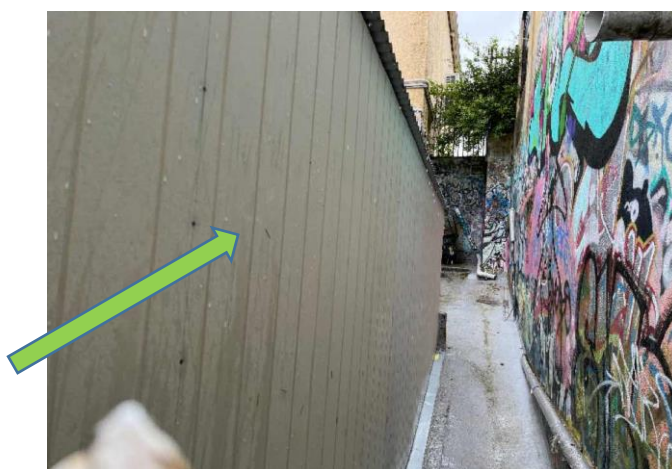
External, GF, Exterior, South and east elevation - Fibre cement sheet, No asbestos assumed, -

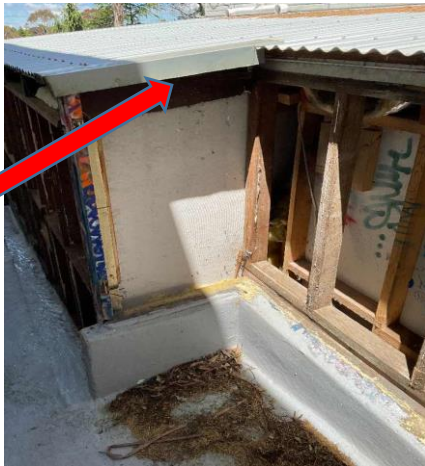
External, GF, Exterior, South and East elevation wall cavities - Fibre cement, Presumed asbestos containing, Similar to 442261/AS01

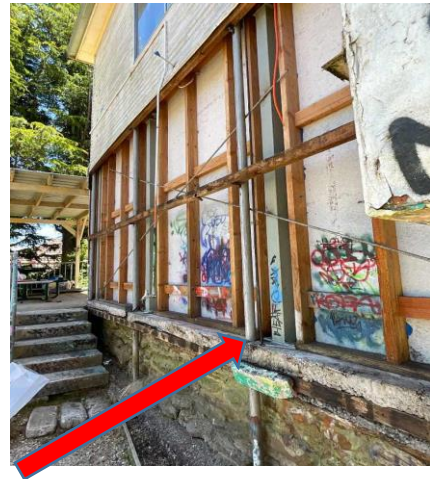
External, GF, Exterior, South and East elevation wall cavities - Fibre cement, Presumed asbestos containing, Similar to 442261/AS01

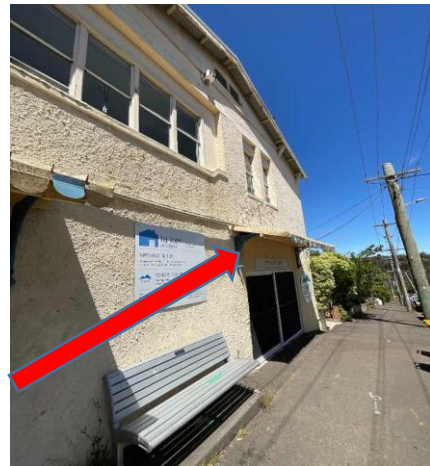
External, GF, Exterior, North East, Wrought iron brackets - Blue - Topcoat, Lead based paint system (9.5%w/w), Previously sampled 17455-S03

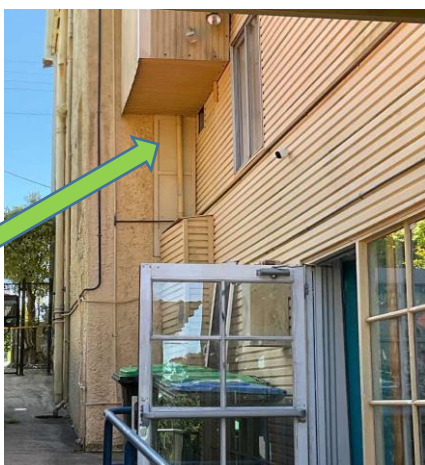
External, L1, Exterior, South West, Corner infill - Fibre cement sheet, No asbestos detected, Previously sampled B17455S05

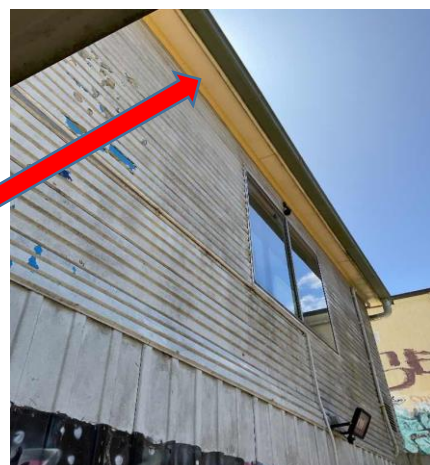
External, L1, Exterior, South, Eaves - Fibre cement sheet, Chrysotile asbestos detected, Previously sampled B17455S09

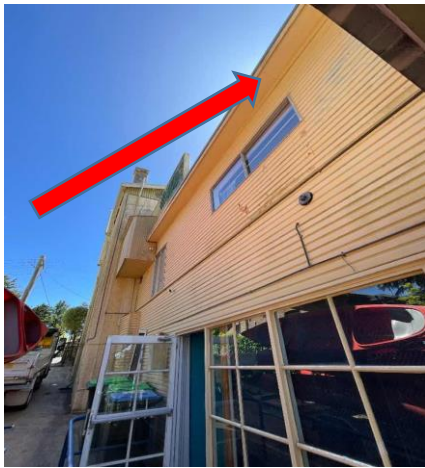
External, L1, Exterior, West, Eaves - Fibre cement sheet, Chrysotile asbestos detected, Similar to Previously sampled B17455S09

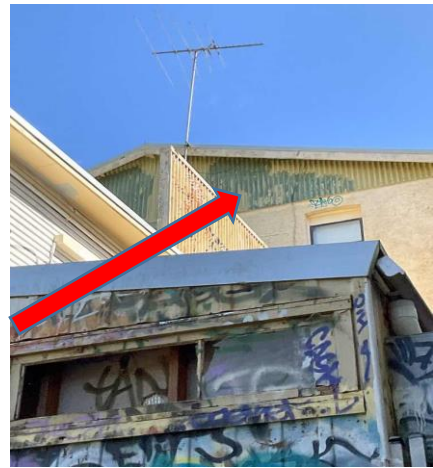
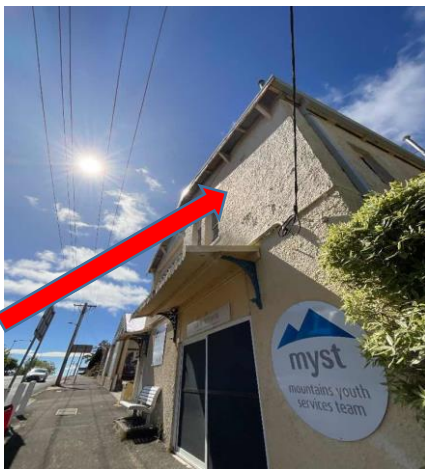
Photo #	REF #	HAZARD	RESULT	SPECIFIC LOCATION	MATERIAL	QUANTITIY	FRIABILITY	OVERALL RISK	ACTION CODE	TIMEFRAME	COMMENTS
14 & 15	Assumed positive	Asbestos	Assumed positive for asbestos	Northeast and southeast gable ends	Fibre cement sheet	15 m ²	Non-Friable	Very Low	A4	5 yearly reinspection	Potential asbestos behind cladding

External, L1, Exterior, Northeast and southeast gable ends - Fibre cement sheet, Assumed positive for asbestos, Assumed positive

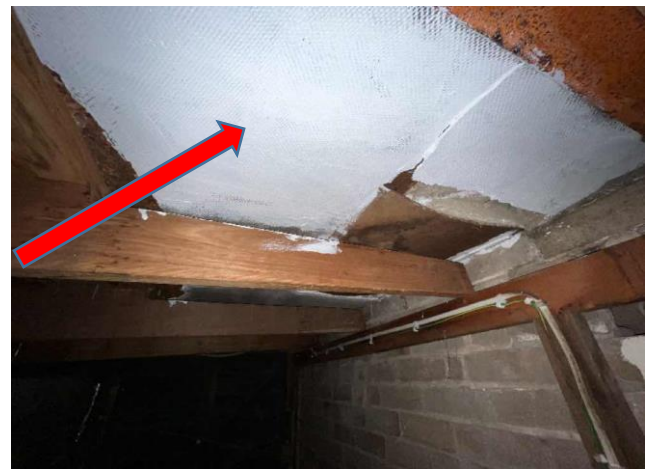
Photo #	REF #	HAZARD	RESULT	SPECIFIC LOCATION	MATERIAL	QUANTITIY	FRIABILITY	OVERALL RISK	ACTION CODE	TIMEFRAME	COMMENTS
16	Previously sampled B17455S23	Asbestos	Chrysotile asbestos detected	Formwork to underside of level 1	Fibre cement sheet	4 m ²	Not Applicable	Very Low	A4	5 yearly inspection	Paint sealed

Internal, GF, Ceiling space, Formwork to underside of level 1 - Fibre cement sheet, Chrysotile asbestos detected, Previously sampled B17455S23

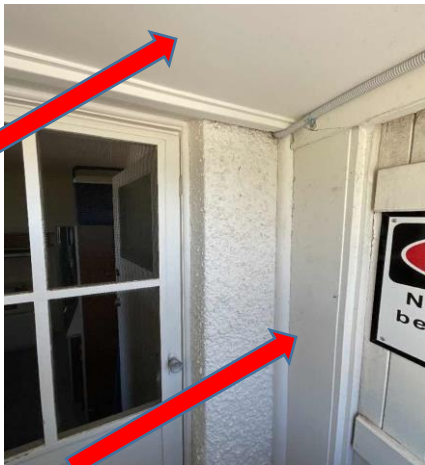
Photo #	REF #	HAZARD	RESULT	SPECIFIC LOCATION	MATERIAL	QUANTITIY	FRIABILITY	OVERALL RISK	ACTION CODE	TIMEFRAME	COMMENTS
17	Previously sampled B17455S29	Asbestos	Chrosotile, Amosite and Crocidolite asbestos detected	Ceiling and walls	Fibre cement sheet	5 m ²	Non-Friable	Very Low	A4	5 yearly reinspection	-
18	Previously sampled 17455-S25	Lead	Lead based paint system (0.2%w/w)	Ceiling, walls, timber trim and doors	Cream - Topcoat	10 m ²	Not Applicable	Very Low	A4	5 yearly reinspection	-

Internal, L1, External south east porch, South West, Ceiling and walls - Fibre cement sheet, Chrysotile, Amosite and Crocidolite asbestos detected, Previously sampled B17455S29

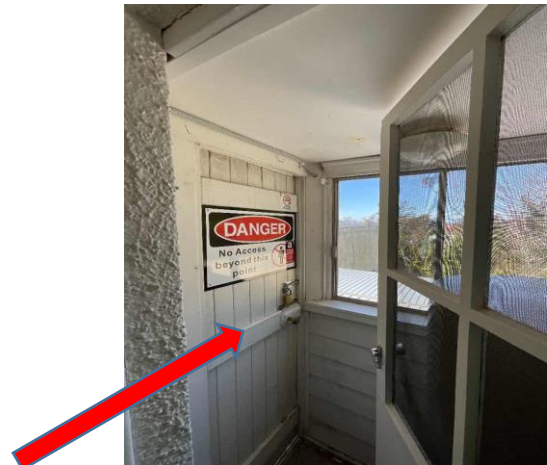
Internal, L1, External south east porch, Ceiling, walls, timber trim and doors - Cream - Topcoat, Lead based paint system (0.2%w/w), Previously sampled 17455-S25

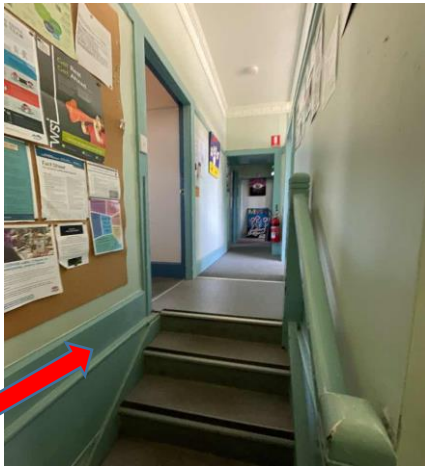
Photo #	REF #	HAZARD	RESULT	SPECIFIC LOCATION	MATERIAL	QUANTITIY	FRIABILITY	OVERALL RISK	ACTION CODE	TIMEFRAME	COMMENTS
19	Previously sampled 17455-S31	Lead	Lead based paint system (0.3%w/w)	On timber trim throughout level 1	Blue & light blue - Topcoat	20 m ²	Not Applicable	Very Low	A4	5 yearly reinspection	-

Internal, L1, Interior, On timber trim throughout level 1 - Blue & light blue - Topcoat, Lead based paint system (0.3%w/w), Previously sampled 17455-S31

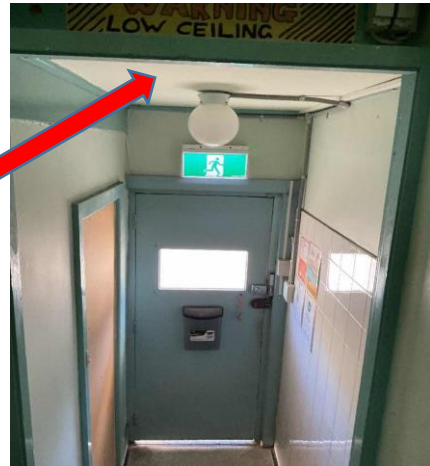
Photo #	REF #	HAZARD	RESULT	SPECIFIC LOCATION	MATERIAL	QUANTITIY	FRIABILITY	OVERALL RISK	ACTION CODE	TIMEFRAME	COMMENTS
20	Previously sampled B17455S27	Asbestos	Chrysotile and Amosite asbestos detected	Ceiling of entry to level 1	Fibre cement sheet	2 m ²	Non-Friable	Very Low	A4	5 yearly reinspection	-

Internal, L1, Internal hallway, North East, Ceiling of entry to level 1 - Fibre cement sheet, Chrysotile and Amosite asbestos detected, Previously sampled B17455S27

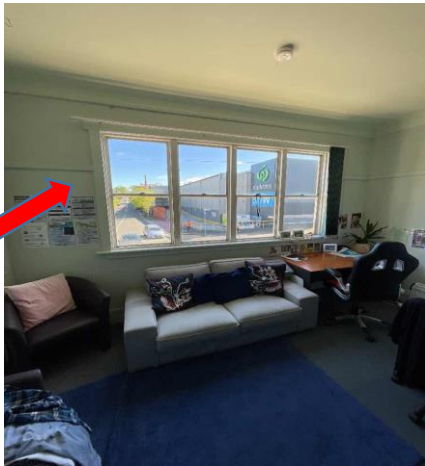
Photo #	REF #	HAZARD	RESULT	SPECIFIC LOCATION	MATERIAL	QUANTITIY	FRIABILITY	OVERALL RISK	ACTION CODE	TIMEFRAME	COMMENTS
21	442261/AS01	Asbestos	Contains Chrysotile and Amosite Asbestos	Wall infills on left and right of window	Fibre cement sheet	2 m²	Non-Friable	Very Low	A4	5 yearly reinspection	-

Internal, L1, North east office, North, Wall infills on left and right of window - Fibre cement sheet, Contains Chrysotile and Amosite Asbestos, 442261/AS01
