Asbestos Register

Management Plan

Blaxland Community Health Centre

23 Normic Avenue, BLAXLAND NSW 2774

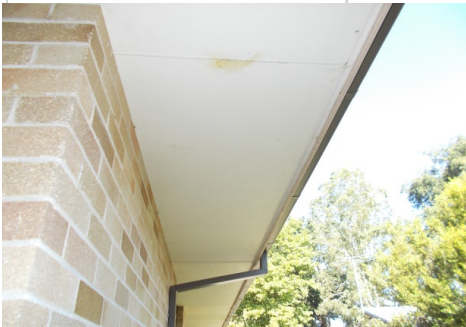
Ref No.	Date Identified	Clearance Cert Date	Onsite Register	Last Inspection Date	Next Inspection Date
	1271	19/12/2014		Yes	15-May-2019	15-May-2024
	Accessibility	Material	Extent	Result		
	Accessible	Fibreboard		Chrysotile		
	Friability	Sealed / Surface Treatment	Risk Assessment	Control Actions	Labels Affixed	
Non Friable	Sealed	RA04 - Very Low	No Remedial Action - Reinspect Periodically	No		
Specific Location						
Blaxland Community Health Centre - External - Eastern Awning Lining						
Additional Comments						GPS Lat,Long
Sample - 25132-46-1

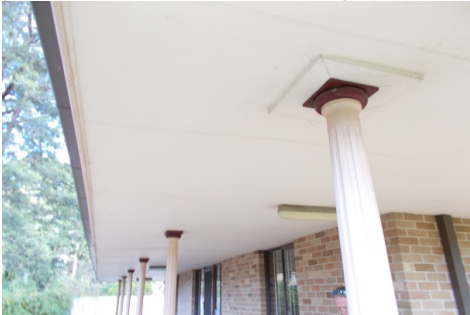
Ref No.	Date Identified	Clearance Cert Date	Onsite Register	Last Inspection Date	Next Inspection Date	
	1272	19/12/2014		Yes	15-May-2019	15-May-2024	
	Accessibility	Material	Extent	Result			
	Accessible	Fibreboard		Assumed Positive			
	Friability	Sealed / Surface Treatment	Risk Assessment	Control Actions	Labels Affixed		
	Non Friable	Sealed	RA04 - Very Low	No Remedial Action - Reinspect Periodically	No		
	Specific Location						
Blaxland Community Health Centre - External - Eastern Awning Lining							
Additional Comments						GPS Lat,Long	
Sample - Similar to 25132-46-1

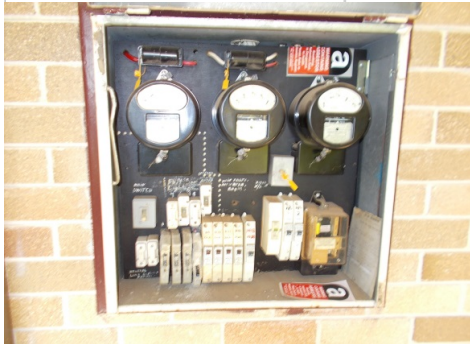
Ref No.	Date Identified	Clearance Cert Date	Onsite Register	Last Inspection Date	Next Inspection Date	
	1274	19/12/2017		Yes	15-May-2019	15-May-2024	
	Accessibility	Material	Extent	Result			
	Accessible	Bituminous Backing Board		Chrysotile			
	Friability	Sealed / Surface Treatment	Risk Assessment	Control Actions	Labels Affixed

Non Friable	Sealed	RA04 - Very Low	No Remedial Action - Reinspect Periodically	No		
	Specific Location						
Blaxland Community Health Centre - External Northern Perimeter Electrical Box Electrical Backing Board							
Additional Comments						GPS Lat,Long	
Sample - 25132-46-2
