Asbestos Register and Management Plan

Report N°: 18/167871

The site is located: 1-59 Ridgewell Road, Blackheath, NSW 2785

Asset Name:	Rhododendron Garden	Date:	2-7-2019	RAR No:	45
Asset Address:	1-59 Ridgewell Road Blackheath	Inspection Carried Out By:	Brian Ashton	HPE No:	18/167871
Are Staff/PCBU aware that there is ACM onsite?	Yes				
Is there a copy of the Asbestos Register for this location onsite?	Yes				
Is there a copy of the Asbestos Management Plan for this location onsite?	Yes				
Is there a Warning Asbestos Onsite Label	No

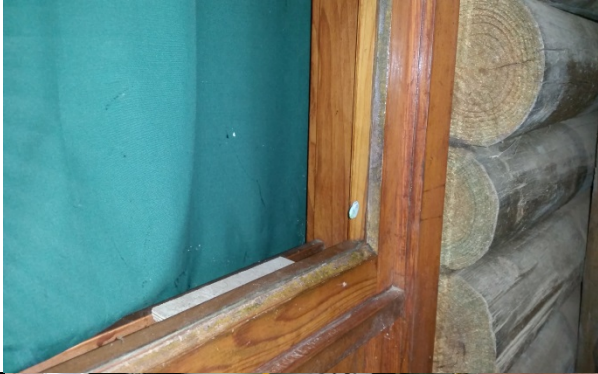
Reference Number Int / Ext Floor Specific Location	Photographs
1118 Window Putty Throughout

37272 - 118	Admin Building - The Rhododendron Gardens - 1-59 Ridgewell Road, Blackheath - Windows throughout	1g mastic fragment	Chrysotile asbestos detected
37272 - 119	Admin Building - The Rhododendron Gardens - 1-59 Ridgewell Road,	1g fibreboard fragment	No asbestos detected Organic fibres detected

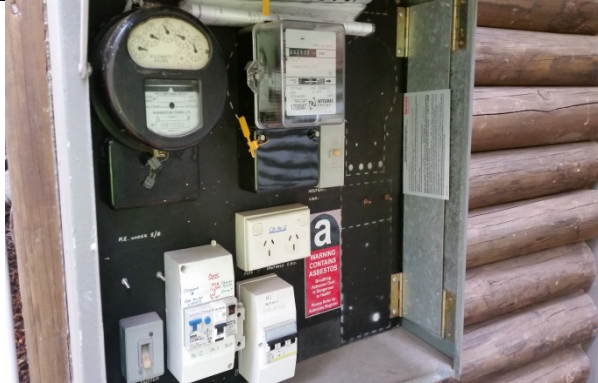
1119 Electrical Box
