Amenities Block

Asbestos Register & Management Plan

DOCUMENT NO.	DATA ENTRY		APPROVED & AUTHORISED	
	DATE	PERSONNEL	DATE	PERSONNEL
Blackheath Caravan Park53694101 02022AMR	10/10/2022	Luke Trevena	19/12/2022	Jason Adams

Blue Mountains City Council were commissioned by Blue Mountains City Council to conduct Asbestos Management Register for the building located at 67 Prince Edward Street Blackheath NSW 2785.

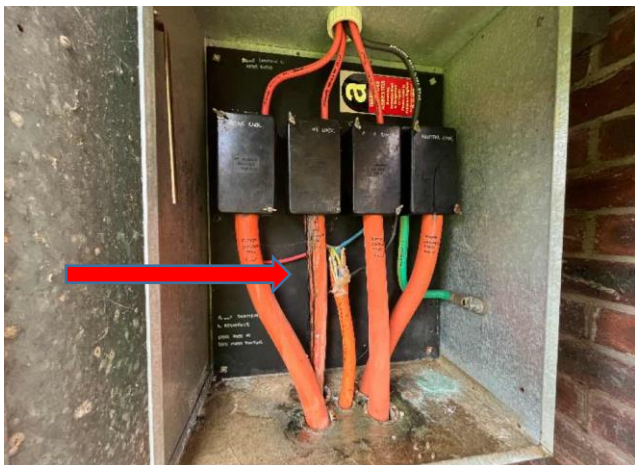
External, GF, Exterior, External cabinet - link panel 1 - Electrical backing board, Suspected Asbestos, Assumed positive

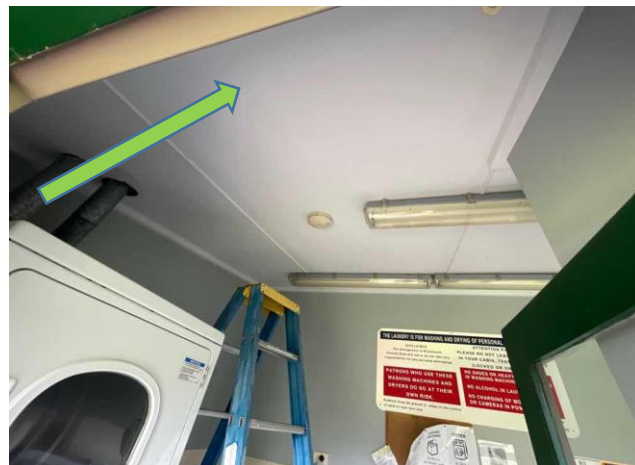
Internal, GF, Laundry, Laundry Ceiling Lining - Fibreboard, Assumed Negative, Similar to 37272-5

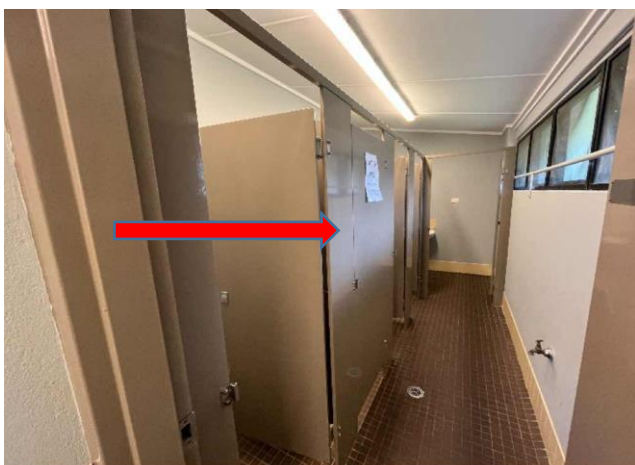
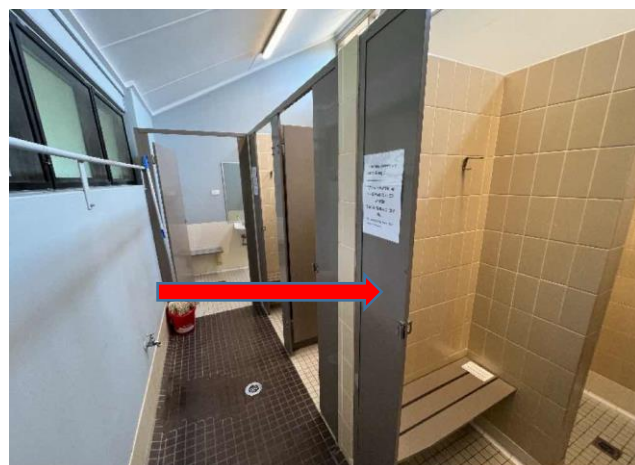
Internal, GF, Men's Bathroom, Toilet Partition Walls - Fibreboard, Chrysotile Asbestos, 37272-6

37272 - 6	Asset E00409 – Amenities Block Men’s bathroom – Blackheath tourist park – Toilet partition walls	15x7x3mm fibreboard fragment	Chrysotile asbestos detected Organic fibres detected
37272 - 7	Asset E00409 – Amenities Block Old boiler room/ Gas room – Blackheath tourist park – Ceiling lining and fragments	15x5x3mm fibreboard fragment	No asbestos detected Organic fibres detected
37272 - 8	Asset E00440 – Pump House Pump (Green) – Blackheath tourist park – Gasket	1g fibrous gasket fragments	No asbestos detected Organic fibres detected Synthetic mineral fibres detected
37272 - 9	Blackheath Tourist Park – Wattle Cabins Wattle Cabin 4 – Fragment on ground	190x5x3mm fibreboard fragment	No asbestos detected Organic fibres detected
37272 - 10	Blackheath Tourist Park – Wattle Cabins Wattle Cabin 4 – Sub floor – Packer	10x5x2mm fibreboard fragment	No asbestos detected Organic fibres detected
37272 - 11	Blackheath Tourist Park – Wattle Cabins Wattle Cabin 2 – Sub floor – Packer	40x25x5mm fibreboard fragment	No asbestos detected Organic fibres detected

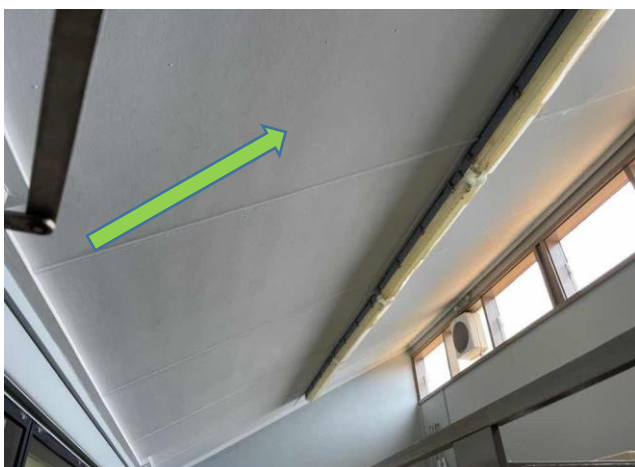
Internal, GF, Women's Bathroom, Ceiling Lining - Fibreboard, Assumed Negative, Similar to 37272-5

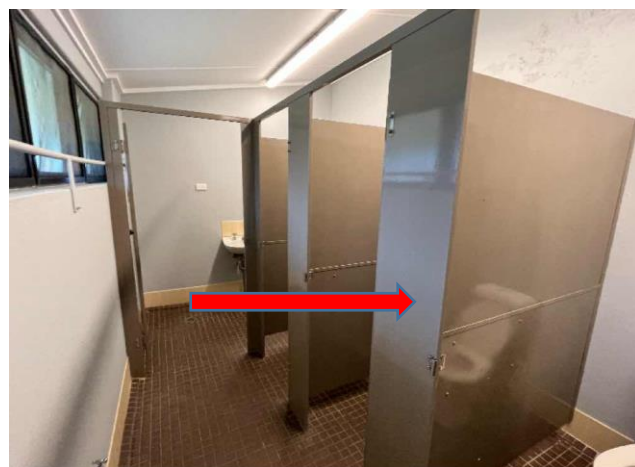
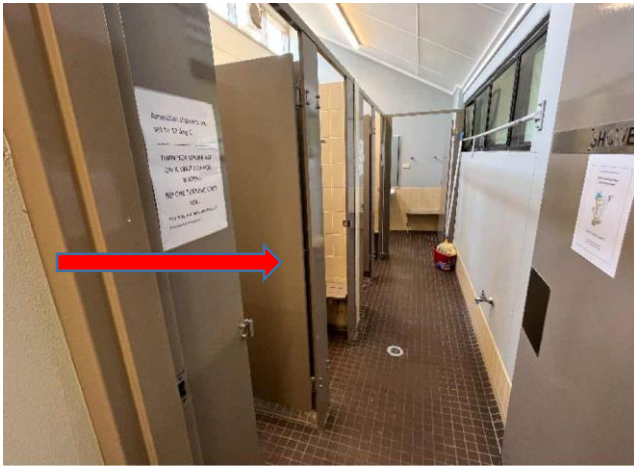
#	REF #	HAZARD	RESULT	SPECIFIC LOCATION	MATERIAL	QUANTITIY	FRIABILITY	OVERALL RISK	ACTION CODE	TIMEFRAME	COMMENTS
6 & 7	Similar to Sample 37272-6	Asbestos	Assumed Positive	Toilet Partition Walls	Fibreboard	20 m ²	Non-Friable	Very Low	A4	5 Yearly Reinspection	-
-	Similar to 37272-4 - Assumed Negative	Asbestos	Assumed Negative	Wall Cladding	Fibreboard	-	-	-	A6 - Investigate	-	-

Internal, GF, Women's Bathroom, Toilet Partition Walls - Fibreboard, Assumed Positive, Similar to Sample 37272-6
