ASBESTOS REGISTER

LAPSTONE TENNIS CLUB

2 EXPLORERS ROAD, LAPSTONE

**Project No.
37272**

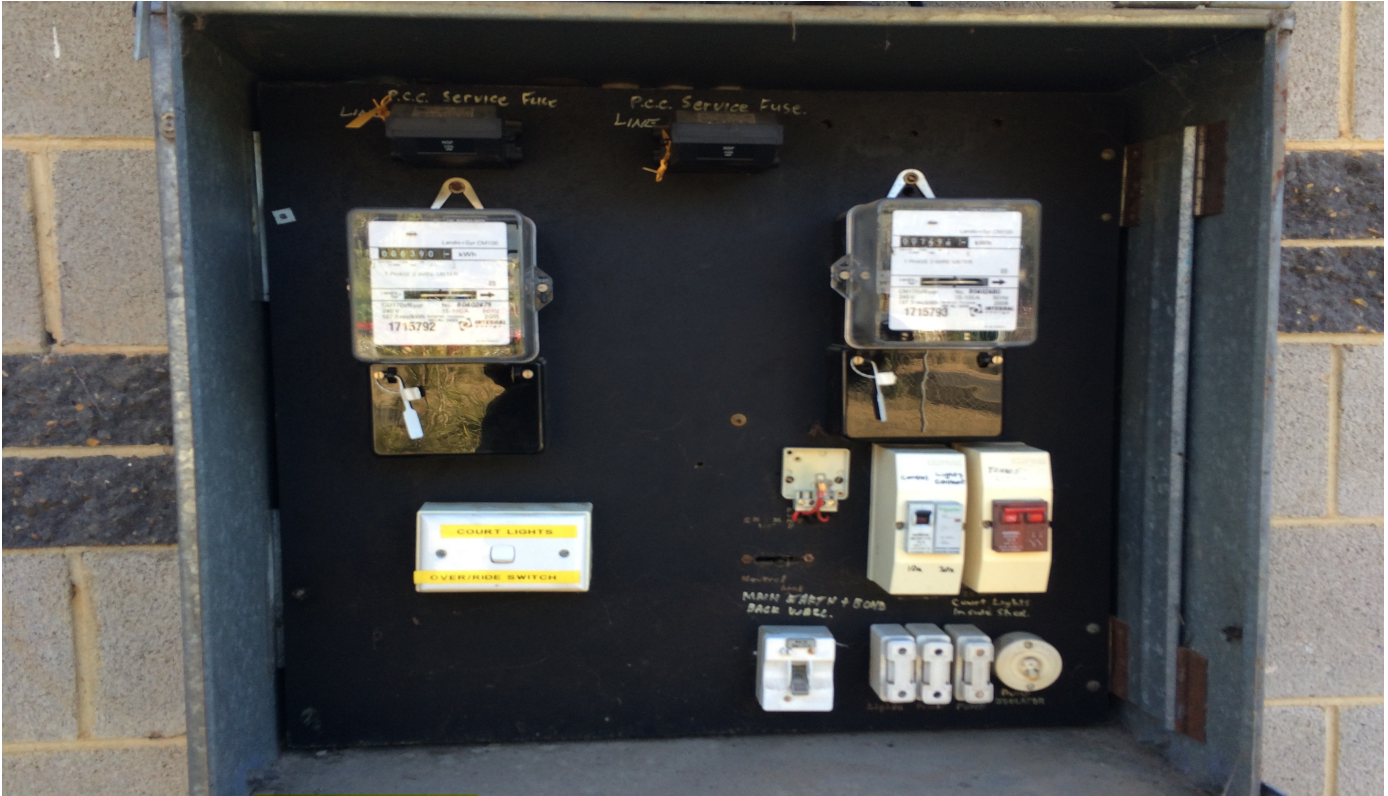
Location	Material	Sample ID	Sample Status	Photo No.	Asbestos Classification	Condition	Accessibility	Re-inspect	Current Label	Control Measure	Record of Works Undertaken
E00319 – Shelter Shed (Tennis Courts)											
3202	No material suspected of containing asbestos identified at the time of inspection.										
D00156 – Tennis Clubhouse											
External											
Switchboard – Electrical backing board 1741	Electrical Backing Board	-	Assumed Positive	23	Bonded	Stable	Low	September 2021	Labeled	4	-

Photo 23: D00156 – Tennis Clubhouse – Explorers Road, Lapstone – Switchboard – Electrical backing board.

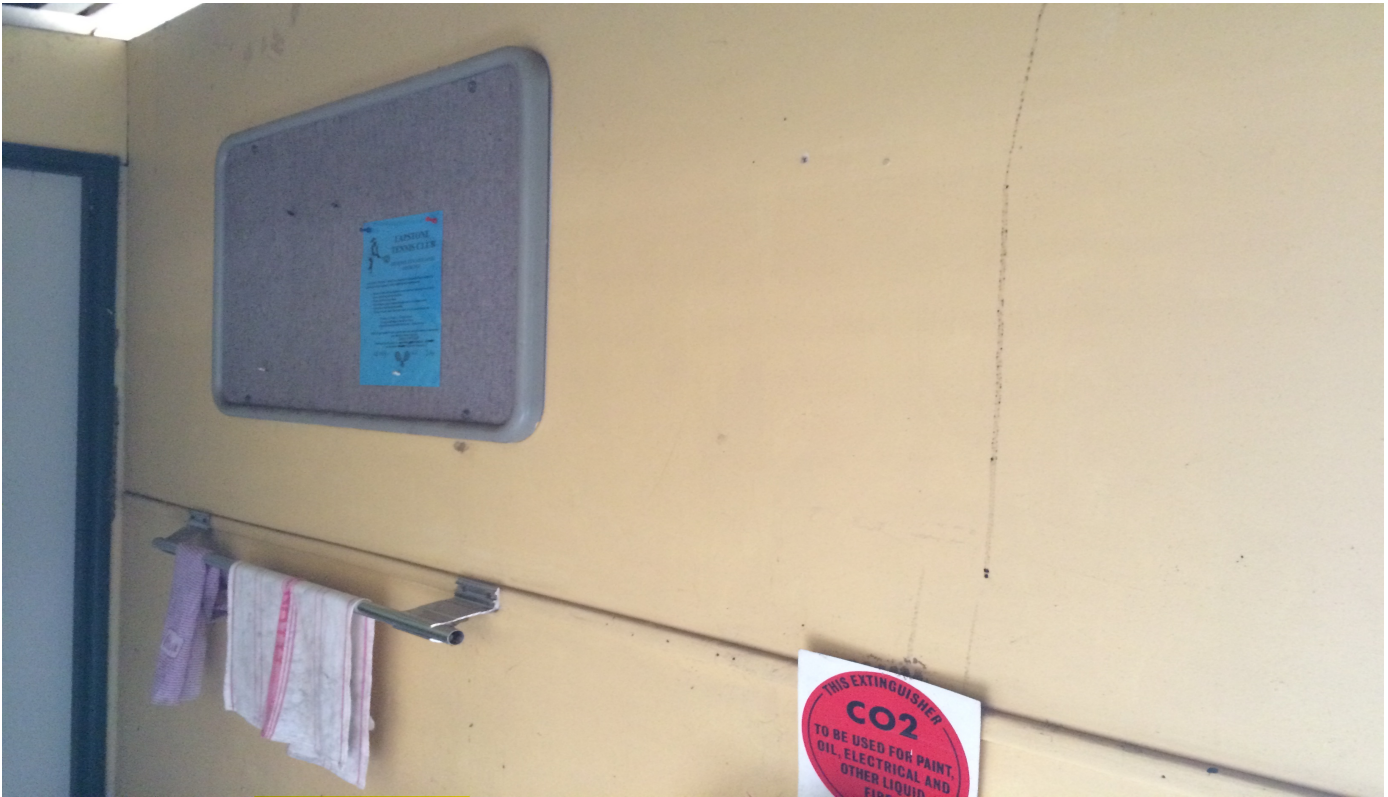
Location	Material	Sample ID	Sample Status	Photo No.	Asbestos Classification	Condition	Accessibility	Re-inspect	Current Label	Control Measure	Record of Works Undertaken
Internal											
Women's – Ceiling lining 1745	Fibreboard	37272-54	Negative	-	-	-	-	-	-	-	-
Women's – Infill strip above brickwork 1747	Fibreboard	Similar to 37272-54	Assumed Negative	-	-	-	-	-	-	-	-
Men's – Ceiling lining 1749	Fibreboard	Similar to 37272-54	Assumed Negative	-	-	-	-	-	-	-	-
Kitchenette – Ceiling lining 1752	Fibreboard	Similar to 37272-54	Assumed Negative	-	-	-	-	-	-	-	-
Kitchenette – Wall cladding 1754	Fibreboard	37272-55	Positive	24	Bonded	Stable	Low	September 2021	-	4	-

37272 – 55	D00156 – Tennis Clubhouse - Explorers Road, Lapstone – Kitchenette – Wall cladding	15x10x2mm fibreboard fragment	Chrysotile asbestos detected Organic fibres detected
37272 – 56	D00048 – Lawson Council Building and Library - 5-7 Loftus Street, Lawson - Window Mastic	1g mastic fragment	No asbestos detected
37272 – 57	D00048 – Lawson Council Building and Library - 5-7 Loftus Street, Lawson - Upper level – Infill panels above entry windows	20x15x3mm fibrous cement sheet fragment	Chrysotile asbestos detected
37272 – 58	D00048 – Lawson Council Building and Library - 5-7 Loftus Street, Lawson - Upper level – Entry ceiling lining	5x3x1mm fibrous cement sheet fragment	Chrysotile asbestos detected
37272 – 59	D00048 – Lawson Council Building and Library - 5-7 Loftus Street, Lawson - Upper level – Rear kitchenette – Ceiling lining	5x3x2mm fibrous cement sheet fragment	Chrysotile asbestos detected

Photo 24: D00156 – Tennis Clubhouse – Explorers Road, Lapstone – Kitchenette – Wall cladding.
