ASBESTOS REGISTER

LAWSON LIBRARY

1 LOFTUS STREET, LAWSON

**Blue Mountains City
Council – August 2017**

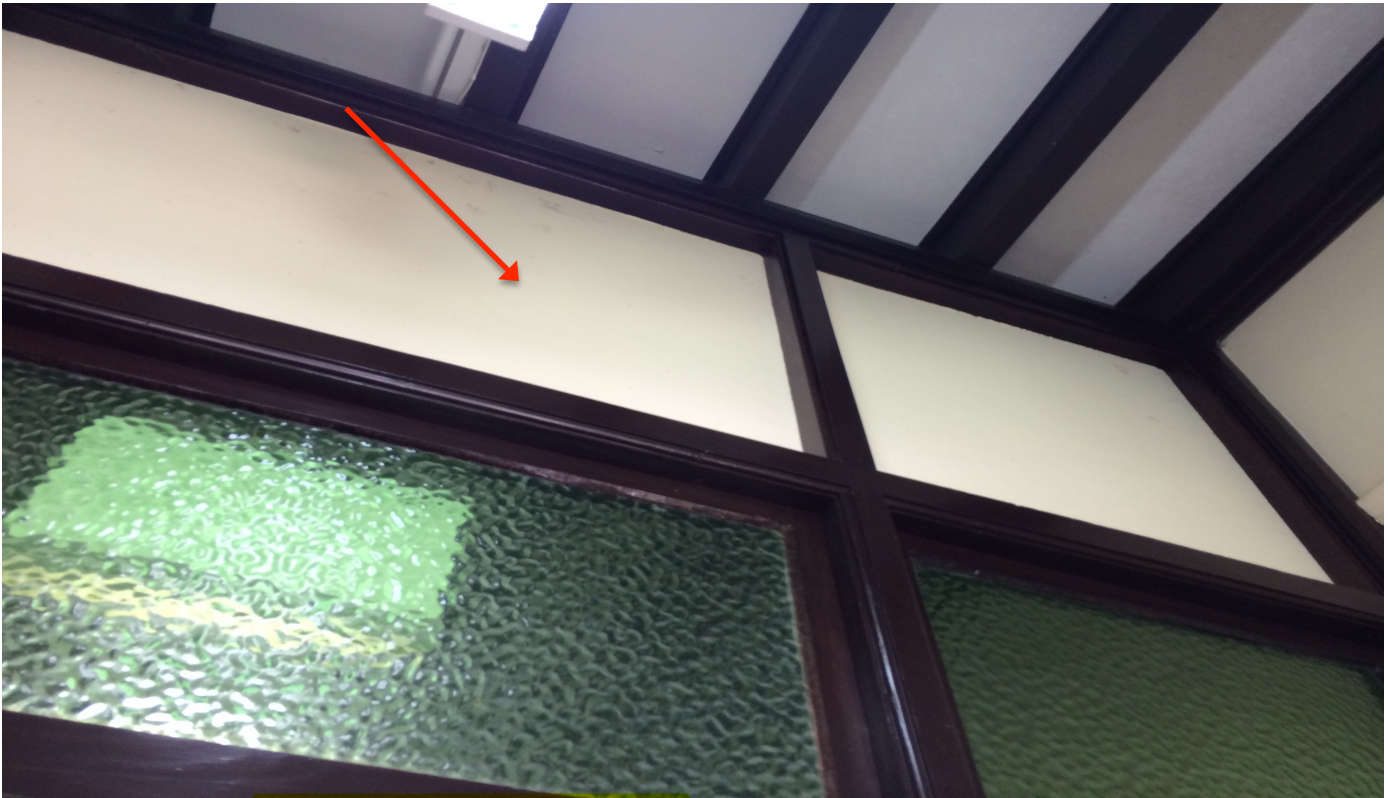
Location	Material	Sample ID	Sample Status	Photo No.	Asbestos Classification	Condition	Accessibility	Re-inspect	Current Label	Control Measure	Record of Works Undertaken
D00048 – Lawson Council Building and Library											
External											
Window Mastic 1867	Mastic	37272-56	Negative	-	-	-	-	-	-	-	-
Internal											
Upper level – Infill panels above entry windows 1868	Fibrous Cement Sheeting	37272-57	Positive	25	Bonded	Stable	Low	September 2021	-	4	-
Upper level – Entry ceiling lining 1869	Fibrous Cement Sheeting	37272-58	Positive	26	Bonded	Stable	Low	September 2021	-	4	-

Photo 25: D00048 – Lawson Council Building and Library – 1 Loftus Street, Lawson – Upper level – Infill panels above entry windows.

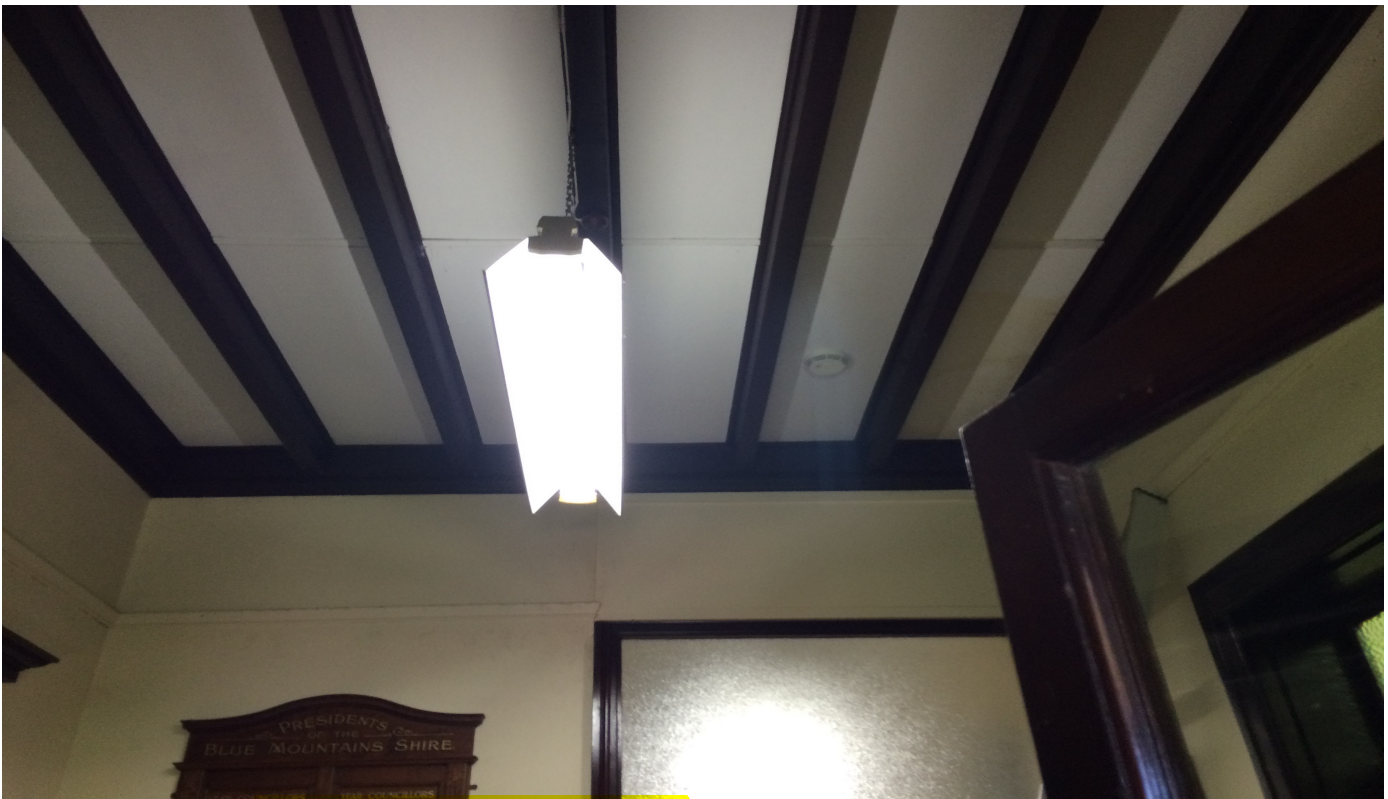
Photo 26: D00048 – Lawson Council Building and Library – 1 Loftus Street, Lawson – Upper level – Entry ceiling lining.

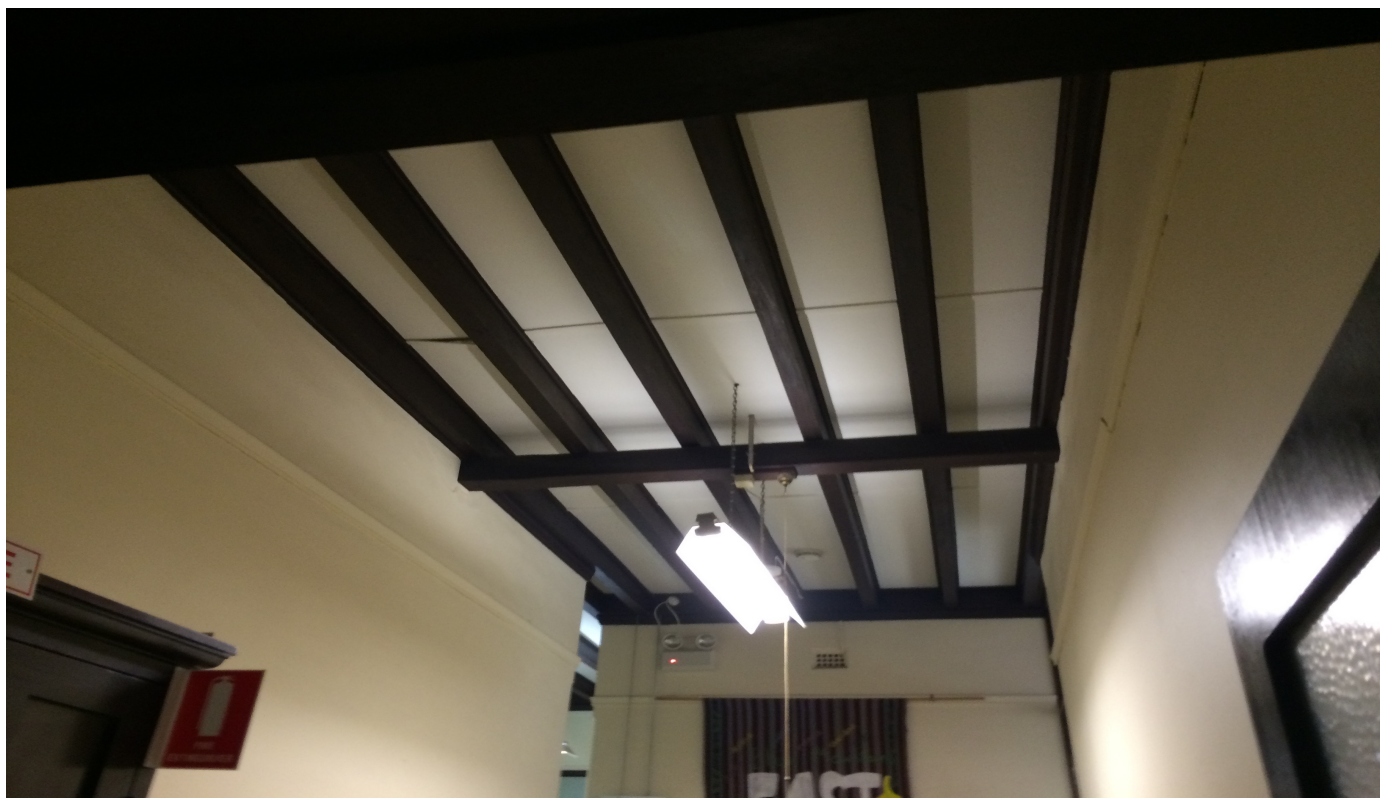
Location	Material	Sample ID	Sample Status	Photo No.	Asbestos Classification	Condition	Accessibility	Re-inspect	Current Label	Control Measure	Record of Works Undertaken
Upper level – Ceiling throughout – Day care/ Hallway/ Offices/ Library 1870	Fibrous Cement Sheeting	Similar to 37272-58	Assumed Positive	27	Bonded	Stable	Low	September 2021	-	4	-
Upper level – Rear kitchenette – Ceiling lining 1871	Fibrous Cement Sheeting	37272-59	Positive	28	Bonded	Stable	Low	September 2021	-	4	-
Upper level – Ceiling throughout rear – Hallway/ LME label room/ Bathroom 1872	Fibrous Cement Sheeting	Similar to 37272-59	Assumed Positive	-	Bonded	Stable	Low	September 2021	-	4	-
Upper level – Library – Rear infill panel 1873	Fibrous Cement Sheeting	37272-60	Positive	29	Bonded	Stable	High	September 2021	-	4	-
Lower level – Subfloor fragments 1874	Fibreboard	37272-61	Positive	30	Bonded	Stable	Medium	September 2021	-	4	-

Photo 27: D00048 – Lawson Council Building and Library – 1 Loftus Street, Lawson – Example of Upper level – Ceiling throughout – Day care/ Hallway/ Offices/ Library.

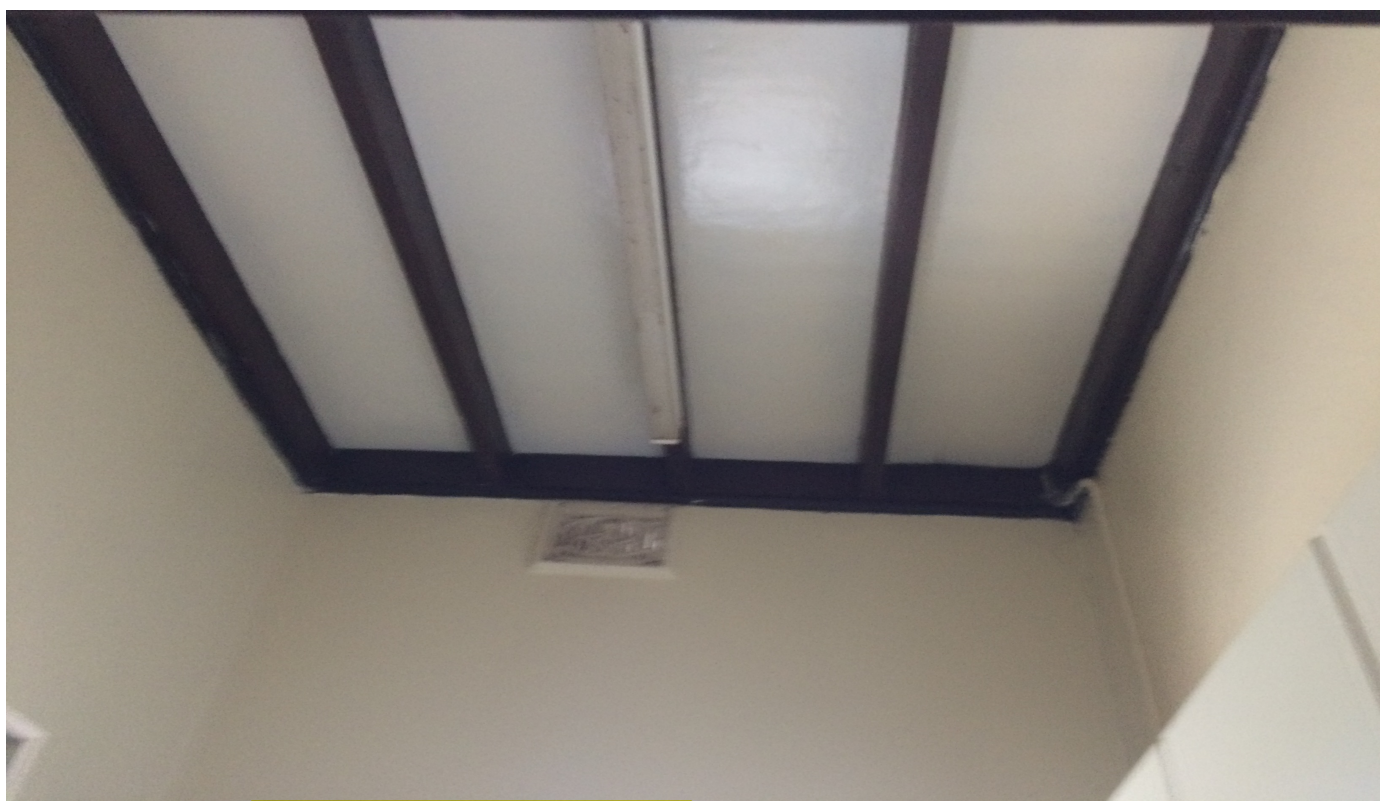
Photo 28: D00048 – Lawson Council Building and Library – 1 Loftus Street, Lawson – Upper level – Rear kitchenette – Ceiling lining.

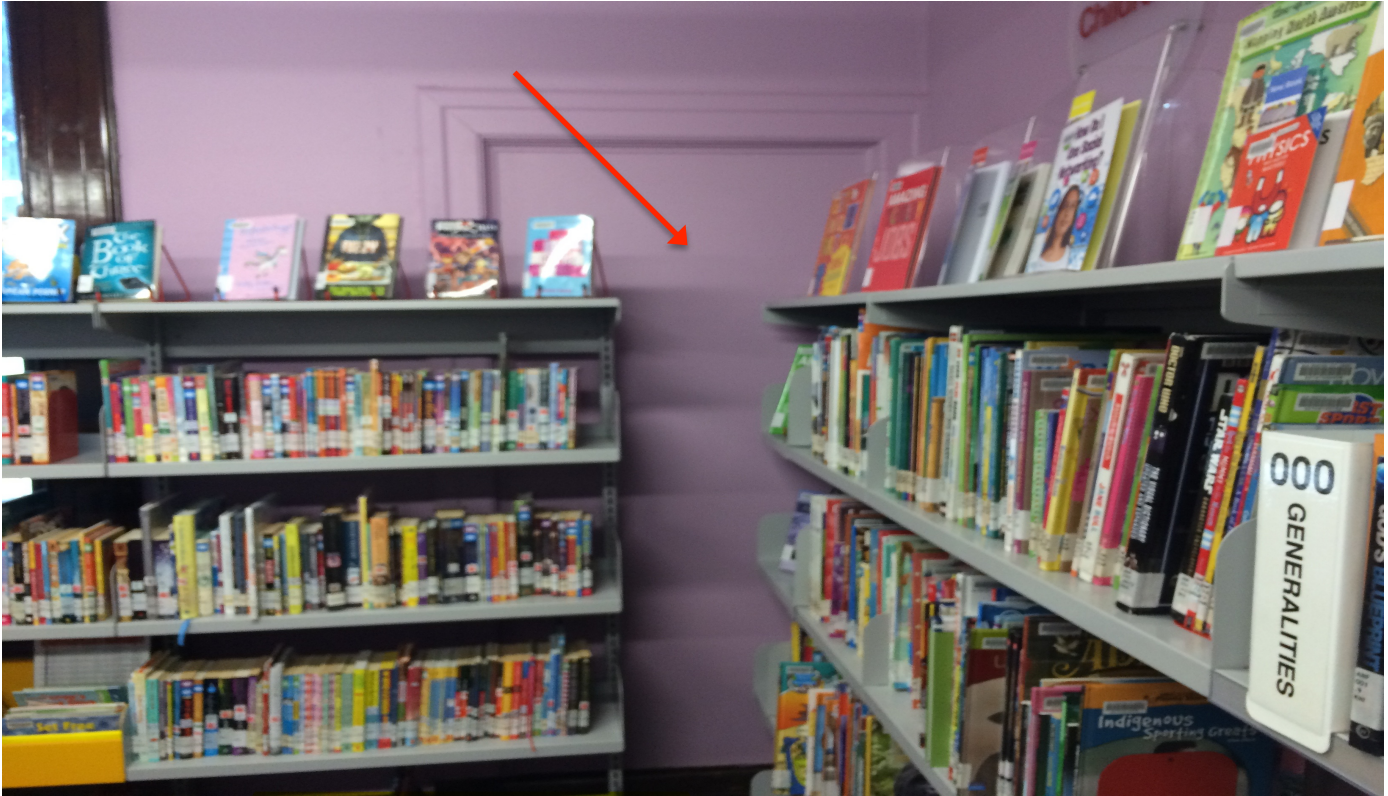
Photo 29: D00048 – **Lawson Council Building and Library** – 1 Loftus Street, Lawson – Upper level – Library – Rear infill panel.

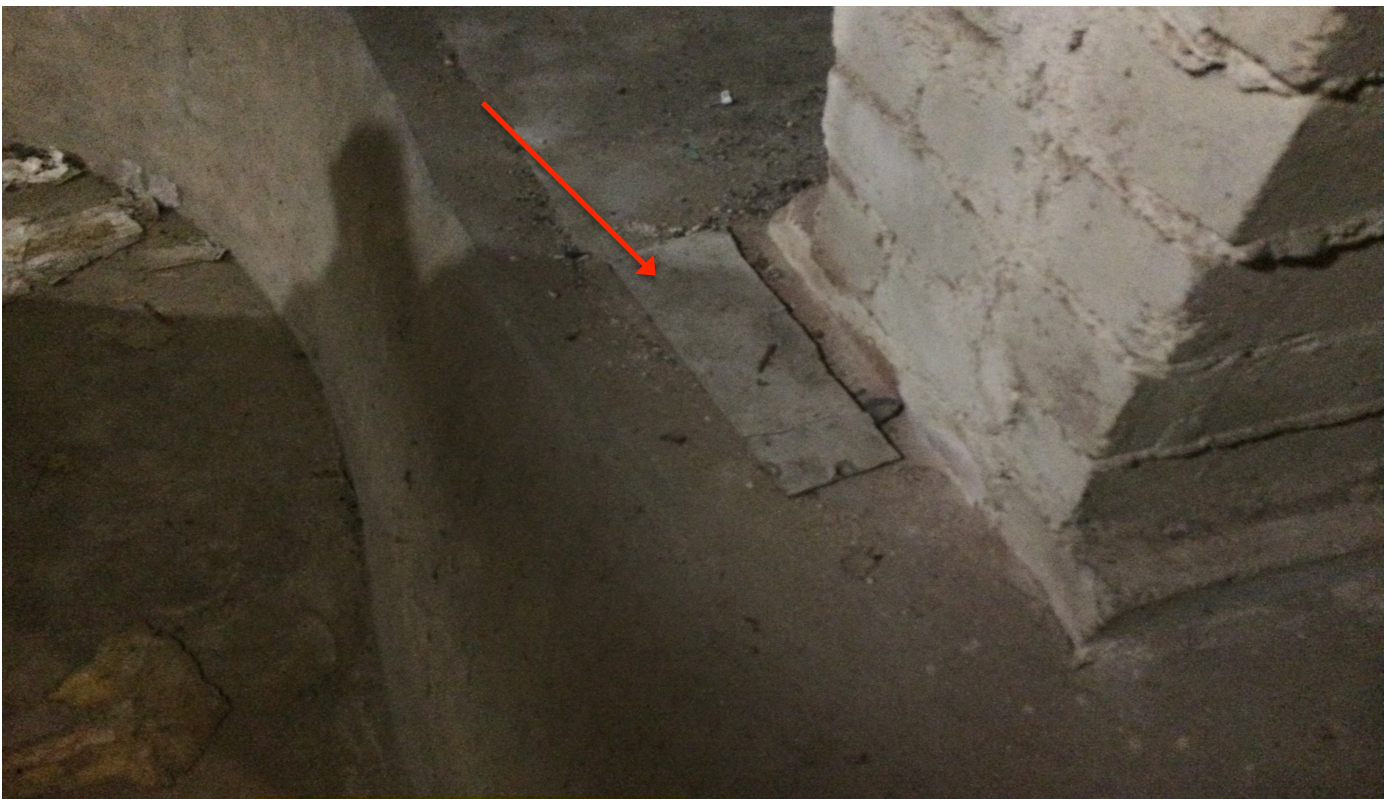
37272 – 61	D00048 – Lawson Council Building and Library - 1 Loftus Street, Lawson - Lower level – Subfloor fragments	90x60x5mm fibreboard fragment	Chrysotile asbestos detected Organic fibres detected
37272 – 62	D00048 – Lawson Council Building and Library - 1 Loftus Street, Lawson - Lower level – Bathroom – Partition wall adj. sink	10x3x2mm fibrous cement sheet fragment	Chrysotile asbestos detected
37272 – 63	D00048 – Lawson Council Building and Library - 1 Loftus Street, Lawson - Lower level – Bathroom ceiling lining	10x5x2mm fibrous cement sheet fragment	Chrysotile asbestos detected Organic fibres detected
37272 – 64	Heatherbrae House – 1 Benang Street, Lawson - Window Mastic	1g mastic fragment	No asbestos detected
37272 – 65	Heatherbrae House – 1 Benang Street, Lawson - Sub-floor – Packers	65x60x8mm fibreboard fragment	No asbestos detected Organic fibres detected
37272 – 66	Heatherbrae House – 1 Benang Street, Lawson - Bathroom – Wall cladding	5x5x2mm fibreboard fragment	No asbestos detected Organic fibres detected

Photo 30: D00048 – **Lawson Council Building and Library** – 1 Loftus Street, Lawson – Lower level – Subfloor fragments.

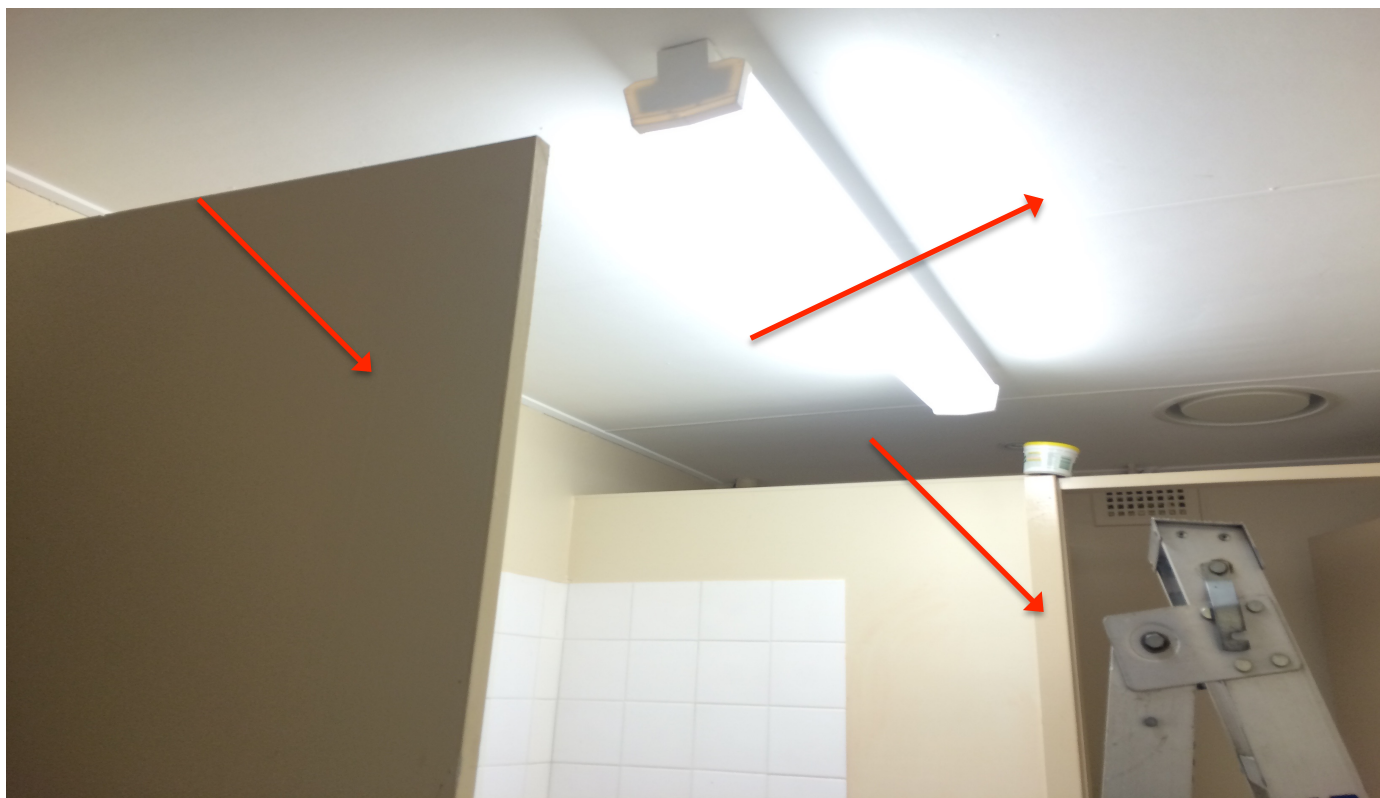
Lower level – Bathroom – Partition wall adj. sink 1875	Fibrous cement sheeting	37272-62	Positive	31	Bonded	Stable	High	September 2021	-	4	-
Lower level – Bathroom – Shower partition 1876	Fibrous cement sheeting	Similar to 37272-62	Assumed Positive	31	Bonded	Stable	High	September 2021	-	4	-

Location	Material	Sample ID	Sample Status	Photo No.	Asbestos Classification	Condition	Accessibility	Re-inspect	Current Label	Control Measure	Record of Works Undertaken
Lower level – Bathroom ceiling lining 1877	Fibreboard	37272-63	Positive	31	Bonded	Stable	Low	September 2021	-	4	-

Photo 31: D00048 – Lawson Council Building and Library – 1 Loftus Street, Lawson – Lower level – Bathroom – Partition walls and ceiling lining.
