**ASBESTOS REGISTER**

**HEATHERBRAE HOUSE**

**1 BENANG STREET**

**LAWSON**

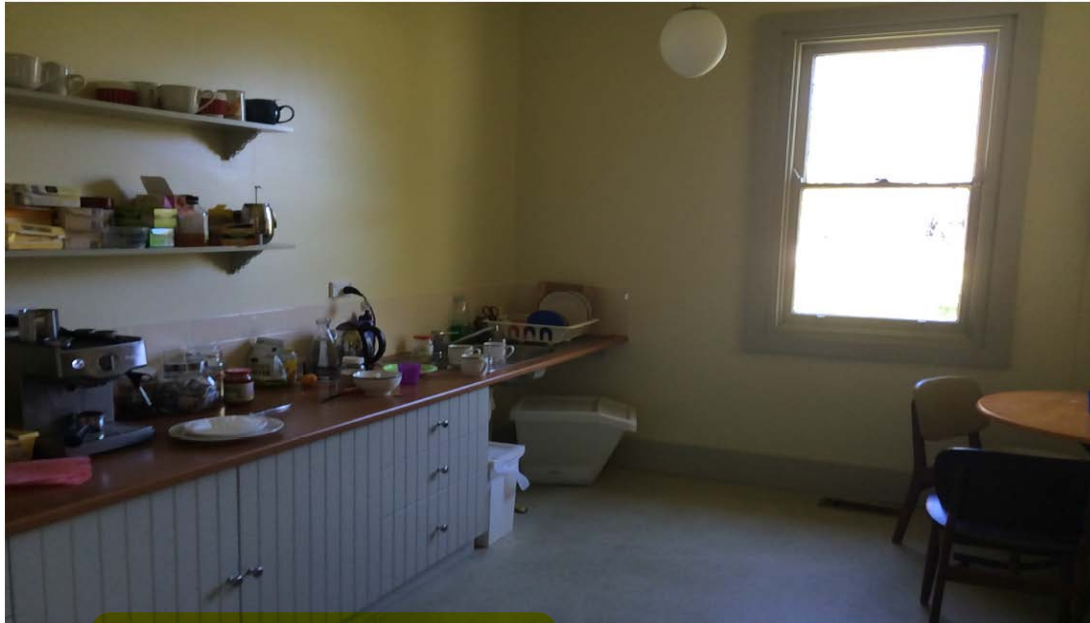
Photo 34: Heatherbrae House – 1 Benang Street, Lawson - Bathroom – Kitchen – Wall cladding.

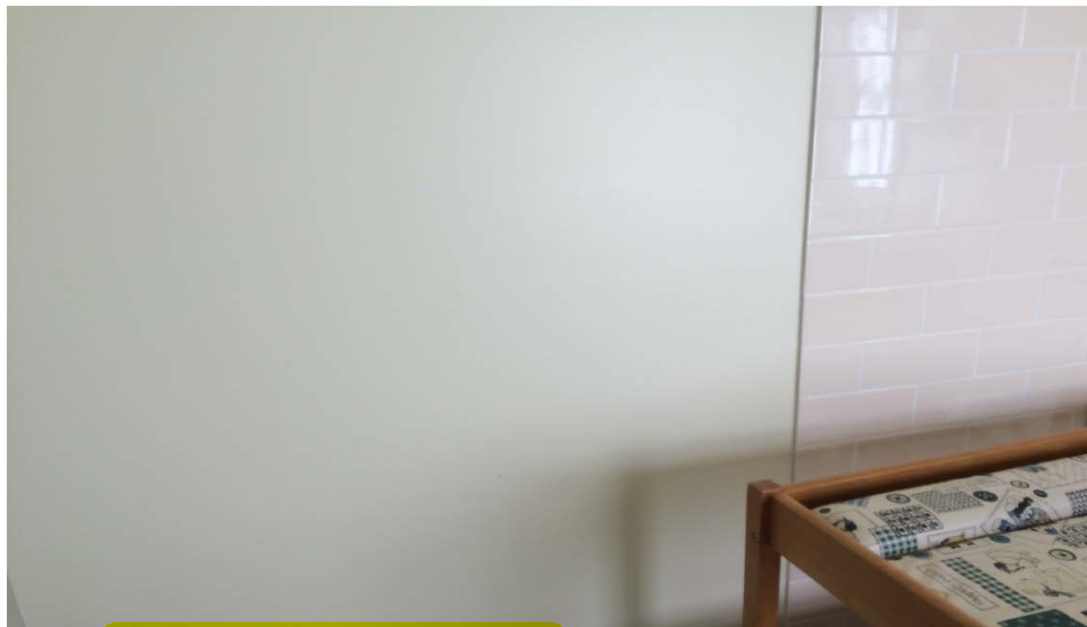
Photo 33: Heatherbrae House – 1 Benang Street, Lawson - Bathroom – Bathroom – Wall cladding.

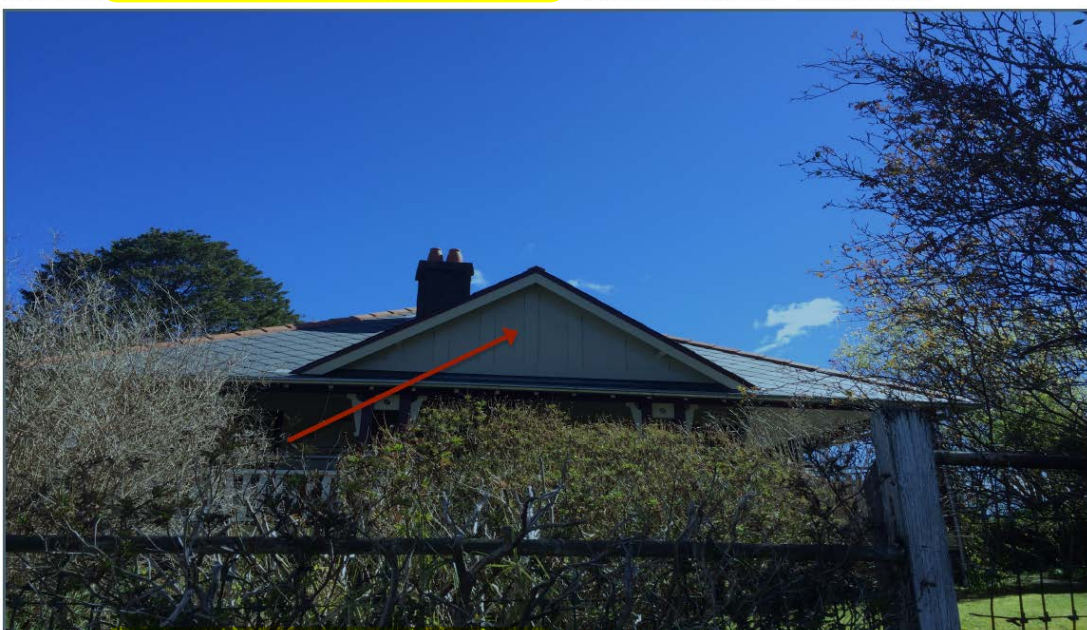
Photo 32: Heatherbrae House – 1 Benang Street, Lawson – Gable linings

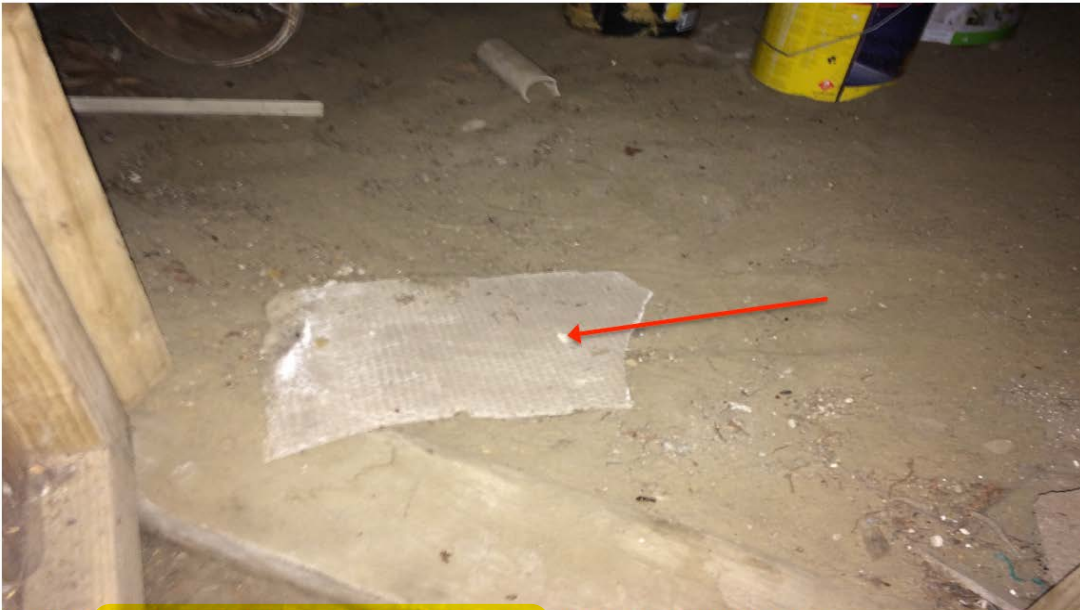
1854	2237	Sub-floor – Redundant sheet	Fibrous cement sheeting	37272-68	Positive	37	Bonded	Unstable	Low	Sep-21	-	3	-

Photo 37: Heatherbrae House – 1 Benang Street, Lawson - Sub-floor – Redundant sheet.

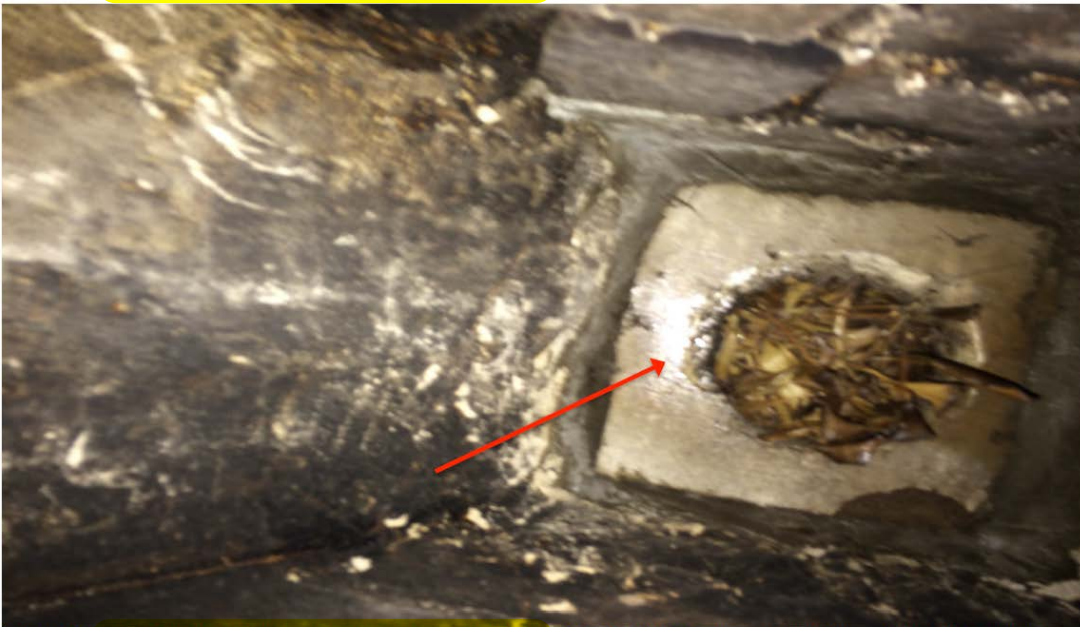
Photo 36: Heatherbrae House – 1 Benang Street, Lawson - Children's play area – Fireplace – Formwork around chimney.

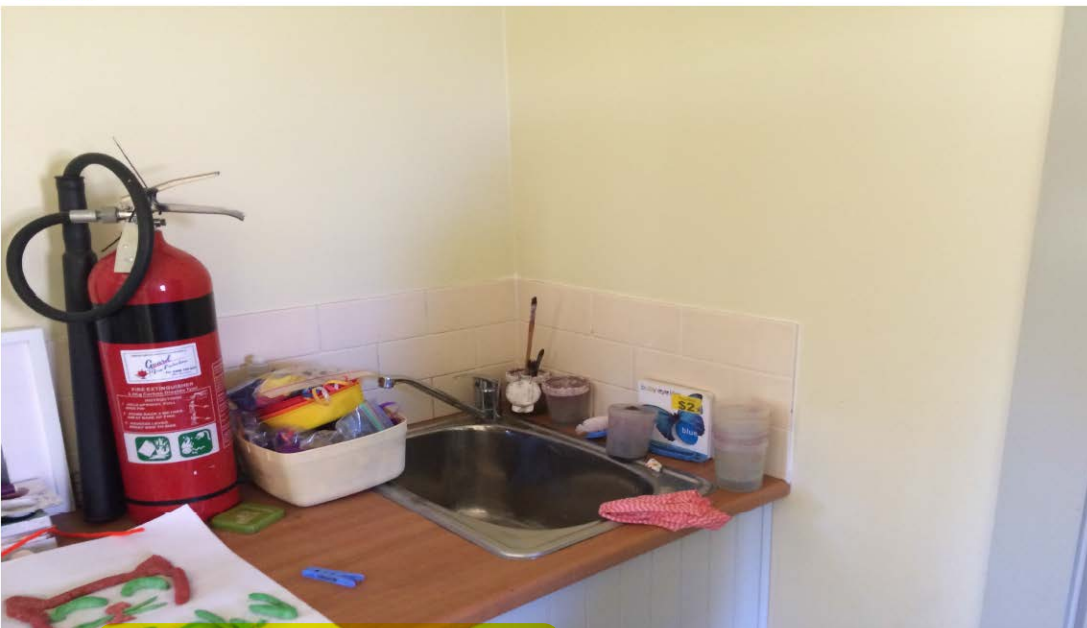
Photo 35: Heatherbrae House – 1 Benang Street, Lawson - Bathroom – Hallway – Wall cladding.
