ASBESTOS REGISTER

LAWSON POOL
TOILET BLOCK, SWIMMING POOL
PUMP BUILDING & 4 SHELTER
SHEDS

2-16 ST BERNARDS DRIVE, LAWSON

**Blue Mountains City
Council – August 2017**

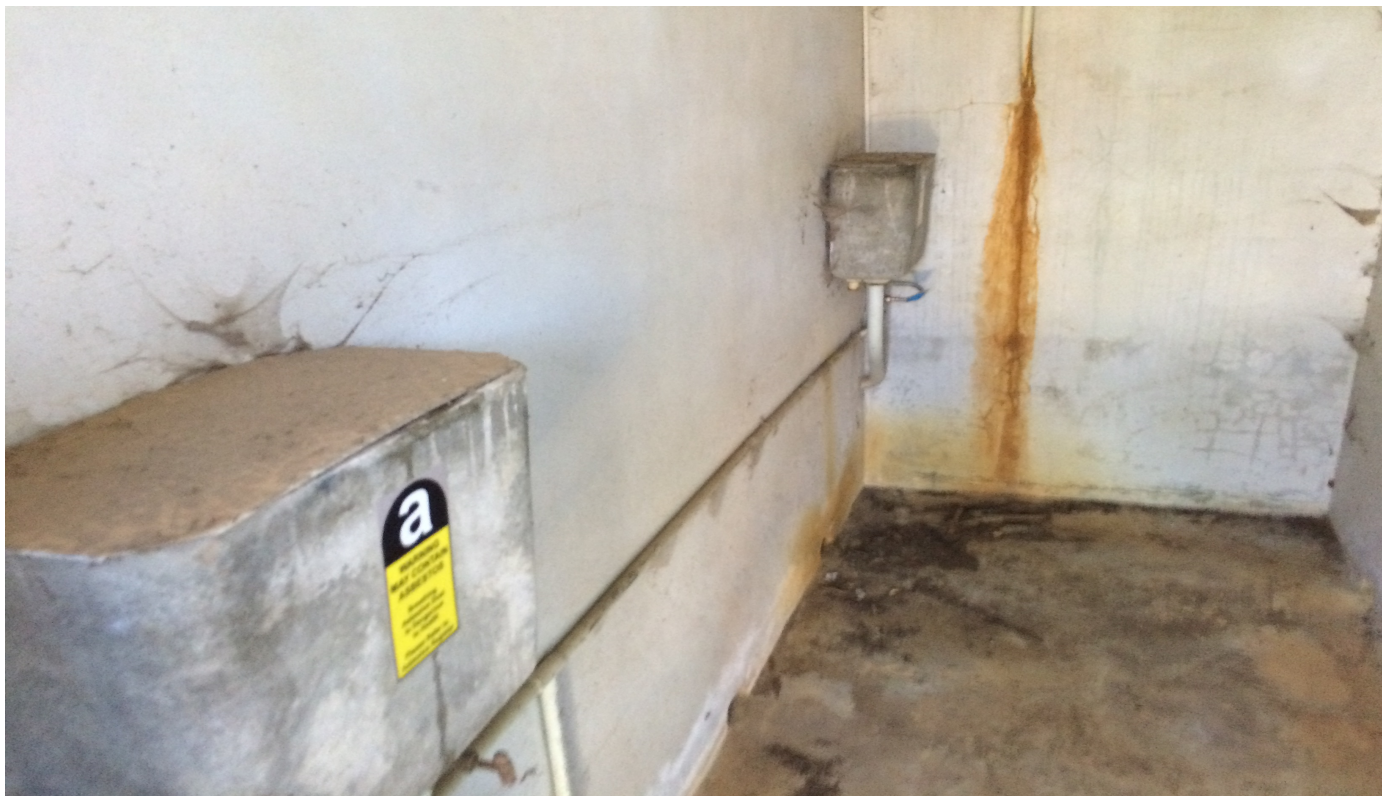
Location	Material	Sample ID	Sample Status	Photo No.	Asbestos Classification	Condition	Accessibility	Re-inspect	Current Label	Control Measure	Record of Works Undertaken
E00133 – Toilet Block											
Internal											
Tank room – Cement tanks x3 1845	Fibrous cement sheeting	37272-69	Positive	38	Bonded	Stable	Medium	September 2021	Labeled	4	-
Swimming Pool											
External											
Main inlet pipe. Continues underground after valve and polyurethane pipe – North of swimming pool 1846	Fibrous cement	37272-70	Positive	39	Bonded	Stable	Low	September 2021	-	4	-

37272 – 69	E00133 – Toilet Block - Lawson Swimming Pool – 2-16 St Bernards Drive, Lawson - Tank room – Cement tanks x3	5x5x2mm fibrous cement sheet fragment	Chrysotile asbestos detected
37272 – 70	E00133 – Toilet Block - Lawson Swimming Pool – 2-16 St Bernards Drive, Lawson - Main inlet pipe. Continues underground after valve and polyurethane pipe – North of swimming pool	5x5x2mm fibrous cement sheet fragment	Chrysotile asbestos detected Amosite asbestos detected
37272 – 71	E00521 – Shelter Shed 4 (North) - Lawson Swimming Pool – 2-16 St Bernards Drive, Lawson – Wall cladding	10x10x2mm fibreboard fragment	No asbestos detected Organic fibres detected
37272 – 72	E00499 – Toilet Block - Carpark – Megalong Street, Leura - Ceiling linings	10x5x1mm fibreboard fragment	No asbestos detected Organic fibres detected
37272 – 73	E00499 – Toilet Block - Carpark – Megalong Street, Leura – Cubicle partitions	10x2x1mm fibreboard fragment	No asbestos detected Organic fibres detected

Photo 38: E00133 – Toilet Block - Lawson Swimming Pool – 2-16 St Bernards Drive, Lawson - Tank room – Cement tanks.

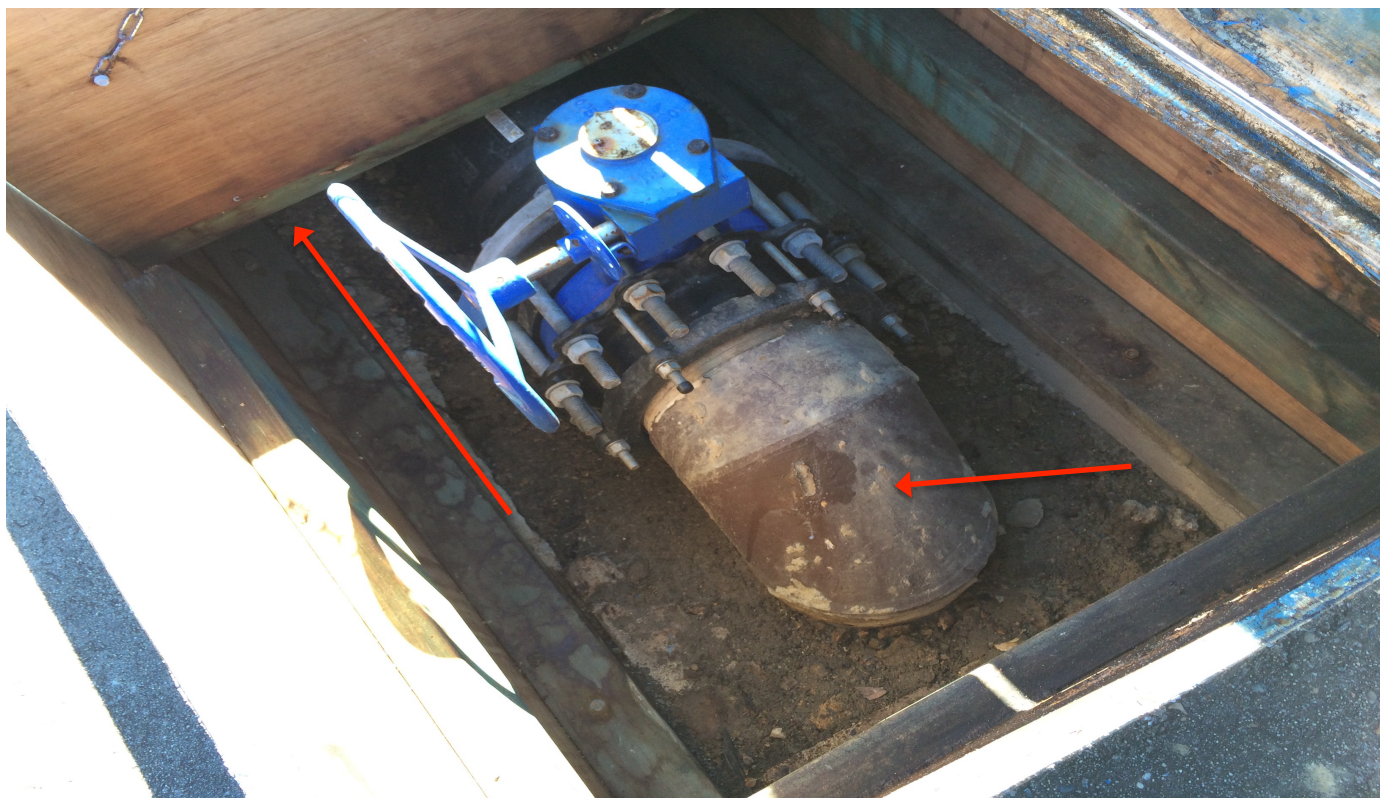
Photo 39: Lawson Swimming Pool – 2-16 St Bernards Drive, Lawson - Main inlet pipe. Continues underground after valve and polyurethane pipe – North of swimming pool.
