Asbestos Register

Management Plan

Leura Oval, 34-36 Gordon Road, Leura

Asbestos Register and Management Plan

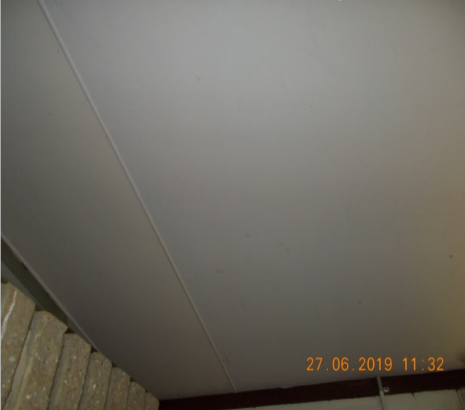
Licence Number	Address	Asset Type	Property Owner	Activity Level		
LEURA NSW 2780						
RAR-155	Leura Oval 34-36 Gordon Road LEURA	Sporting amenity	The Crown	Risks on site		
Amenties block						
Status: Active						
	Ref No.	Date Identified	Clearance Cert Date	Onsite Register	Last Inspection Date	Next Inspection Date
	1897	19/12/2014		Yes	27/06/2019	27/06/2024

Accessibility	Material	Extent	Result		
	Accessible	Fibreboard	8m2	Assumed Positive		
	Friability	Sealed / Surface Treatment	Risk Assessment	Control Actions	Labels Affixed	
	Non Friable	Sealed	RA04 - Very Low	No Remedial Action - Reinspect Periodically	Yes	
Specific Location						
Leura Oval - Amenities Block - Internal Male Toilets Ceiling Lining						
Additional Comments					GPS Lat,Long	
Sample - Similar to 25132-12-3 - Assumed Chrysotile

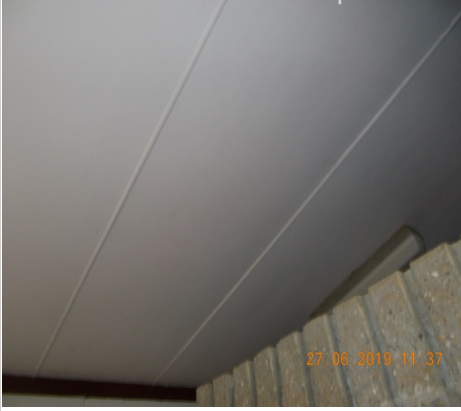
Ref No.	Date Identified	Clearance Cert Date	Onsite Register	Last Inspection Date	Next Inspection Date	
	1898	19/12/2014		Yes	27/06/2019	27/06/2024	
	Accessibility	Material	Extent	Result			
	Accessible	Fibreboard	8m2	Assumed Positive			
	Friability	Sealed / Surface Treatment	Risk Assessment	Control Actions	Labels Affixed		
	Non Friable	Sealed	RA04 - Very Low	No Remedial Action - Reinspect Periodically	Yes		
	Specific Location						
Leura Oval - Amenities Block - Internal Female Toilets Ceiling Lining							
Additional Comments					GPS Lat,Long		
Sample - Similar to 25132-12-3 - Assumed Chrysotile

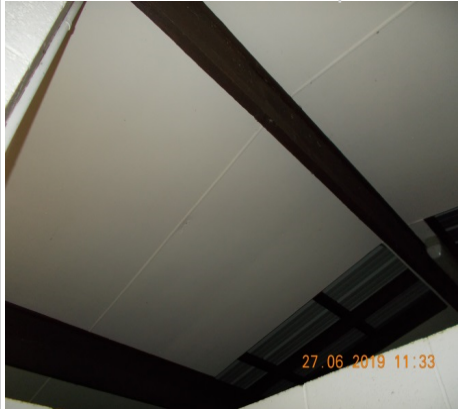
Ref No.	Date Identified	Clearance Cert Date	Onsite Register	Last Inspection Date	Next Inspection Date	
	1899	19/12/2014		Yes	27/06/2019	27/06/2024	
	Accessibility	Material	Extent	Result			
	Accessible	Fibreboard	14m2	Chrysotile			
	Friability	Sealed / Surface Treatment	Risk Assessment	Control Actions	Labels Affixed

Non Friable	Sealed	RA04 - Very Low	No Remedial Action - Reinspect Periodically	Yes		
	Specific Location						
Leura Oval Amenities - Internal - Changeroom #1 Ceiling Lining							
Additional Comments					GPS Lat,Long		
Sample - 25132-12-3

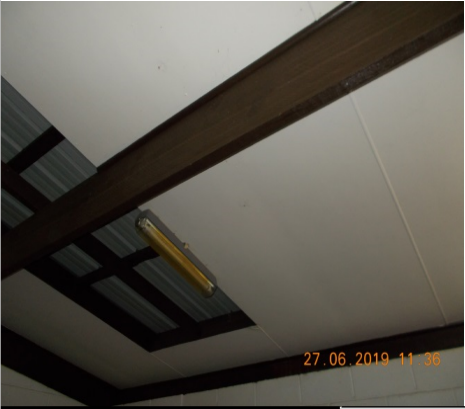
Ref No.	Date Identified	Clearance Cert Date	Onsite Register	Last Inspection Date	Next Inspection Date	
	1900	19/12/2014		Yes	27/06/2019	27/06/2024	
	Accessibility	Material	Extent	Result			
	Accessible	Fibreboard	14m2	Assumed Positive			
	Friability	Sealed / Surface Treatment	Risk Assessment	Control Actions	Labels Affixed		
	Non Friable	Sealed	RA04 - Very Low	No Remedial Action - Reinspect Periodically	Yes		
	Specific Location						
Leura Oval - Amenities Block - Internal Changeroom #1 Ceiling Lining							
Additional Comments						GPS Lat,Long	
Sample - Similar to 25132-12-3 - Assumed Chrysotile							
	Ref No.	Date Identified	Clearance Cert Date	Onsite Register	Last Inspection Date	Next Inspection Date	
	3205	19/12/2014		Yes	27/06/2019	27/06/2024	
	Accessibility	Material	Extent	Result			
	Inaccessible	Bonded Asbestos Sheeting	Approx 12m2	Chrysotile			
	Friability	Sealed / Surface Treatment	Risk Assessment	Control Actions	Labels Affixed

Non Friable	Sealed	RA04 - Very Low	No Remedial Action - Reinspect Periodically	Yes		
	Specific Location						
Leura Oval - Amenities Block - Internal Toilet Cistern Roof							
Additional Comments						GPS Lat,Long	
Assumed Positive
