ASBESTOS REGISTER

**SILVA PLANA RESERVE, TOILET
BLOCK**

12-14 THE AVENUE, MT WILSON

**Blue Mountains City
Council – August 2017**

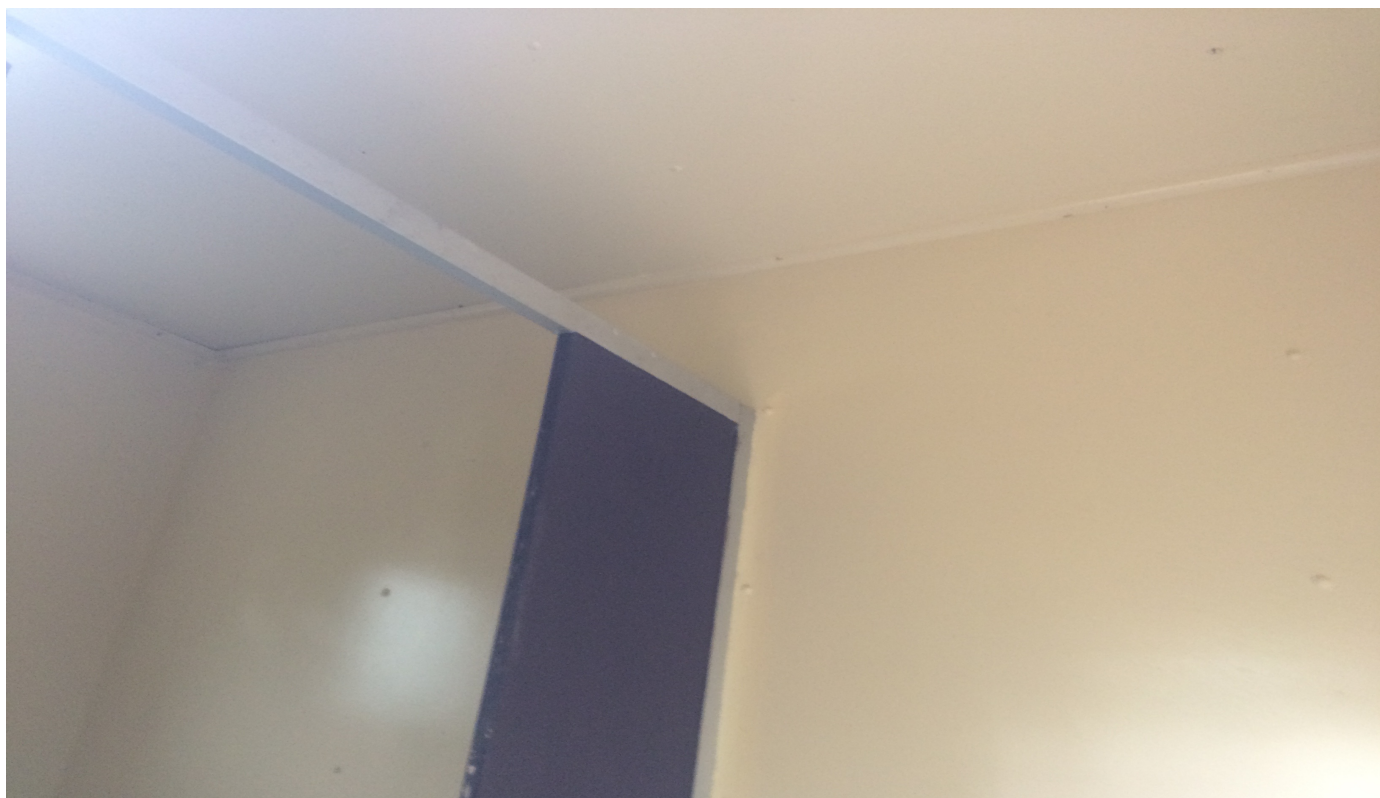
Location	Material	Sample ID	Sample Status	Photo No.	Asbestos Classification	Condition	Accessibility	Re-inspect	Current Label	Control Measure	Record of Works Undertaken
E00197 – Toilet Block											
Internal											
Wall cladding 1915	Fibreboard	37272-76	Positive	43	Bonded	Stable	High	September 2021	-	4	-
Ceiling lining 1916	Fibreboard	Similar to 37272-76	Assumed Positive	43	Bonded	Stable	High	September 2021	-	4	-

Photo 43: E00197 – Toilet Block - 12-14 The Avenue, Mount Wilson – Wall cladding and ceiling lining.
