**BLUE MOUNTAINS CITY
COUNCIL**

ASBESTOS REGISTER

**BUTTENSCHAW PARK MACHINERY
SHED**

**389-407 GREAT WESTERN HIGHWAY,
SPRINGWOOD**

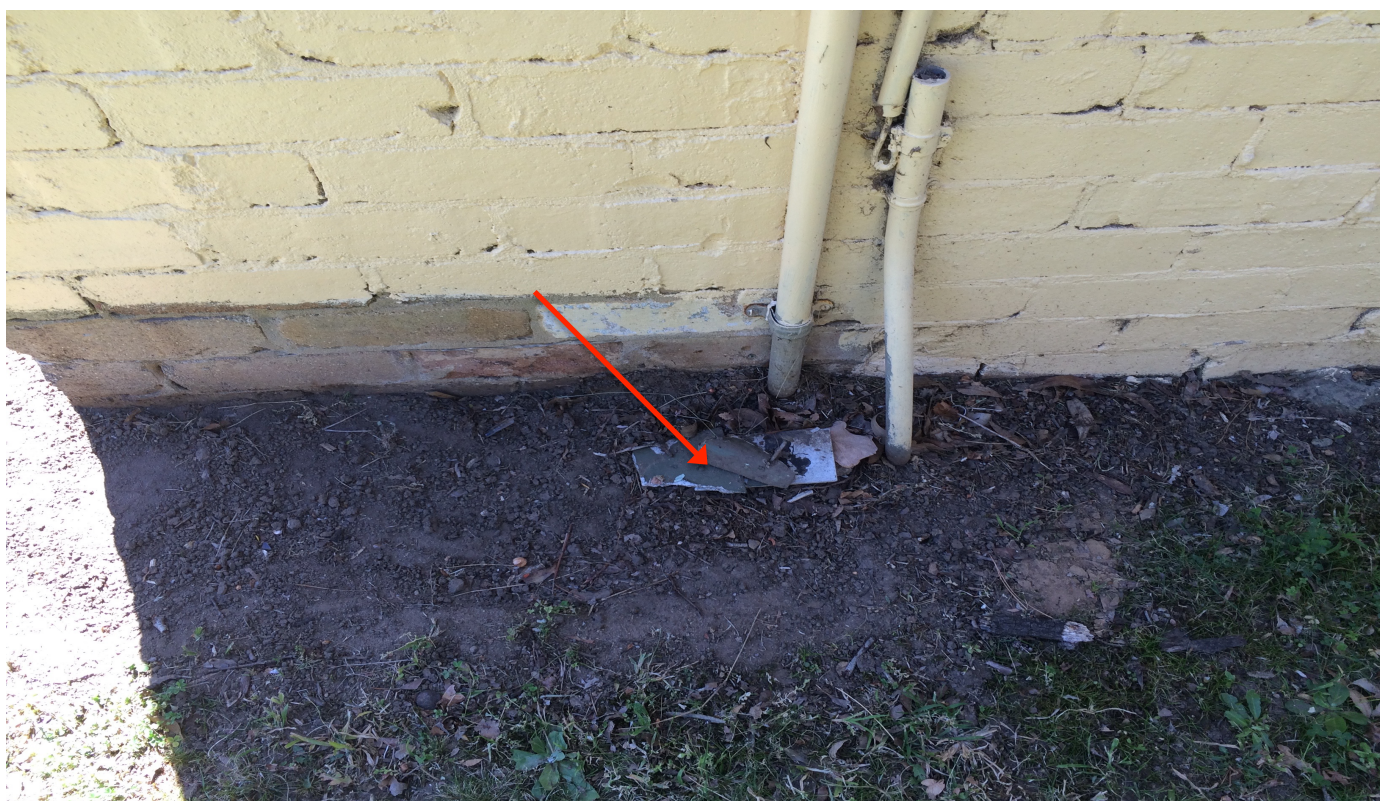
Location	Material	Sample ID	Sample Status	Photo No.	Asbestos Classification	Condition	Accessibility	Re-inspect	Current Label	Control Measure	Record of Works Undertaken
E00251 – Machinery Shed											
External											
Fragments under switchboard 3260	Fibrous cement sheeting	37272-81	Positive	45	Bonded	Unstable	High	September 2021	-	3	-

Photo 45: E00251 – Machinery Shed - 389-407 Great Western Highway, Springwood - Fragments under switchboard.

- Control Measure 1 -** If the ACM are friable and not in a stable condition, and there is a risk to health from exposure, they should be removed by an asbestos removalist as soon as practicable.
- Control Measure 2 -** If the ACM are friable but are in a stable condition and are accessible, serious consideration should be given to their removal. If the removal is not immediately practicable, short-term control measures, such as sealing and enclosure, May be able to be used until removal is possible.
- Control Measure 3 -** If the ACM are not friable and are in a good, stable condition, minimising disturbance and encapsulation may be appropriate controls.
- Control Measure 4 -** Any remaining ACM should be clearly labeled, where possible, and regularly inspected to ensure they are not deteriorating or otherwise contributing to an unacceptable health risk.
