# **Asbestos Register & Management Plan**

**Bullaburra Brigade Station,  
4 Kalinda Road, BULLABURRA NSW 2784**

# Asbestos Register

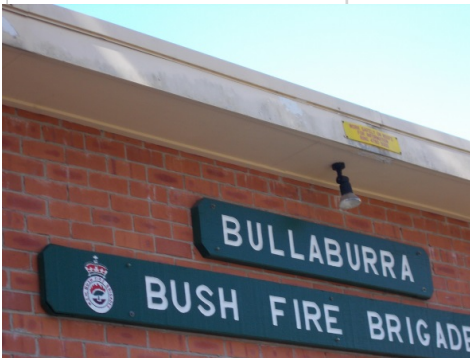
Ref No.	Date Identified	Clearance Cert Date	Onsite Register	Last Inspection Date	Next Inspection Date	
	1323	19/12/2014		Yes	26-Apr-2019	24-Apr-2024	
	Accessibility	Material	Extent		Result		
	Accessible	Fibreboard			Chrysotile		
	Friability	Sealed / Surface Treatment	Risk Assessment	Control Actions	Labels Affixed		
	Non Friable	Sealed	RA04 - Very Low	No Remedial Action - Reinspect Periodically	No		
Specific Location							
Bullaburra RFS - External - Eave linings							
Additional Comments							GPS Lat,Long
Sample - 25132-25-1

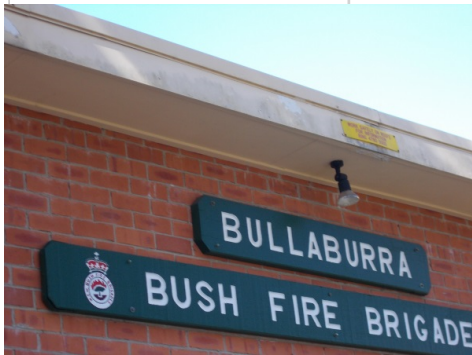
Ref No.	Date Identified	Clearance Cert Date	Onsite Register	Last Inspection Date	Next Inspection Date
	1324	19/12/2014		Yes	26-Apr-2019	26-Apr-2024
	Accessibility	Material	Extent	Result		
	Accessible	Fibreboard		Chrysotile		
	Friability	Sealed / Surface Treatment	Risk Assessment	Control Actions	Labels Affixed	
	Non Friable	Sealed	RA04 - Very Low	No Remedial Action - Reinspect Periodically	No	
	Specific Location					
Bullaburra RFS - External - Flashing adjacent eave linings						
Additional Comments					GPS Lat,Long	
Sample - 25132-25-2

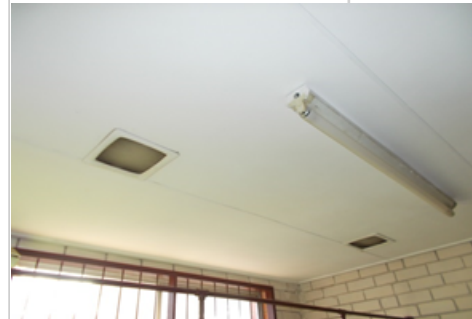
Ref No.	Date Identified	Clearance Cert Date	Onsite Register	Last Inspection Date	Next Inspection Date
	1347	26/04/2019		Yes	26-Apr-2019	26-Apr-2024
	Accessibility	Material	Extent	Result		
	Accessible	Fibreboard	8m2	Chrysotile		
	Friability	Sealed / Surface Treatment	Risk Assessment	Control Actions	Labels Affixed	
	Non Friable	Sealed	RA04 - Very Low	No Remedial Action - Reinspect Periodically	No	
	Specific Location					
Bullaburra RFS - Internal - Male Toilets and Wash Area– Ceiling Lining						
Additional Comments					GPS Lat,Long	
Sample - BB/A3

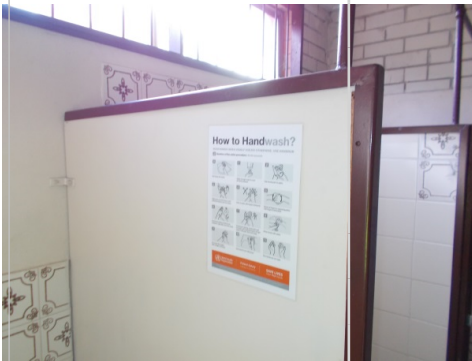
Ref No.	Date Identified	Clearance Cert Date	Onsite Register	Last Inspection Date	Next Inspection Date
	1349	19/12/2014		Yes	26-Apr-2019	26-Apr-2024
	Accessibility	Material	Extent	Result		
	Accessible	Fibrous cement sheeting		Chrysotile		
	Friability	Sealed / Surface Treatment	Risk Assessment	Control Actions	Labels Affixed	
	Non Friable	Sealed	RA04 - Very Low	No Remedial Action - Reinspect Periodically	No	
	Specific Location					
	Bullaburra RFS - Internal - Male Toilets – toilet partition walls (x2)					
	Additional Comments					GPS Lat,Long
	Sample - 25132-25-6					
Status: Closed						
	Ref No.	Date Identified	Clearance Cert Date	Onsite Register	Last Inspection Date	Next Inspection Date
	1327	19/12/2014	19/12/2014	Yes		
	Accessibility	Material	Extent	Result		
	Accessible	Fibreboard		No Asbestos identified		
	Friability	Sealed / Surface Treatment	Risk Assessment	Control Actions	Labels Affixed	
				No Action Required - No ACM Identified

Specific Location					
	Bullaburra RFS - Internal - Operations Room – external wall cladding					
	Additional Comments					GPS Lat,Long
	Sample - 25132-25-4
