ASBESTOS REGISTER

CORONATION PARK

TOILET BLOCK

19P STATION STREET,

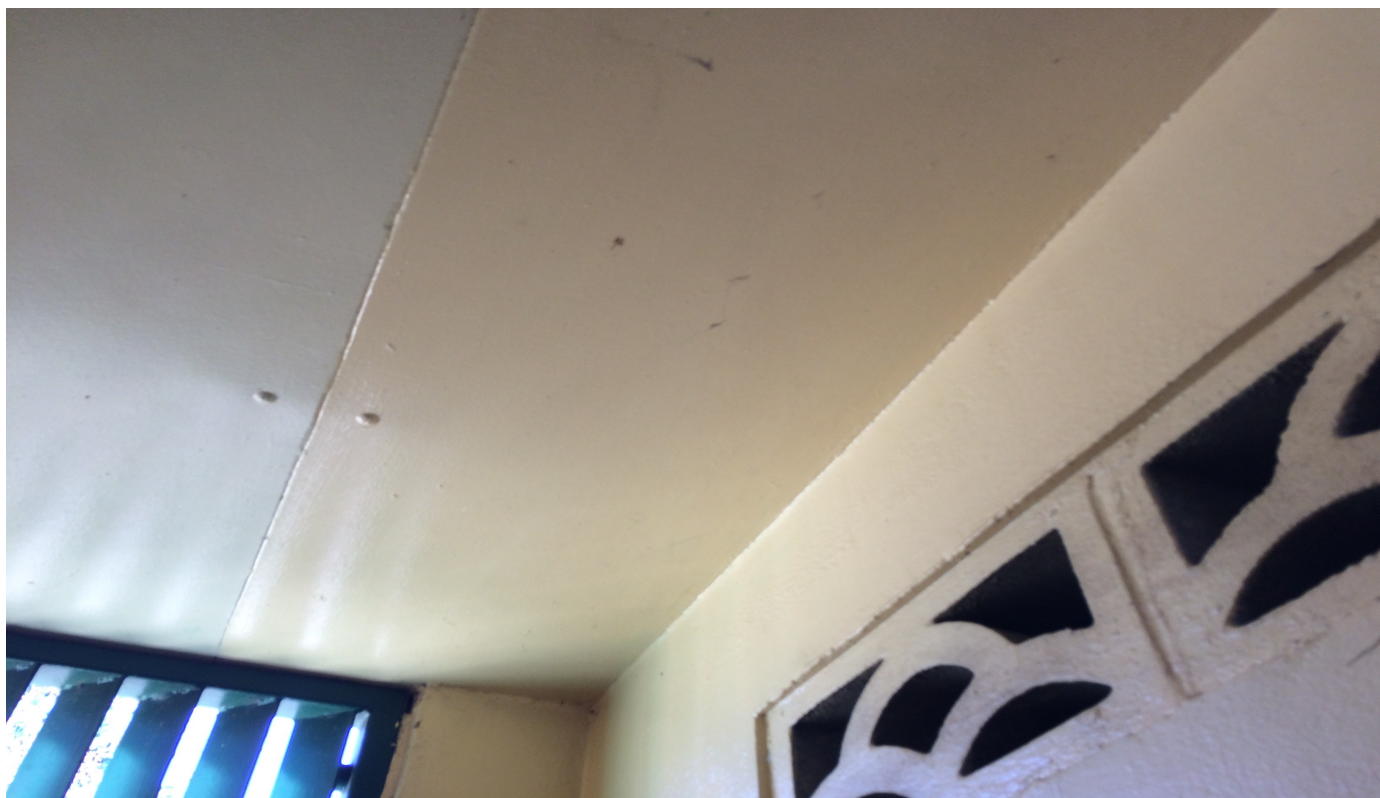
Location	Material	Sample ID	Sample Status	Photo No.	Asbestos Classification	Condition	Accessibility	Re-inspect	Current Label	Control Measure	Record of Works Undertaken
Internal											
Men's bathroom – Ceiling lining 1228	Fibreboard	37272-98	Positive	51	Bonded	Stable	Medium	September 2021	-	4	-
Women's bathroom – Ceiling lining 1229	Fibreboard	Similar to 37272-98	Assumed Positive	52	Bonded	Stable	Medium	September 2021	-	4	-
Disabled bathroom – Ceiling lining 1230	Fibreboard	Similar to 37272-98	Assumed Positive	53	Bonded	Stable	Medium	September 2021	-	4	-
Storage room 1231	Fibreboard	Similar to 37272-98	Assumed Positive	54	Bonded	Stable	Medium	September 2021	-	4	-
Men's toilet partitions 1232	Fibreboard	37272-99	Negative	-	-	-	-	-	-	-	-
Women's toilet partitions 1233	Fibreboard	Similar to 37272-99	Assumed Negative	-	-	-	-	-	-	-	-

Photo 51: E00026 – Toilet Block - 19P Station Street, Wentworth Falls - Men's bathroom – Ceiling lining.

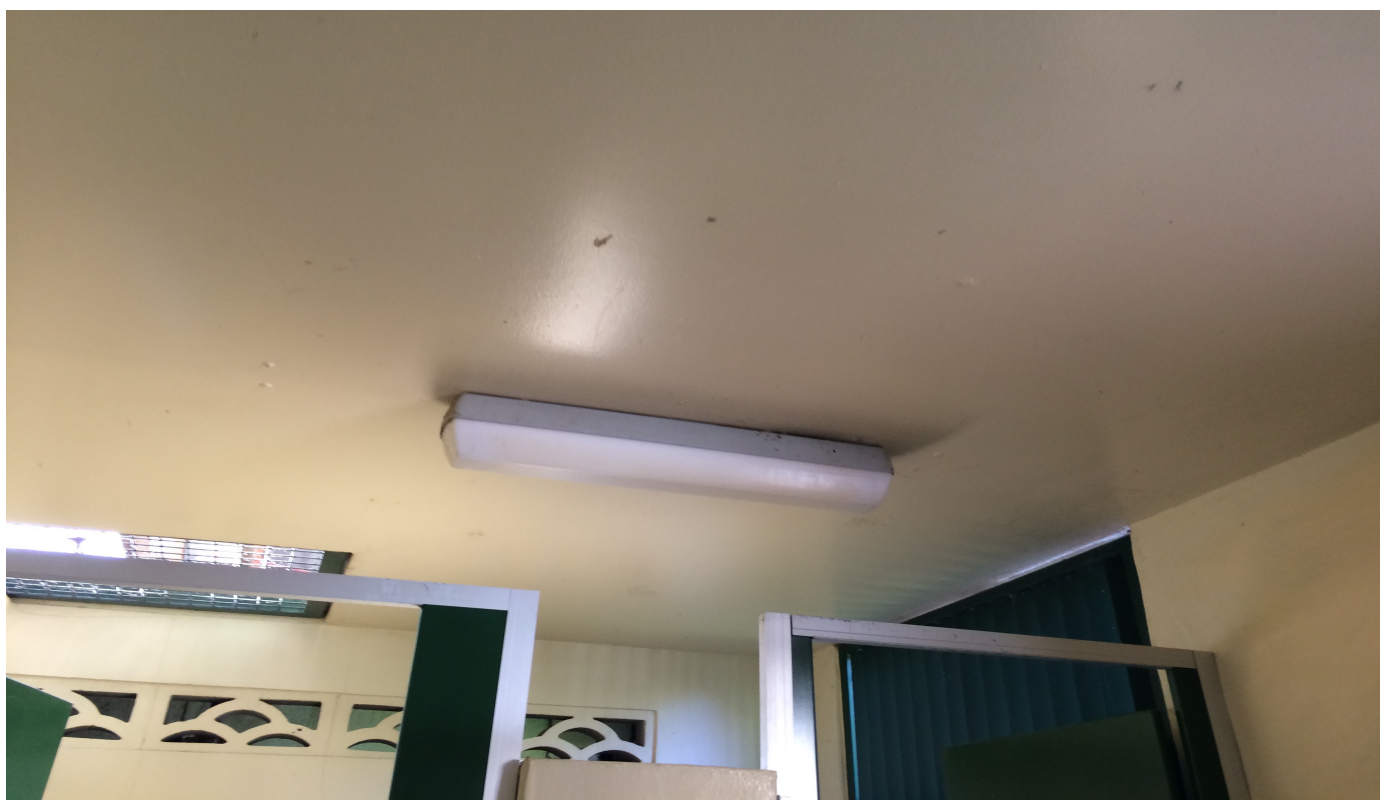
Photo 52: E00026 – Toilet Block - 19P Station Street, Wentworth Falls - Women's bathroom – Ceiling lining.

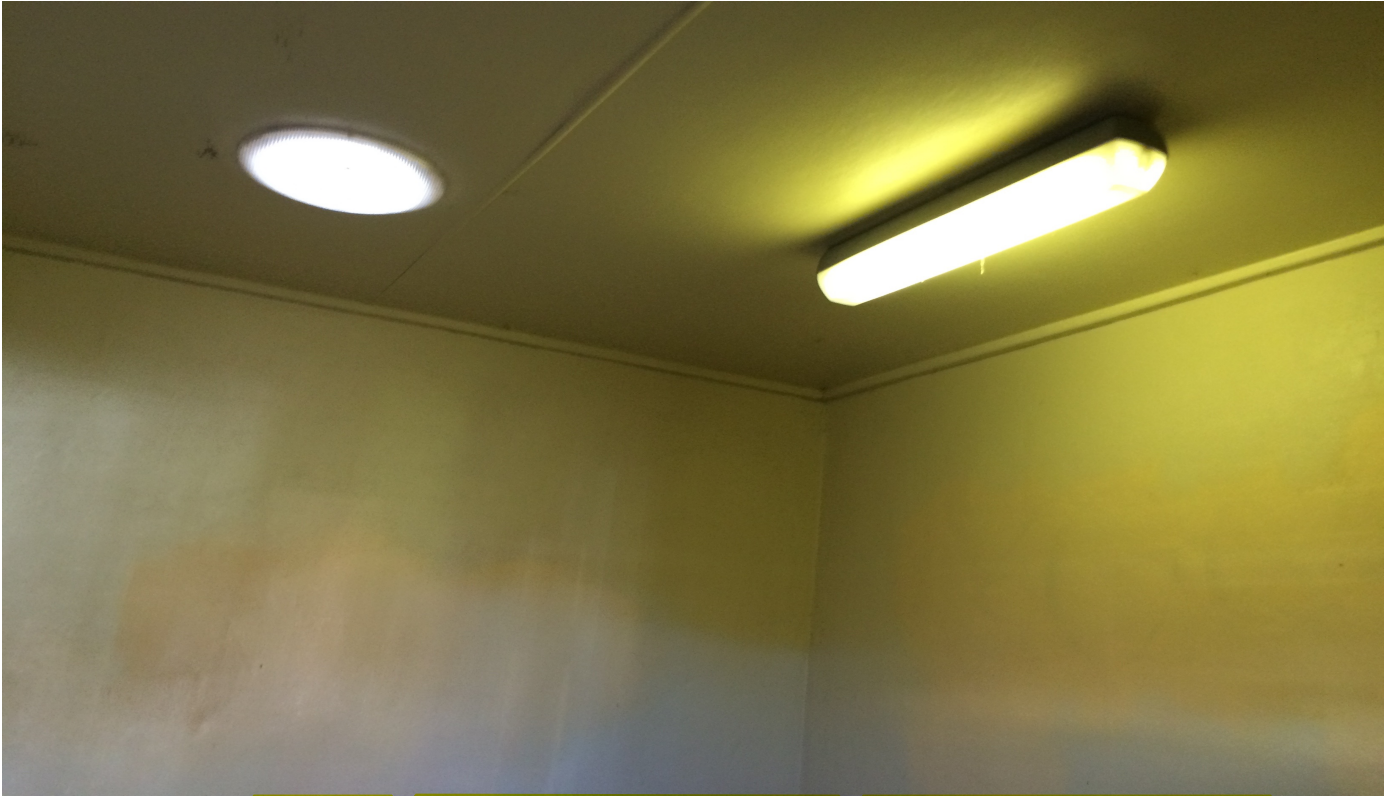
Photo 53: E00026 – Toilet Block - 19P Station Street, Wentworth Falls - Disabled bathroom – Ceiling lining.

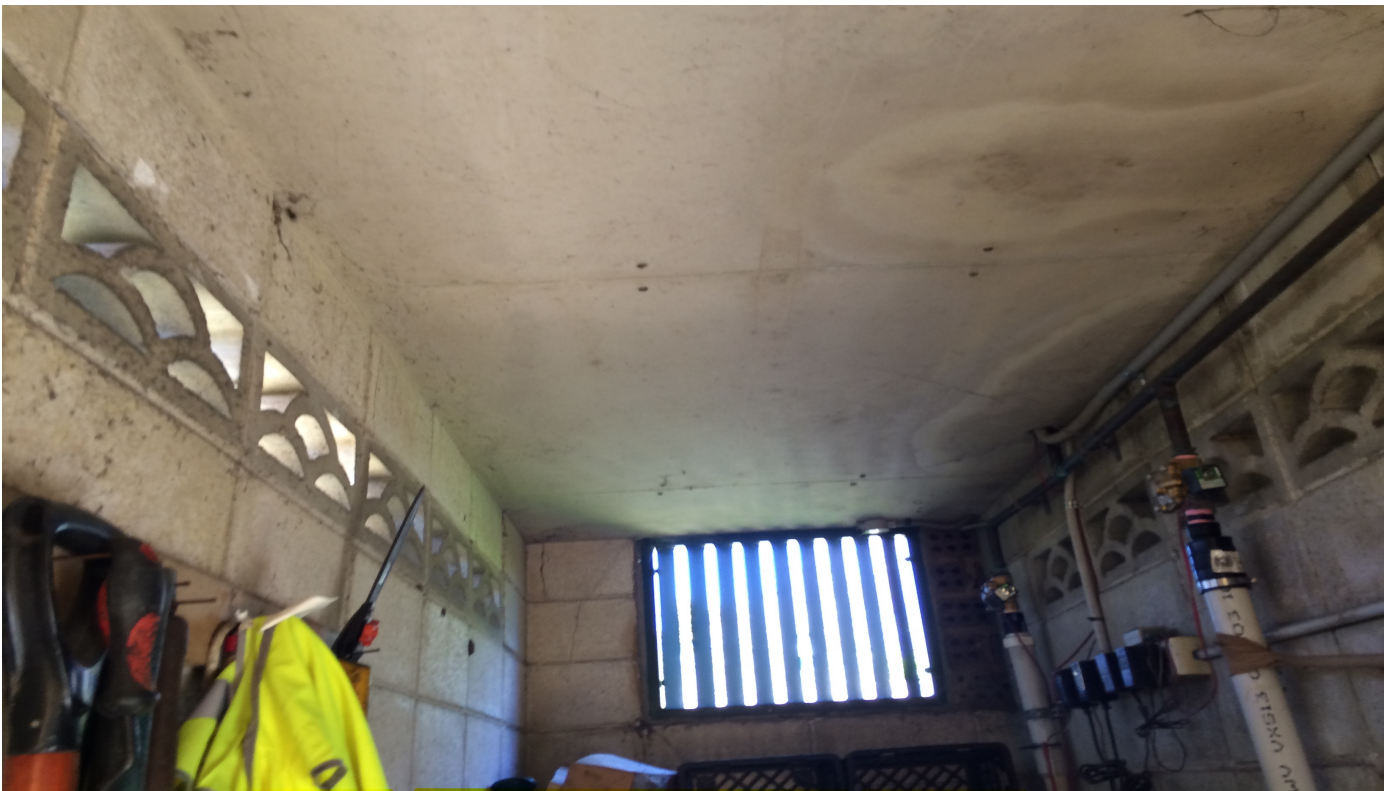
Photo 54: E00026 – Toilet Block - 19P Station Street, Wentworth Falls - Storage room.
