Asbestos Register

ASBESTOS REGISTER

COTTAGE

58-60 WHITE CROSS ROAD, WINMALEE

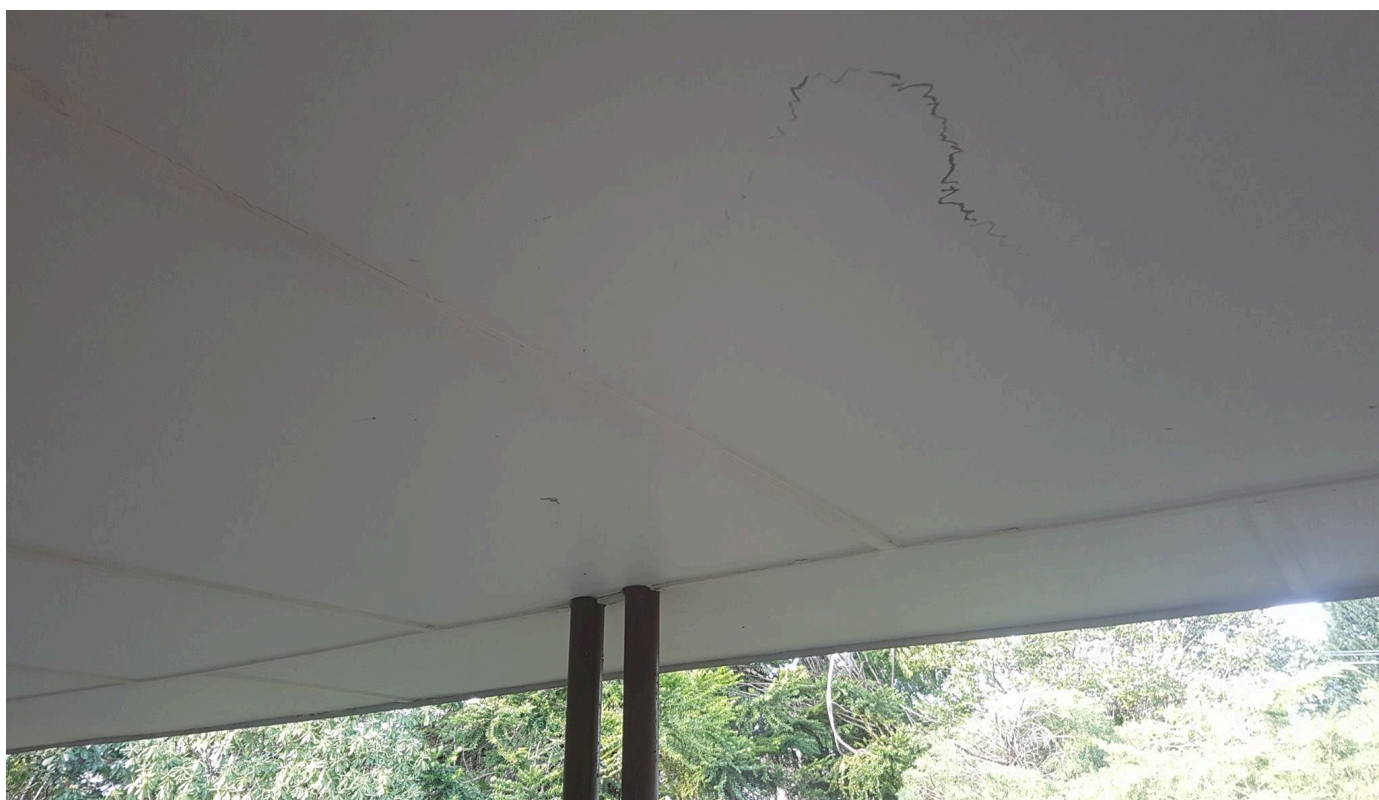
Photo 68: Cottage - 58-60 White Cross Road, Winmalee - Entry awning – Front.

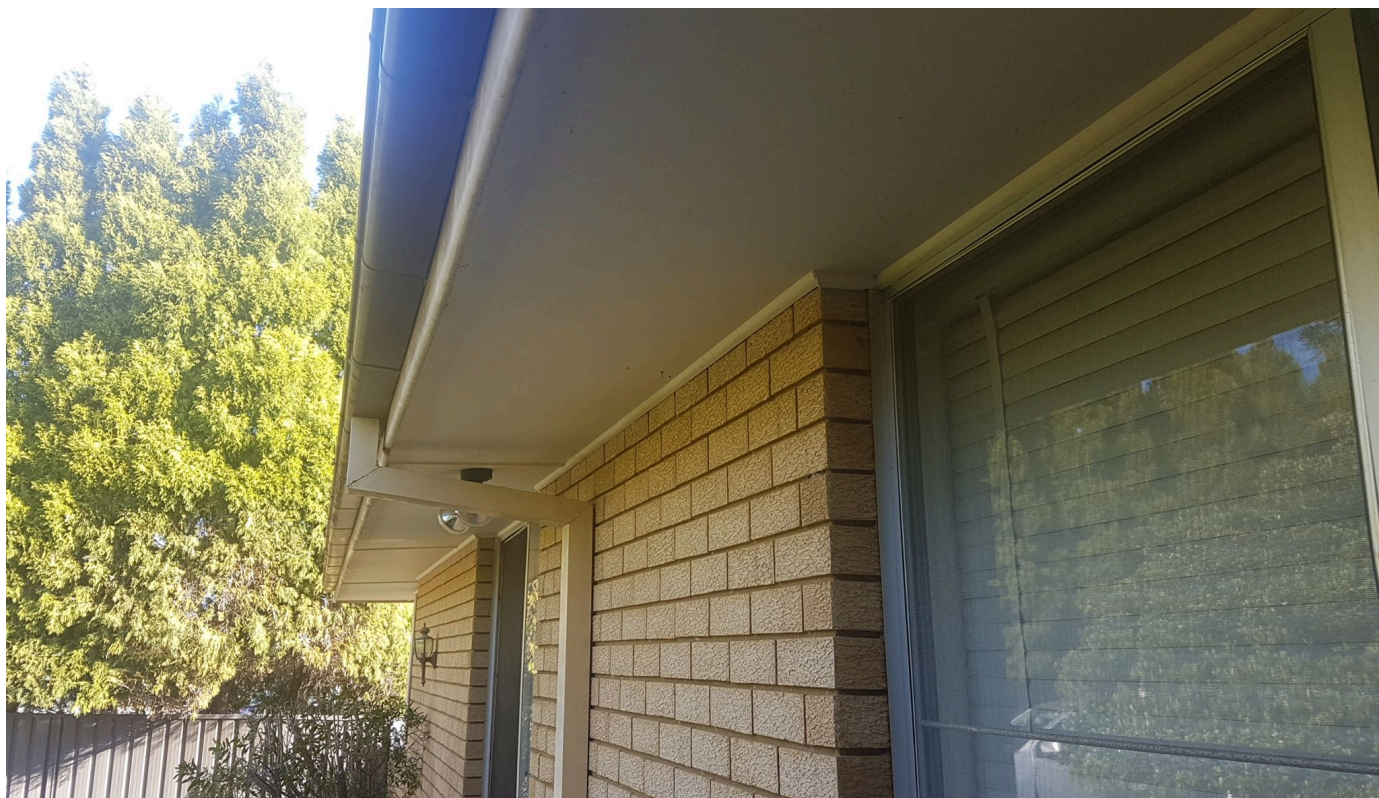
Photo 69: Cottage - 58-60 White Cross Road, Winmalee – Eave linings.

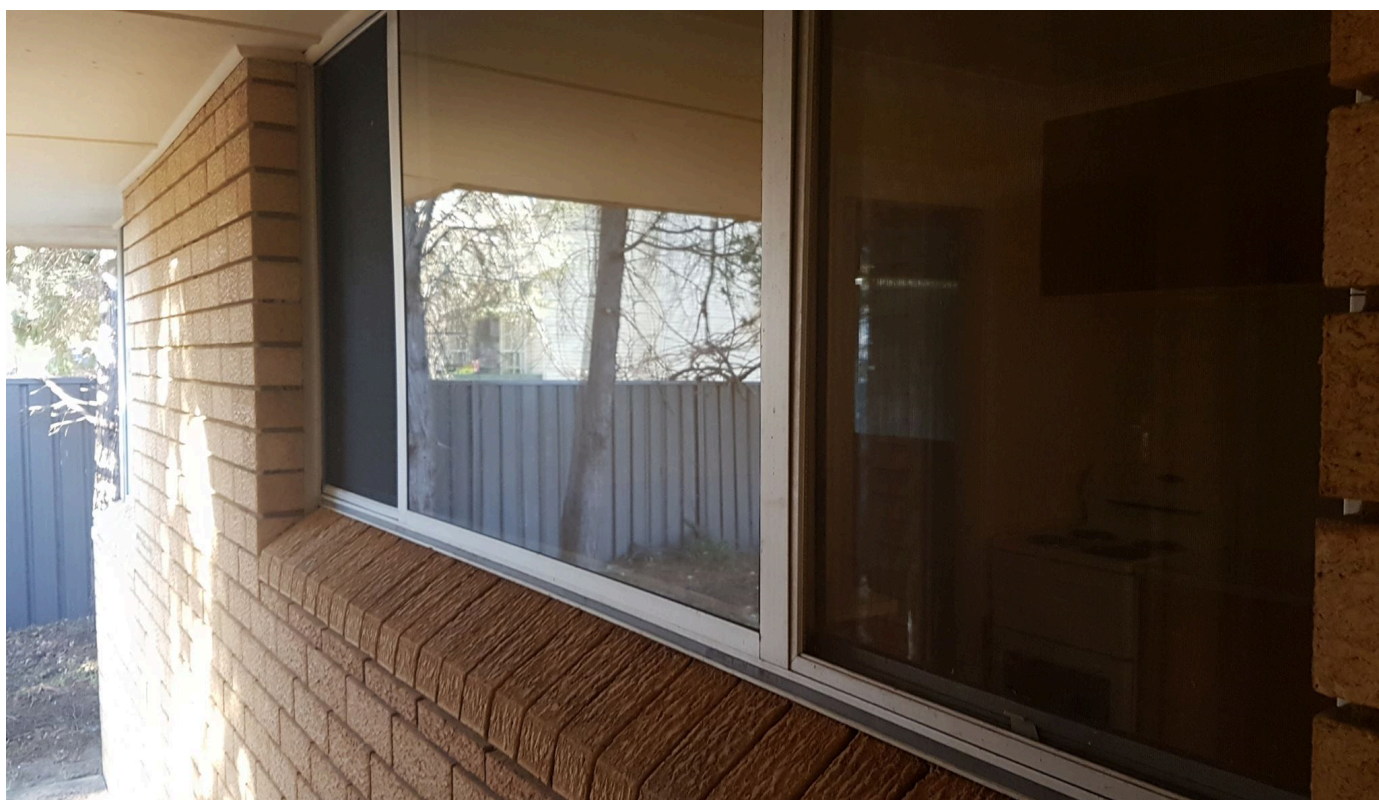
37272 – 112	Cottage - 58-60 White Cross Road, Winmalee – Windows throughout	1g mastic fragment	Chrysotile asbestos detected
37272 – 113	Cottage - 58-60 White Cross Road, Winmalee - Laundry – Wall cladding	5x3x2mm fibreboard fragment	Chrysotile asbestos detected Organic fibres detected
37272 – 114	Cottage - 58-60 White Cross Road, Winmalee - Kitchen – Heater exhaust cupboard lining	15x10x7mm fibreboard fragment	Chrysotile asbestos detected Organic fibres detected
37272 – 115	Cottage - 58-60 White Cross Road, Winmalee - Garage – Wall cladding	15x15x4mm fibreboard fragment	Chrysotile asbestos detected Organic fibres detected
37272 – 116	Cottage - 58-60 White Cross Road, Winmalee - Garage – Ceiling space – Cement slabs	10x5x2mm fibrous cement sheet fragments	Chrysotile asbestos detected
37272 – 117	Cottage - 58-60 White Cross Road, Winmalee - Sub-floor – Form work above brickwork & fragments	160x110x5mm fibrous cement sheet fragments	Chrysotile asbestos detected

Photo 70: Cottage - 58-60 White Cross Road, Winmalee – Windows throughout.

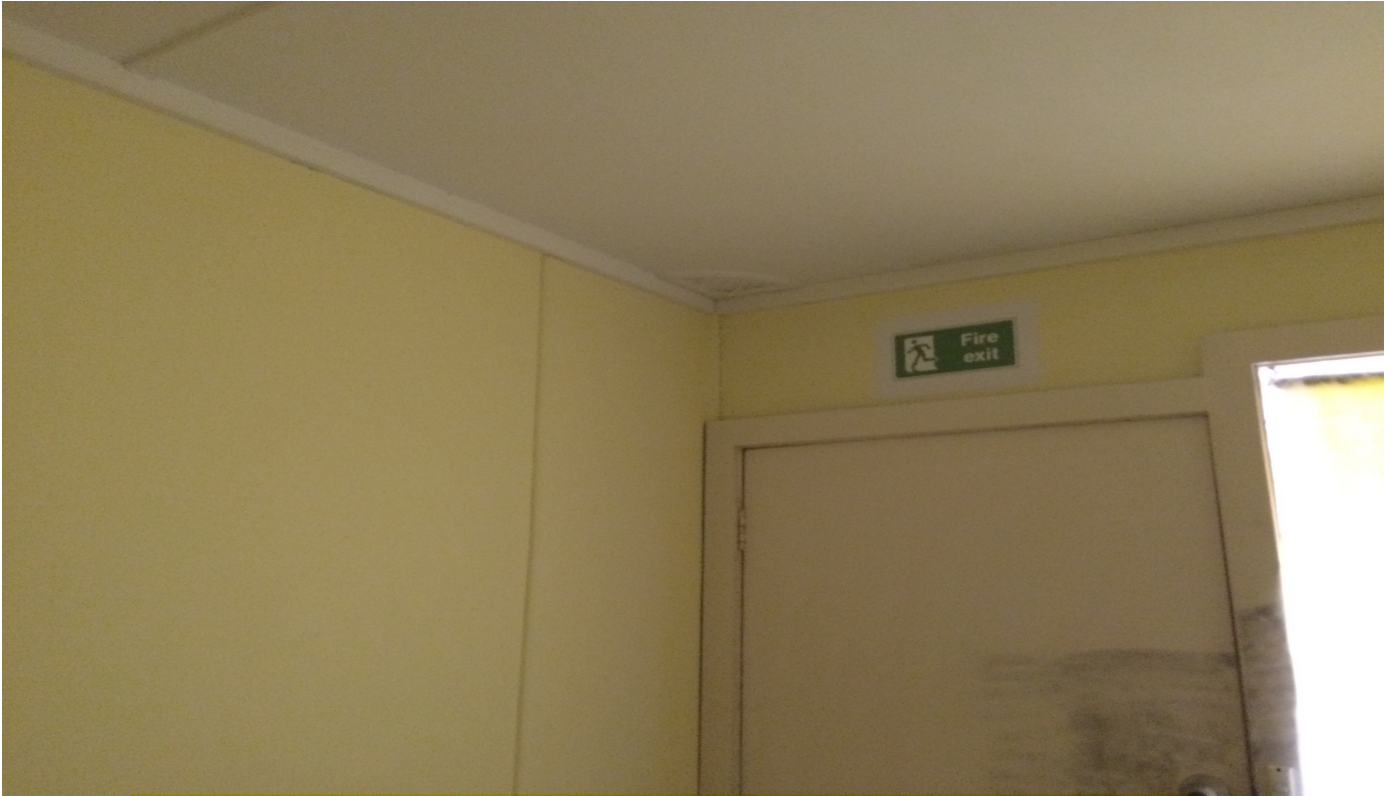
Photo 71: Cottage - 58-60 White Cross Road, Winmalee – Laundry – Wall cladding and ceiling lining.

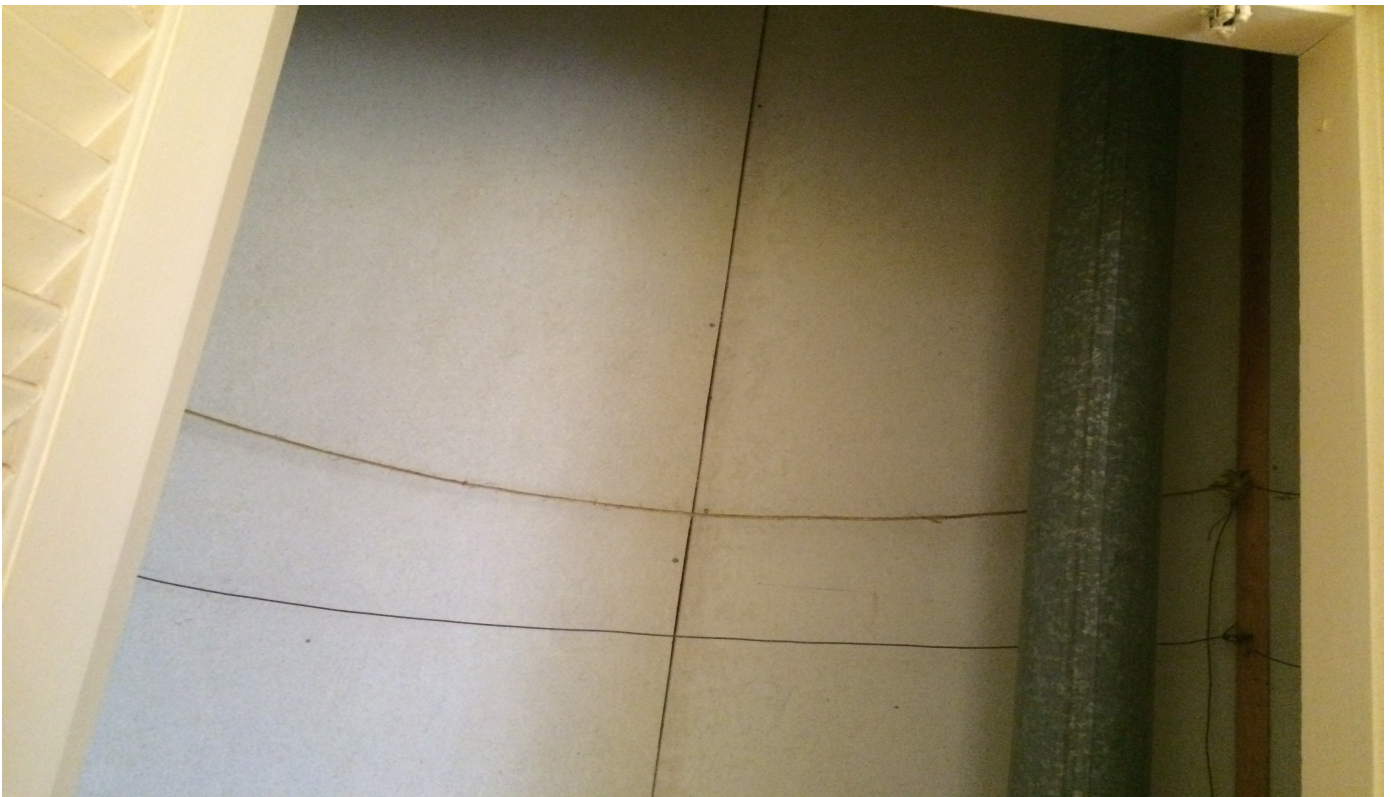
Photo 72: Cottage - 58-60 White Cross Road, Winmalee – Kitchen – Heater exhaust cupboard lining.

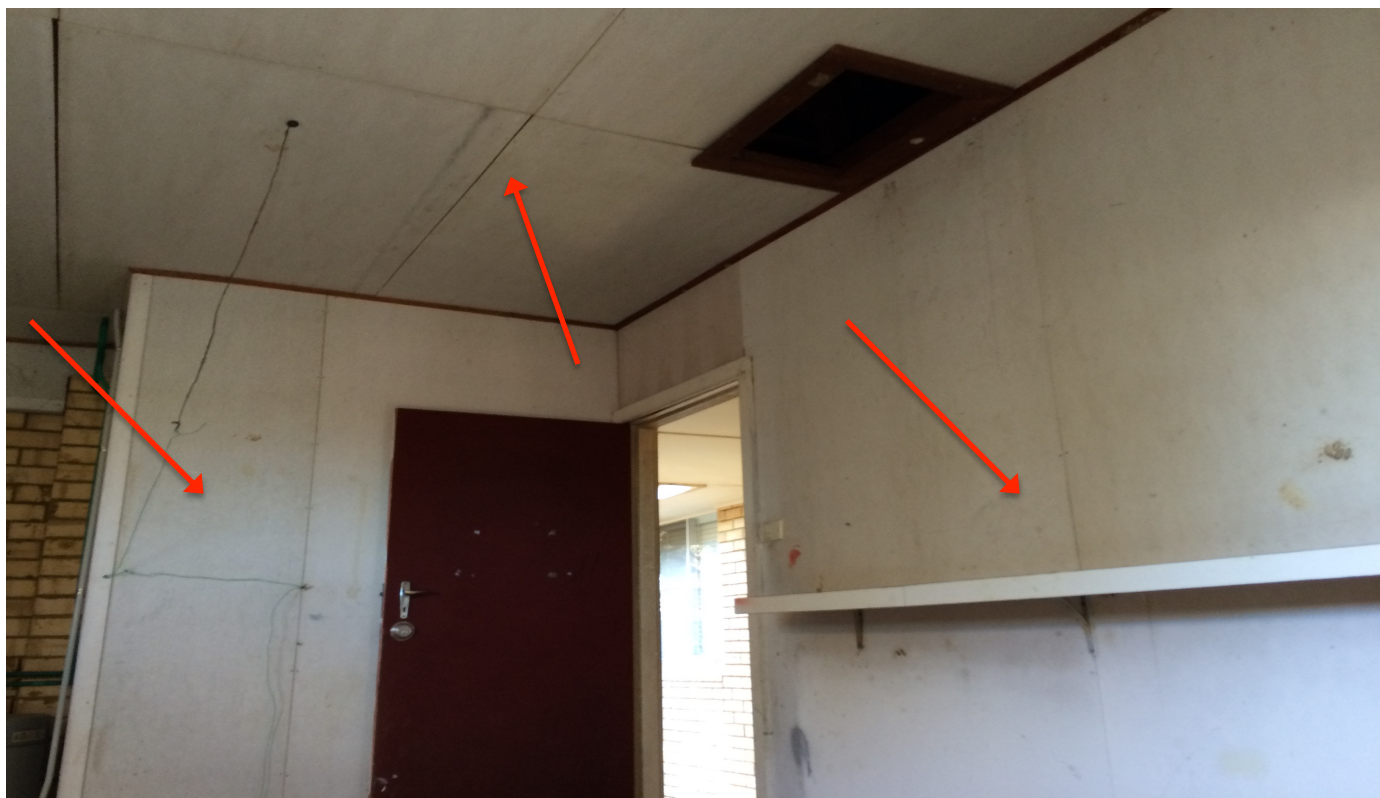
Photo 73: Cottage - 58-60 White Cross Road, Winmalee – Garage and adj. bathroom – Wall cladding and ceiling lining.

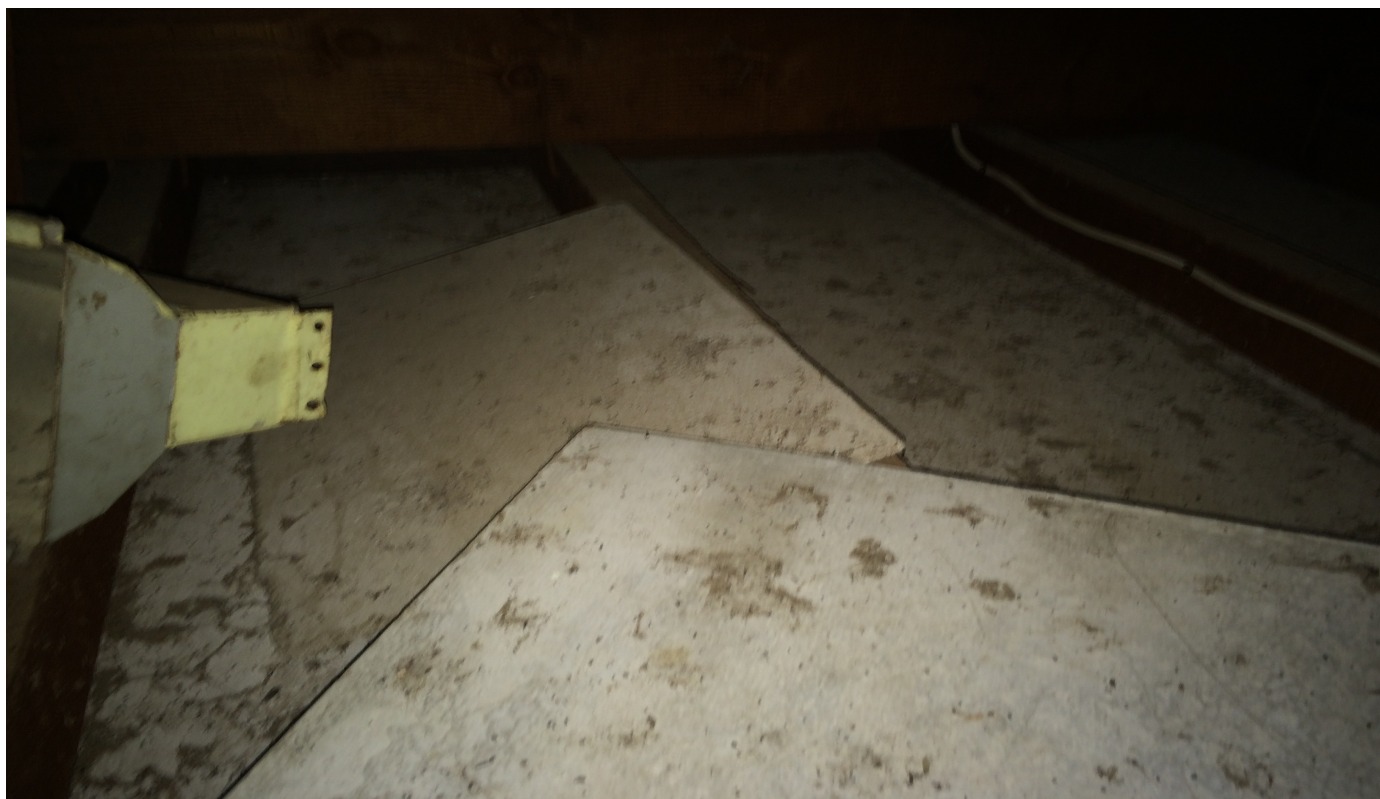
Photo 74: Cottage - 58-60 White Cross Road, Winmalee – Garage – Ceiling space - Redundant sheets.

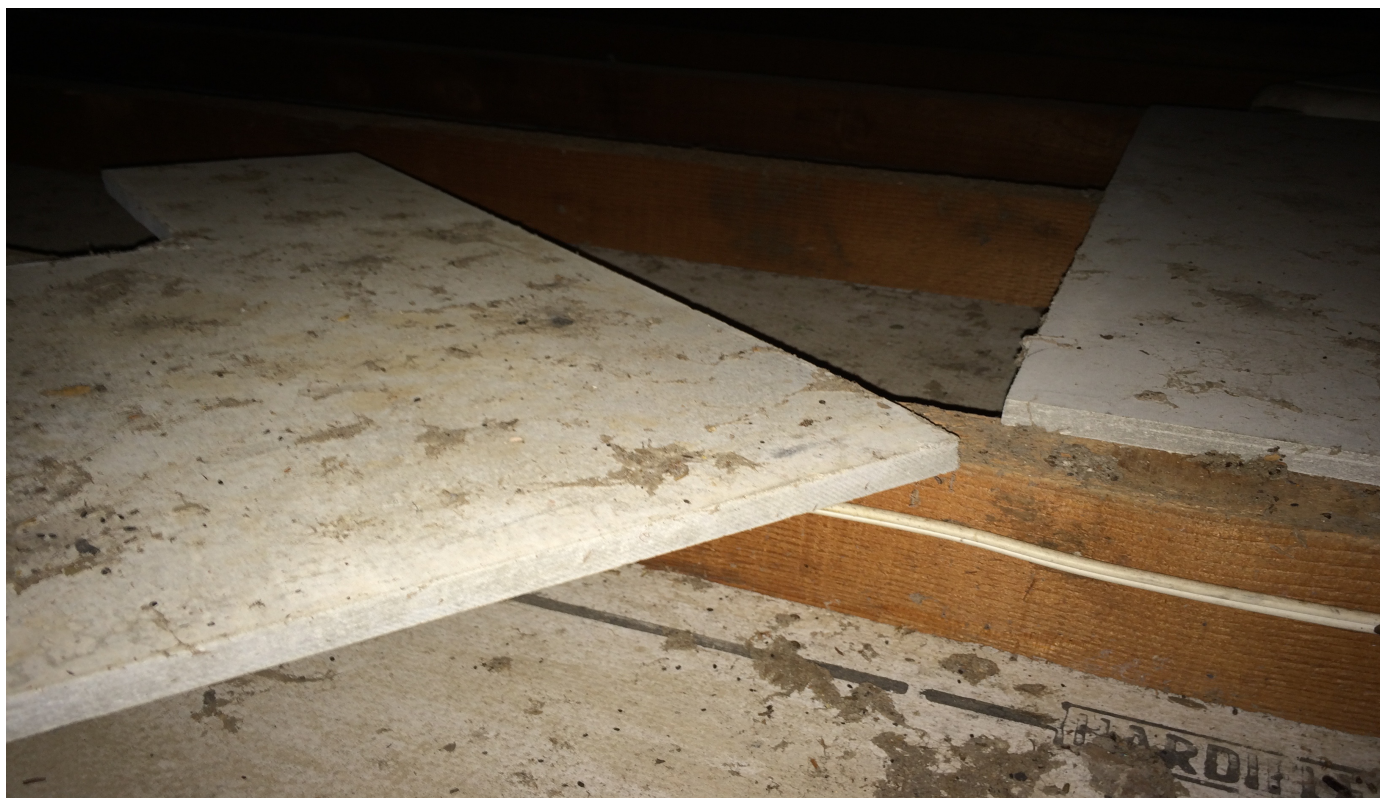
Photo 75: Cottage - 58-60 White Cross Road, Winmalee – Garage – Ceiling space – Cement slabs.

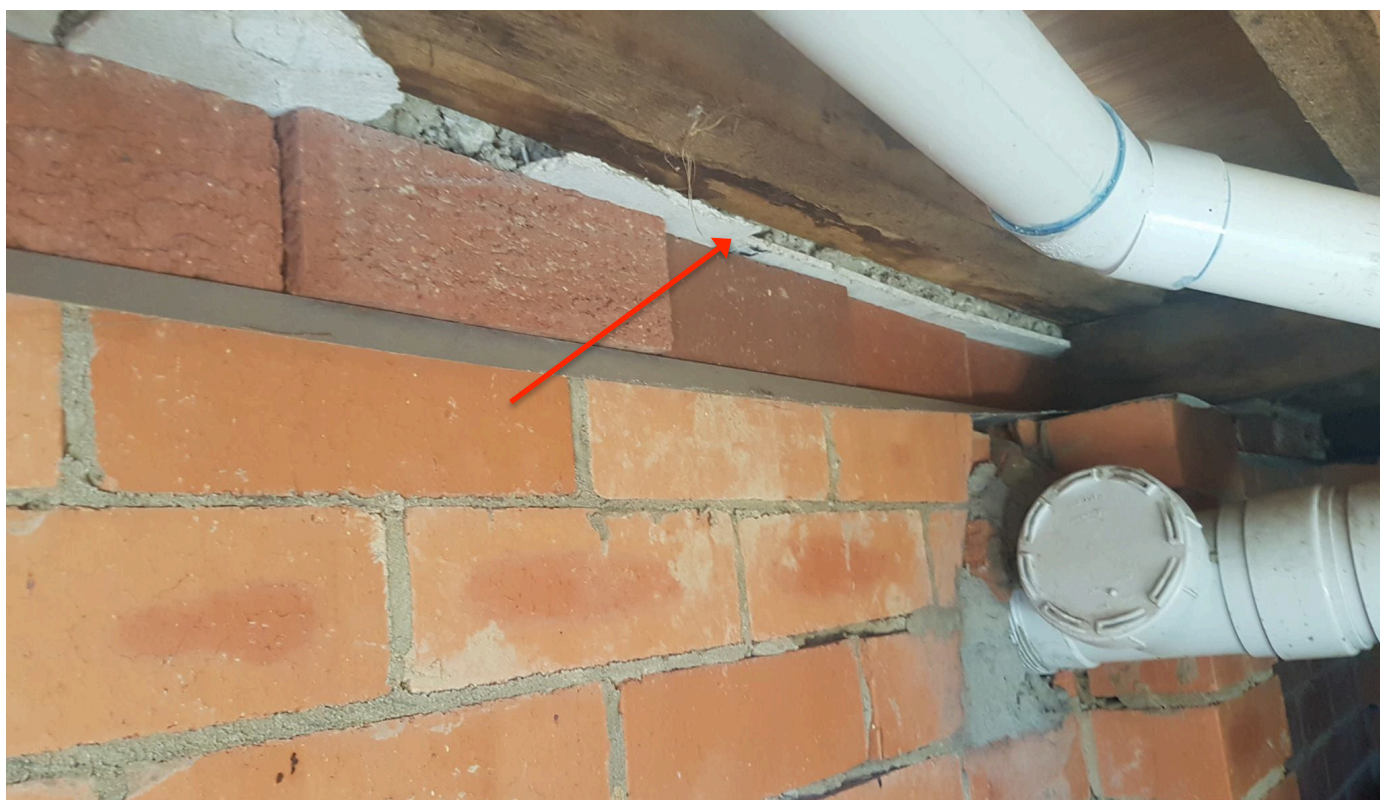
Photo 76: Cottage - 58-60 White Cross Road, Winmalee – Sub-floor – Form work above brickwork.

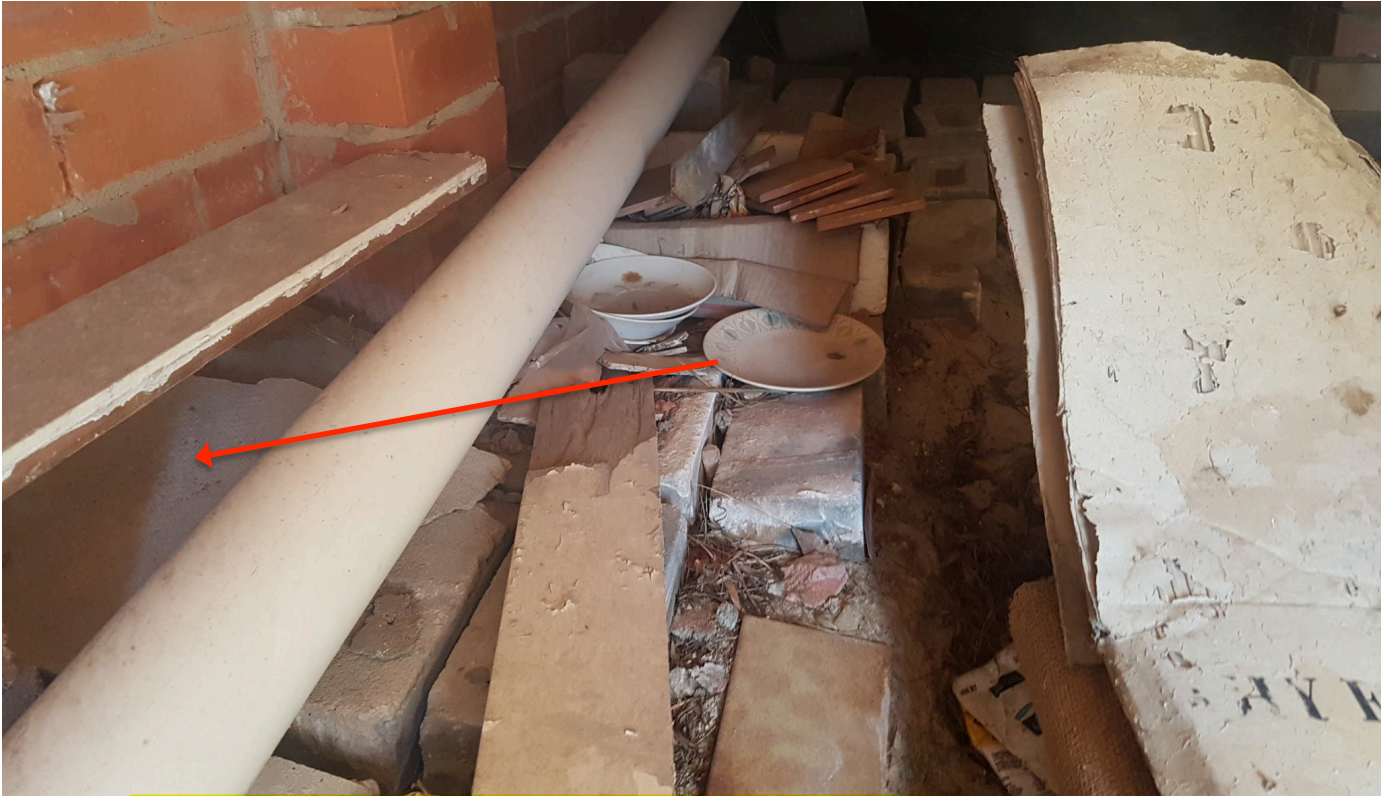
Photo 77: Cottage - 58-60 White Cross Road, Winmalee – Sub-floor –Fragments.
