Red Cross Hall, Buckland Park

Asbestos/Lead Register & Management Plan

1. Executive Summary

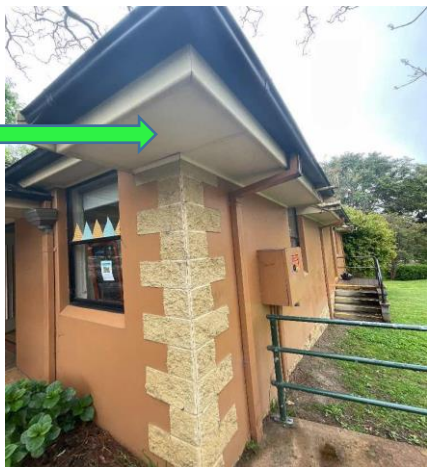
External, GF, Exterior, Eaves and fascia - Yellow - Topcoat, Lead Not Detected (0.003%w/w), 437014-LP02

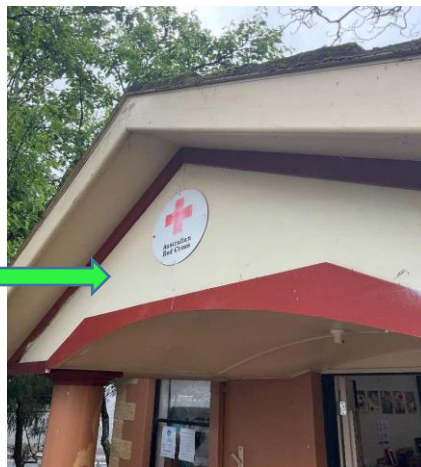
External, GF, Exterior, South, Entrance Gable End - Fibre Cement Sheet, Assumed Negative, 437014-AS03

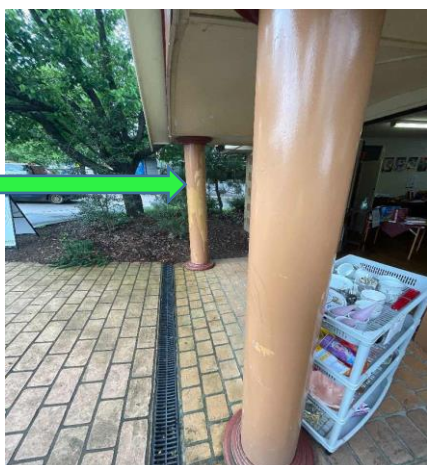
External, GF, Exterior, South, Entrance, Columns - Fibre cement pipe, No asbestos detected, 437014-AS04

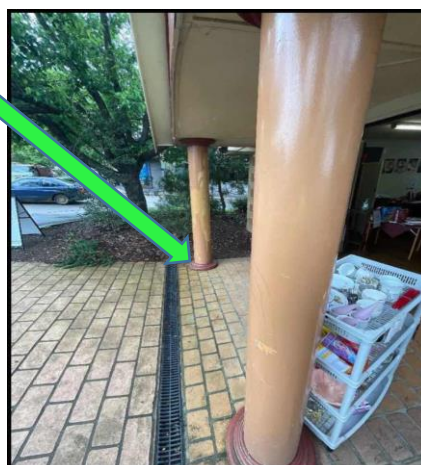
External, GF, Exterior, Entrance, top & bottom sheaths of column - Fibre cement, No Asbestos Detected, Similar to 437014-AS04

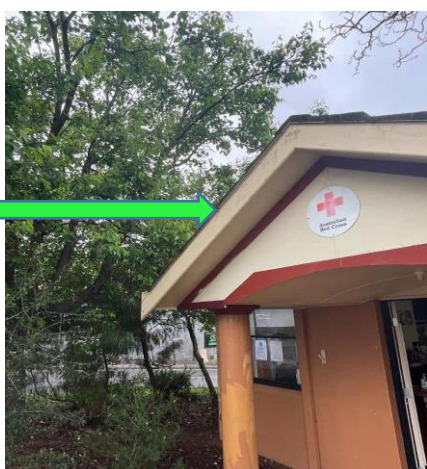
External, GF, Exterior, South, External Roof perimeter, Cloaked Verge Weather Strip - Fibre cement sheet, No Asbestos identified, 437014-

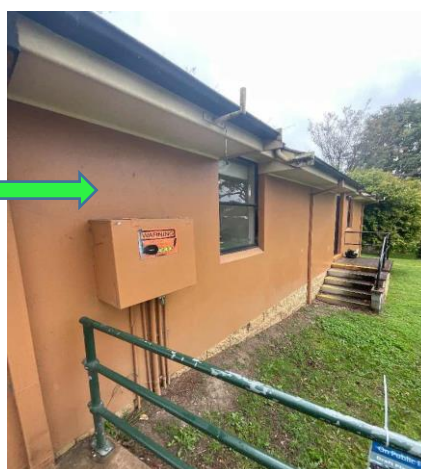
External, GF, Exterior, External walls - Orange - Topcoat, Lead Not Detected (<0.001%w/w), 437014-LP01

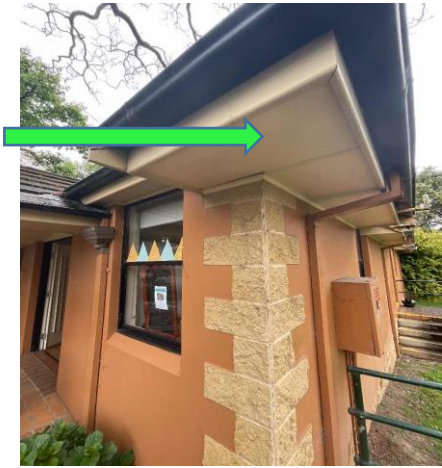
Photo #	REF #	HAZARD	RESULT	SPECIFIC LOCATION	MATERIAL	QUANTITY	FRIABILITY	OVERALL RISK	ACTION CODE	TIMEFRAME	COMMENTS
7	437014-AS02	Asbestos	No Asbestos identified	Perimeter Eave Linings	Fibre Cement Sheet	20 m ²	Not Applicable	-	A5	-	-

External, GF, Exterior, Perimeter Eave Linings - Fibre Cement Sheet,
No Asbestos identified, 437014-AS02

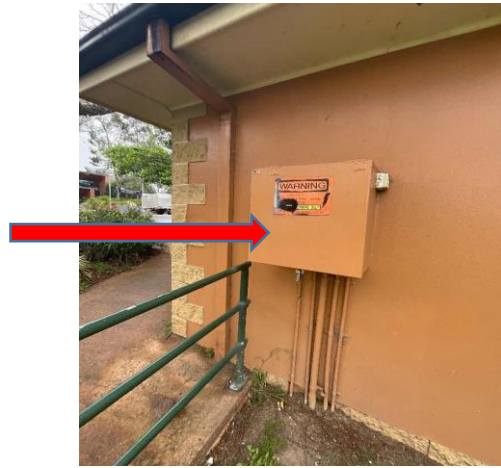
Location	Material Description	Risk Rating
External / GF / Exterior / Electrical Box / Backing board	Bituminous	Very Low

Photo #	REF #	HAZARD	RESULT	SPECIFIC LOCATION	MATERIAL	QUANTITY	FRIABILITY	OVERALL RISK	ACTION CODE	TIMEFRAME	COMMENTS
8	No Sample taken Assumed Positive	Asbestos	Assumed Positive	Backing board	Bituminous	1 Unit	Non-Friable	Very Low	A4	5 Yearly Reinspection	Accessible to tradespeople

External, GF, Exterior Electrical Box, Backing board - Bituminous,
Assumed Positive, No Sample taken Assumed Positive
