**WENTWORTH FALLS SCHOOL OF
ARTS AND LIBRARY**

ASBESTOS REGISTER

**Blue Mountains City
Council – Stage 3**

**Project No.
28781**

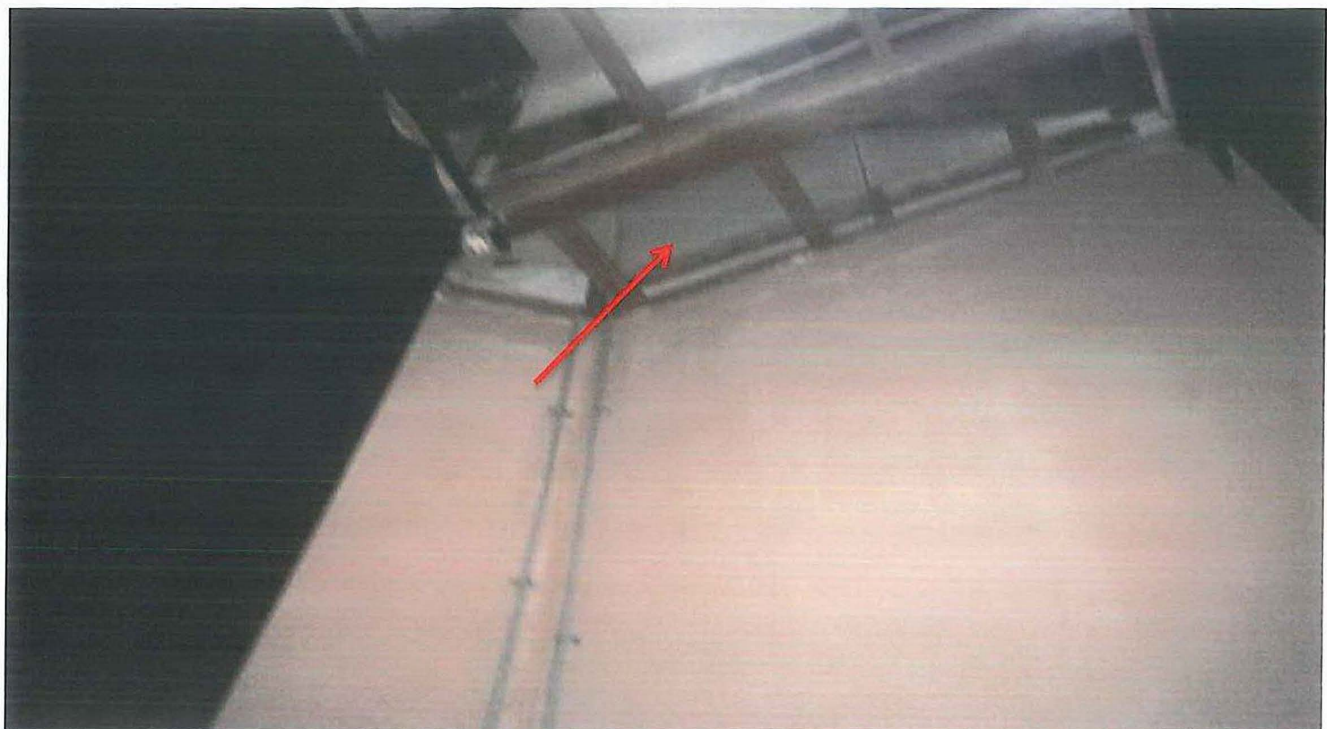
Location	Material	Sample ID	Sample Status	Photo No.	Asbestos Classification	Condition	Accessibility	Re-inspect	Current Label	Control Measure	Record of Works Undertaken
Theatre – Stage Area – northern and southern perimeters – western upper internal wall cladding 313	Fibrous cement sheeting	28781-53-7	Positive	170	Bonded	Stable	Low	November 2020	Not labeled	4	
Theatre – Stage Area – Lower Level – Chang rooms – toilet – internal wall cladding 2257	Fibreboard	28781-53-8	Negative	-	-	-	-	-	-	-	-
Theatre – Stage Area – Lower Level – Chang rooms – toilet – external wall cladding 2258	Fibreboard	Similar to 28781-53-8	Assumed Negative	-	-	-	-	-	-	-	-
Hall Area – ceiling linings throughout 2259	Plaster	-	-	-	-	-	-	-	-	-	-
Hall Area – eastern entrance doorway to main central hall – ceiling lining 2260	Fibreboard	Similar to 28781-53-9	Assumed Negative	-	-	-	-	-	-	-	-
Hall Area – eastern entrance doorway to main central hall – external wall cladding 2261	Fibreboard	28781-53-9	Negative	-	-	-	-	-	-	-	-

Photo 170: Asset D00041 – Wentworth Falls School Of Arts And Library – Theatre – Stage – northern and southern perimeters – asbestos cement sheet western upper internal wall cladding.
