# **Asbestos Register**

# **Management Plan**

**Hazelbrook Brigade Station,  
1-7 Baths Road, HAZELBROOK NSW 2779**

## Asbestos Register and Management Plan

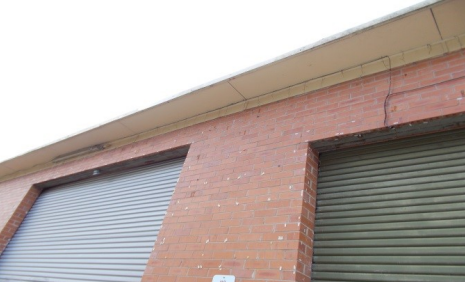
Ref No.	Date Identified	Clearance Cert Date	Onsite Register	Last Inspection Date	Next Inspection Date
	1498	19/12/2014		Yes	17-May-2019	17-May-2024
	Accessibility	Material	Extent	Result		
	Accessible	Fibreboard	10m2	Assumed Positive		
	Friability	Sealed / Surface Treatment	Risk Assessment	Control Actions	Labels Affixed	
	Non Friable	Sealed	RA04 - Very Low	No Remedial Action - Reinspect Periodically	No	
	Specific Location					
Hazelbrook RFS - External - Eastern eave lining						
Additional Comments					GPS Lat,Long	
Sample - Similar to 25132-28-1 - Assumed Chrysotile

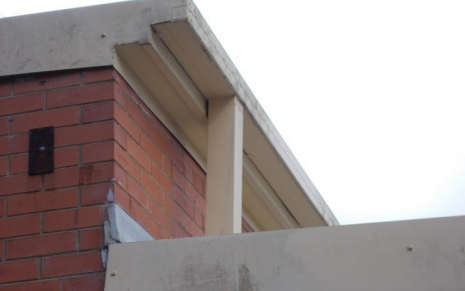
<b>Ref No.</b>	<b>Date Identified</b>	<b>Clearance Cert Date</b>	<b>Onsite Register</b>	<b>Last Inspection Date</b>	<b>Next Inspection Date</b>	
	1499	19/12/2014		Yes	17-May-2019	17-May-2024	
	<b>Accessibility</b>	<b>Material</b>	<b>Extent</b>	<b>Result</b>			
	Accessible	Fibreboard	2m2	Chrysotile			
	<b>Friability</b>	<b>Sealed / Surface Treatment</b>	<b>Risk Assessment</b>	<b>Control Actions</b>	<b>Labels Affixed</b>		
	Non Friable	Sealed	RA04 - Very Low	No Remedial Action - Reinspect Periodically	No		
	<b>Specific Location</b>						
Hazelbrook RFS - External - Western eave lining							
<b>Additional Comments</b>					<b>GPS Lat,Long</b>		
Sample - 25132-28-1

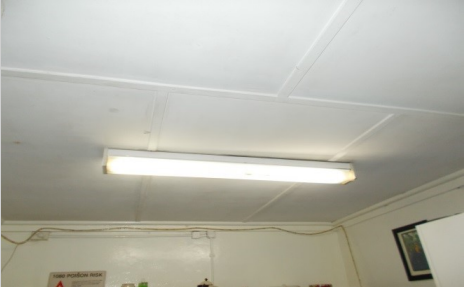
<b>Ref No.</b>	<b>Date Identified</b>	<b>Clearance Cert Date</b>	<b>Onsite Register</b>	<b>Last Inspection Date</b>	<b>Next Inspection Date</b>	
	1501	19/12/2014		Yes	17-May-2019	17-May-2024	
	<b>Accessibility</b>	<b>Material</b>	<b>Extent</b>	<b>Result</b>

Accessible	Fibreboard	7m2	Assumed Positive			
	<b>Friability</b>	<b>Sealed / Surface Treatment</b>	<b>Risk Assessment</b>	<b>Control Actions</b>	<b>Labels Affixed</b>		
	Non Friable	Sealed	RA04 - Very Low	No Remedial Action - Reinspect Periodically	No		
	<b>Specific Location</b>						
Hazelbrook RFS - Internal - Kitchen – ceiling lining							
<b>Additional Comments</b>					<b>GPS Lat,Long</b>		
Sample - Similar to 25132-28-2 - Assumed Chrysotile

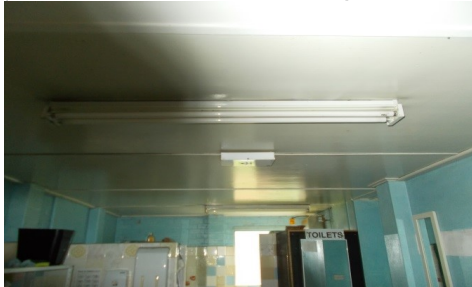
<b>Ref No.</b>	<b>Date Identified</b>	<b>Clearance Cert Date</b>	<b>Onsite Register</b>	<b>Last Inspection Date</b>	<b>Next Inspection Date</b>	
	1503	19/12/2014		Yes	17-May-2019	17-May-2024	
	<b>Accessibility</b>	<b>Material</b>	<b>Extent</b>	<b>Result</b>			
	Accessible	Fibreboard	15m2	Chrysotile			
	<b>Friability</b>	<b>Sealed / Surface Treatment</b>	<b>Risk Assessment</b>	<b>Control Actions</b>	<b>Labels Affixed</b>		
	Non Friable	Sealed	RA04 - Very Low	No Remedial Action - Reinspect Periodically	No		
	<b>Specific Location</b>						
Hazelbrook RFS - Internal - Male/Female Showers – ceiling lining							
<b>Additional Comments</b>					<b>GPS Lat,Long</b>		
Sample - 25132-28-2

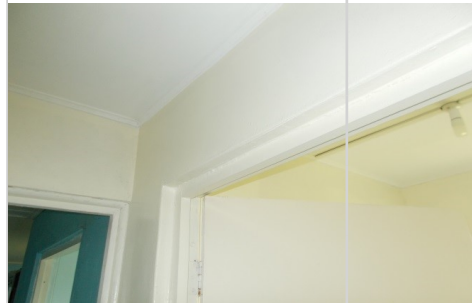
<b>Ref No.</b>	<b>Date Identified</b>	<b>Clearance Cert Date</b>	<b>Onsite Register</b>	<b>Last Inspection Date</b>	<b>Next Inspection Date</b>	
	1505	19/12/2014		Yes	17-May-2019	17-May-2024	
	<b>Accessibility</b>	<b>Material</b>	<b>Extent</b>	<b>Result</b>

Accessible	Fibreboard	6m2	Assumed Positive			
	<b>Friability</b>	<b>Sealed / Surface Treatment</b>	<b>Risk Assessment</b>	<b>Control Actions</b>	<b>Labels Affixed</b>		
	Non Friable	Sealed	RA04 - Very Low	No Remedial Action - Reinspect Periodically	No		
	<b>Specific Location</b>						
Hazelbrook RFS - Internal - Toilets (x2) and adjacent Hallway – ceiling lining							
<b>Additional Comments</b>					<b>GPS Lat,Long</b>		
Sample - Similar to 25132-28-2 - Assumed Chrysotile

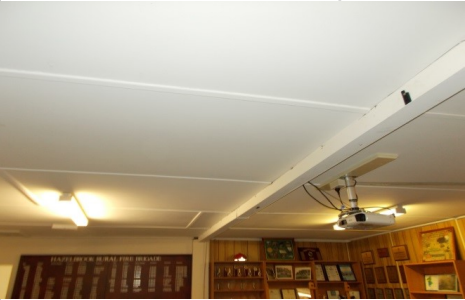
Ref No.	Date Identified	Clearance Cert Date	Onsite Register	Last Inspection Date	Next Inspection Date	
	1506	19/12/2014		Yes	17-May-2019	17-May-2024	
	Accessibility	Material	Extent	Result			
	Accessible	Fibreboard	35m2	Assumed Positive			
	Friability	Sealed / Surface Treatment	Risk Assessment	Control Actions	Labels Affixed		
	Non Friable	Sealed	RA04 - Very Low	No Remedial Action - Reinspect Periodically	No		
	Specific Location						
	Hazelbrook RFS - Internal - Meeting Room – ceiling lining						
	Additional Comments					GPS Lat,Long	
	Sample - Similar to 25132-28-2 - Assumed Chrysotile						
Status: Closed							
	Ref No.	Date Identified	Clearance Cert Date	Onsite Register	Last Inspection Date	Next Inspection Date	
	1500	19/12/2014		Yes	17-May-2019		
	Accessibility	Material	Extent	Result			
	Accessible	Timber		No Asbestos identified			
	Friability	Sealed / Surface Treatment	Risk Assessment	Control Actions	Labels Affixed

No Action Required - No ACM Identified			
	Specific Location						
	Hazelbrook RFS - External - Southern Perimeter – Electrical Box – electrical backing board						
	Additional Comments					GPS Lat,Long	
	No Suspect Material
