Asbestos Register

Melrose Park,

Fitzgerald Street, KATOOMBA NSW 2780

Asbestos Register and Management Plan

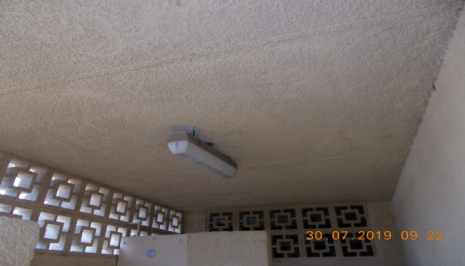
Licence Number	Address	Asset Type	Property Owner	Activity Level		
KATOOMBA NSW 2780						
RAR-136	Melrose Park Fitzgerald Street KATOOMBA	Shelter, Public toilet, The Crown Sporting amenity		Risks on site		
Amenties block						
Status: Active						
	Ref No.	Date Identified	Clearance Cert Date	Onsite Register	Last Inspection Date	Next Inspection Date
	1574	19/12/2014		Yes	05-Jul-2019	05-Jul-2024

Accessibility	Material	Extent	Result		
	Accessible	Fibreboard	6m2	Chrysotile		
	Friability	Sealed / Surface Treatment	Risk Assessment	Control Actions	Labels Affixed	
	Non Friable	Sealed	RA04 - Very Low	No Remedial Action - Reinspect Periodically	No	
Specific Location						
Melrose Park Amenities Block - Internal - Male Toilets - Ceiling Lining						
Additional Comments					GPS Lat,Long	
Sample - 25132-8-1

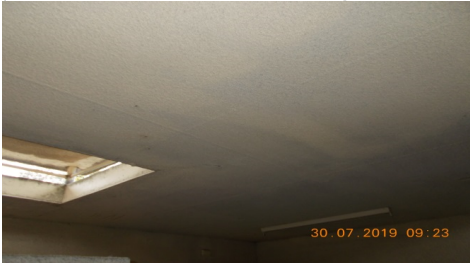
Ref No.	Date Identified	Clearance Cert Date	Onsite Register	Last Inspection Date	Next Inspection Date
	1586	19/12/2017		Yes	05-Jul-2019	05-Jul-2024
	Accessibility	Material	Extent	Result		
	Accessible	Fibreboard	15m2	Assumed Positive		
	Friability	Sealed / Surface Treatment	Risk Assessment	Control Actions	Labels Affixed	
Non Friable	Sealed	RA04 - Very Low	No Remedial Action - Reinspect Periodically	No		
Specific Location						
Melrose Park Amenities Block - Internal - Changeroom #1 - Ceiling Lining						
Additional Comments						GPS Lat,Long
Sample - Similar to 25132-8-1

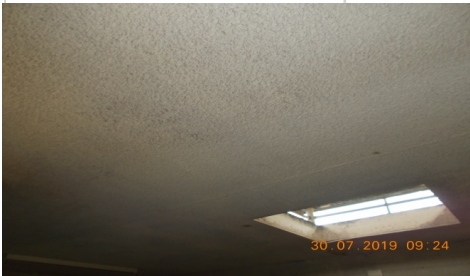
Ref No.	Date Identified	Clearance Cert Date	Onsite Register	Last Inspection Date	Next Inspection Date
	1590	19/12/2017		Yes	05-Jul-2019	05-Jul-2024
	Accessibility	Material	Extent	Result		
	Accessible	Fibreboard	12m2	Assumed Positive		
	Friability	Sealed / Surface Treatment	Risk Assessment	Control Actions	Labels Affixed	
Non Friable	Sealed	RA04 - Very Low	No Remedial Action - Reinspect Periodically	No

Specific Location						
Melrose Park Amenities Block - Internal Changeroom #2 Ceiling Lining						
Additional Comments						GPS Lat,Long
Sample - ART69
