# **Asbestos Register**

# **Management Plan**

**Lawson RFS, 284 Great Western Highway, Katoomba**

## Asbestos Register and Management Plan

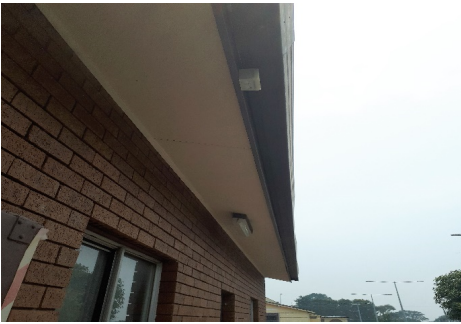
Ref No.	Date Identified	Clearance Cert Date	Onsite Register	Last Inspection Date	Next Inspection Date
	3046	19/12/2014		Yes	2/05/2019	2/05/2024
	Accessibility	Material	Extent	Result		
	Accessible	Fibreboard	16m2	Chrysotile		
	Friability	Sealed / Surface Treatment	Risk Assessment	Control Actions	Labels Affixed	
	Non Friable	Sealed	RA04 - Very Low	No Remedial Action - Reinspect Periodically	No	
	Specific Location					
	Lawson RFS - External Eaves Linings					
	Additional Comments					GPS Lat,Long
	Sample - 25132-30-1

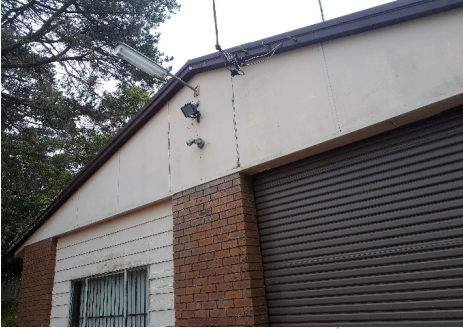
<b>Ref No.</b>	<b>Date Identified</b>	<b>Clearance Cert Date</b>	<b>Onsite Register</b>	<b>Last Inspection Date</b>	<b>Next Inspection Date</b>	
	3047	19/12/2014		Yes	2/05/2019	2/05/2024	
	<b>Accessibility</b>	<b>Material</b>	<b>Extent</b>	<b>Result</b>			
	Accessible	Fibreboard	12m2	Chrysotile			
	<b>Friability</b>	<b>Sealed / Surface Treatment</b>	<b>Risk Assessment</b>	<b>Control Actions</b>	<b>Labels Affixed</b>		
	Non Friable	Sealed	RA04 - Very Low	No Remedial Action - Reinspect Periodically	No		
	<b>Specific Location</b>						
Lawson RFS - External Gable ends							
<b>Additional Comments</b>					<b>GPS Lat,Long</b>		
Sample - 25132-30-2 Unsealed edges

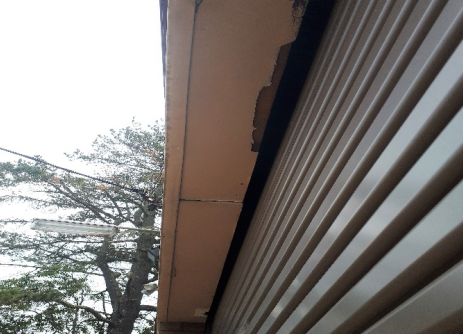
<b>Ref No.</b>	<b>Date Identified</b>	<b>Clearance Cert Date</b>	<b>Onsite Register</b>	<b>Last Inspection Date</b>	<b>Next Inspection Date</b>	
	3048	19/12/2014		Yes	2/05/2019	2/05/20204	
	<b>Accessibility</b>	<b>Material</b>	<b>Extent</b>	<b>Result</b>

Accessible	Fibreboard	.5m2	Chrysotile			
	<b>Friability</b>	<b>Sealed / Surface Treatment</b>	<b>Risk Assessment</b>	<b>Control Actions</b>	<b>Labels Affixed</b>		
	Non Friable	Sealed	RA04 - Very Low	No Remedial Action - Reinspect Periodically	No		
	<b>Specific Location</b>						
Lawson RFS - External - Above Roller Doors Fascia Linings							
<b>Additional Comments</b>					<b>GPS Lat,Long</b>		
Sample - 25132-30-3

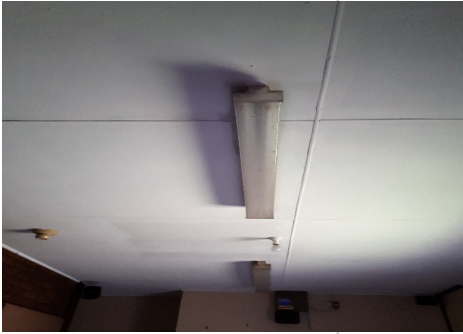
Ref No.	Date Identified	Clearance Cert Date	Onsite Register	Last Inspection Date	Next Inspection Date
	3058	19/12/2014		Yes	2/05/2019	2/05/2024
	Accessibility	Material	Extent	Result		
	Accessible	Fibreboard		Chrysotile		
	Friability	Sealed / Surface Treatment	Risk Assessment	Control Actions	Labels Affixed	
	Non Friable	Sealed	RA04 - Very Low	No Remedial Action - Reinspect Periodically	No	
	Specific Location					
Lawson RFS - Internal Kitchen Ceiling Lining						
Additional Comments					GPS Lat,Long	
Sample - 25132-30-9						
Status: Closed						
<p>No Photo</p>	Ref No.	Date Identified	Clearance Cert Date	Onsite Register	Last Inspection Date	Next Inspection Date
	3049	19/12/2014		Yes	2/05/2019	
	Accessibility	Material	Extent	Result		
	Accessible	Fibreboard		No Asbestos identified		
	Friability	Sealed / Surface Treatment	Risk Assessment	Control Actions	Labels Affixed	
				No Action Required - No ACM Identified

Specific Location					
Lawson RFS - External - Southern Perimeter – external wall cladding						
Additional Comments					GPS Lat,Long	
Sample -25132-30-4
