Asbestos Register

Katoomba/Leura Brigade Station,
26 Fitzgerald Street, KATOOMBA NSW 2780

Asbestos Register and Management Plan

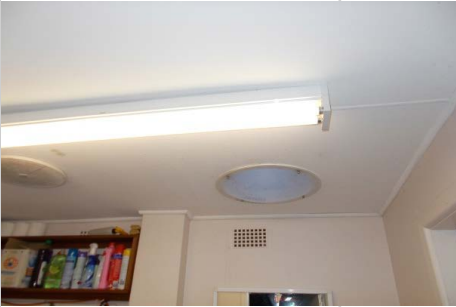
Ref No.	Date Identified	Clearance Cert Date	Onsite Register	Last Inspection Date	Next Inspection Date
	235	19/12/2014		Yes	15-May-2019	15-May-2024
	Accessibility	Material	Extent	Result		
	Accessible	Fibreboard	4m2	Chrysotile		
	Friability	Sealed / Surface Treatment	Risk Assessment	Control Actions	Labels Affixed	
Non Friable	Sealed	RA04 - Very Low	No Remedial Action - Reinspect Periodically	No		
Specific Location						
Katoomba/Leura - Internal - Male/Female Toilet – ceiling lining						
Additional Comments					GPS Lat,Long	
Sample - 25132-29-4
